An Assessment of Abandoned Mines in Northern Saskatchewan

March, 2001

Prepared for:
***Saskatchewan Environment
and Resource Management***

Prepared By: ***(KHS) Environmental Management
Group Ltd.***

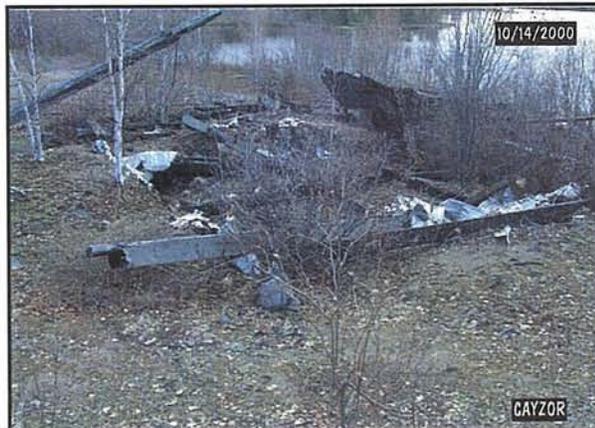
The main shaft (N 59° 34.758'; W 108° 39.466') is also sealed. The shaft area is approximately 4 by 5 m and is sealed by concrete, rock and lumber. The stability of the closure must be considered suspect. It is in poor condition and the stability of closure is in question, making it unpredictable. There were no liquid discharges at the time of inspection, nor was there evidence of previous flooding. The remains of the headframe consist of a pile of rubble composed primarily of rotting lumber and steel debris.

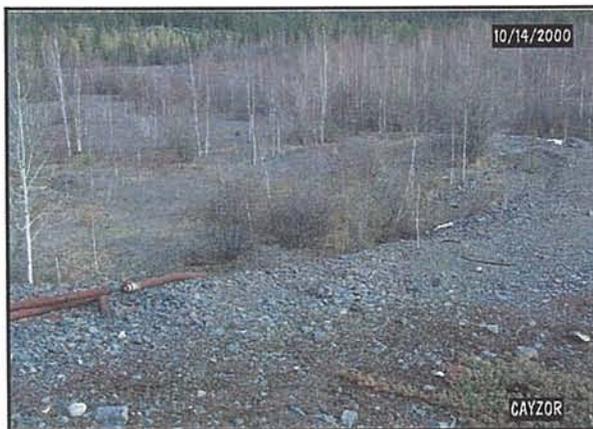
Waste rock covers a large area of the mine site. It makes up all the roads in the area and covers approximately 15-20 hectares. Generally the waste rock appears shallow and relatively stable. The waste rock also comprises a portion of the shoreline of a lake at the south east section of the site.

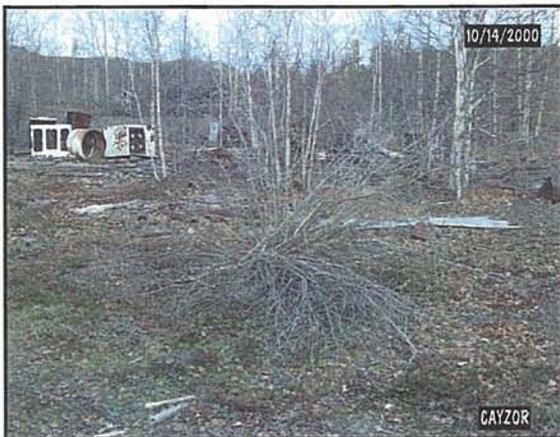
There is a large amount of debris throughout the area. It is suspected that before the access road was washed out people used the area to dump refuse. There is also a large amount of debris that can be associated with the mine activities. This includes rail tracks, barrels, a steel generator, ore buckets and cars. Some of this debris has been pushed down a slope towards the lake on the north east end of the site.

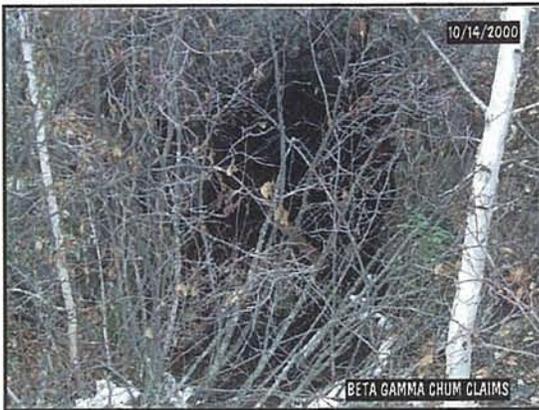
The adit (N 59° 36.522'; W 108° 38.215') is located approximately 65 m north of the shaft. It is a 1.5 by 2 m opening. It is in poor condition and was flooded at the time of inspection. There was no liquid discharge at the time of inspection but there was evidence of previous flooding,

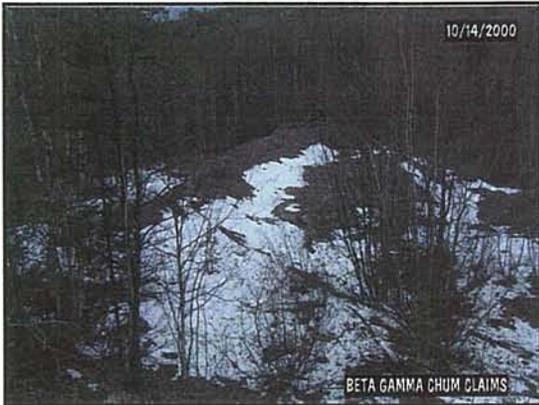
There is a large amount of waste rock on site. This rock is scattered throughout the site however the bulk of the waste rock is concentrated in one large pile near the shaft. The pile has steep sides and should not be considered stable.

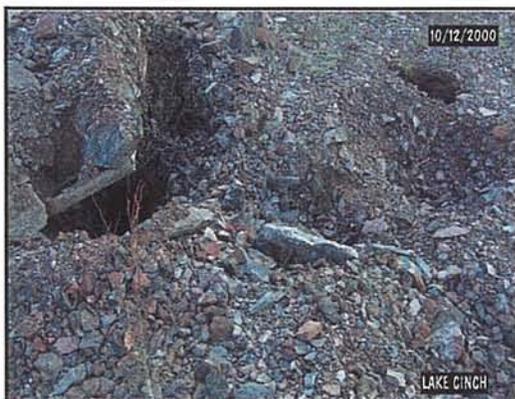
Shaft #2 which is approximately 10 m west of Shaft #1 is slightly larger. It is approximately 5.5 by 5.5 m in size and is also sealed with a grate and waste rock. Shaft #2 is in extremely poor condition and shows extensive signs of slumping. There was no liquid discharge or evidence of previous flooding from Shaft #2.

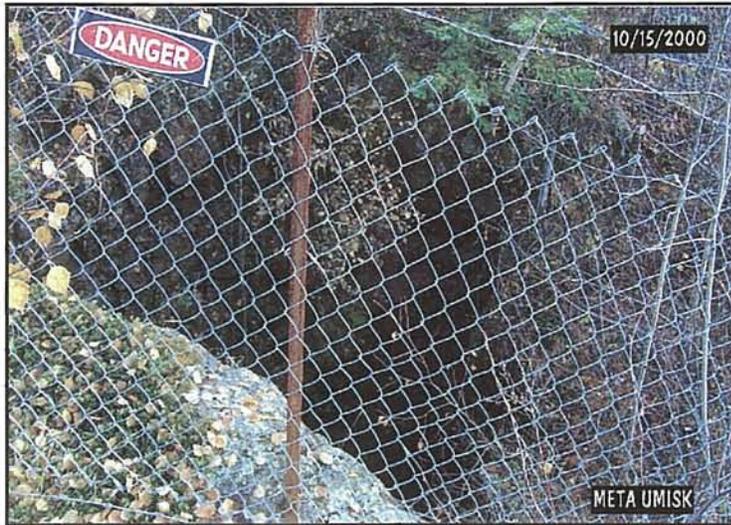
The raise is approximately 20 m up the slope from the adit entrance to the northeast at N 59° 31.809'; W 108° 29.051'. The entrance is approximately 4 by 3 m and remains open. There is a fence around the raise, however, the hole showed signs of slumping and the fence may collapse standing if the sides continue to fall inward. There was no liquid discharge or signs of previous flooding from the raise entrance.

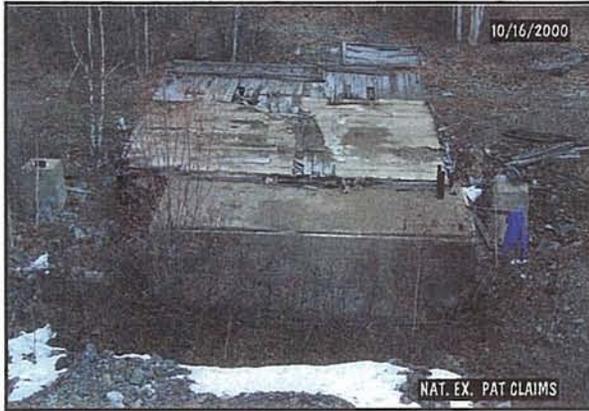
The shaft is located near the east end of the mine site. The shaft is approximately 5 by 5 m and is sealed with concrete. The concrete is thin and evidence of rotting is apparent. The cap is deteriorating and is not in good condition. There is several concrete foundations associated with the shaft. There was no liquid discharge at the time of inspection and no evidence of previous flooding.

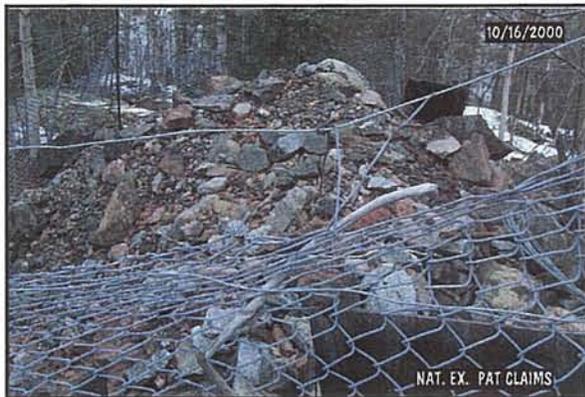
The raise is located up the slope from the shaft approximately 100 m to the northeast (N 59° 35.495'; W 108° 26.057'). The size of the opening is approximately 2 by 3 m. The opening is securely sealed with rock and is in stable condition. There was no liquid discharge and no evidence of previous flooding.

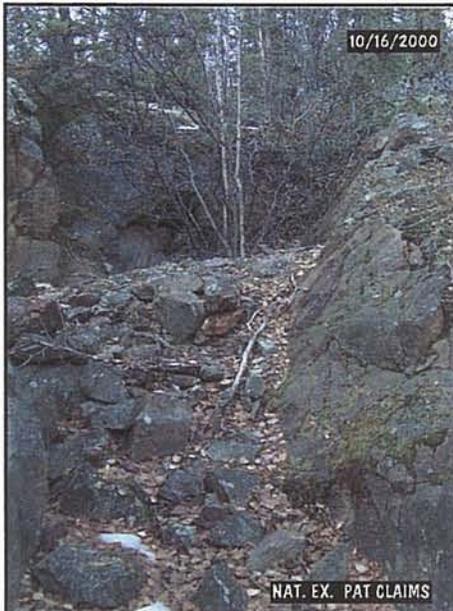
The inclined shaft is approximately 50 m south of the raise and approximately 100 m east of the main shaft. The opening is sealed with blasted rock and appears to be stable. It is difficult to estimate the size of the opening because the blasting has created a trench, where the entrance has collapsed. The opening appears to be stable and in relatively good condition. There was no liquid discharge at the time of inspection and no evidence of previous flooding.

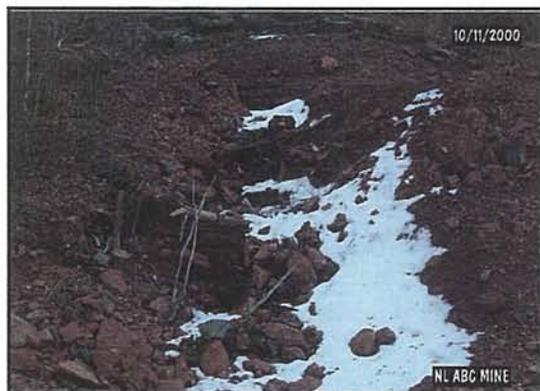
Adit #2 is located approximately 35 m north of adit #1. This adit entrance also appears to have been sealed with waste rock. The rock has been washed away and at the time of inspection there was a small amount of liquid discharging from the adit entrance which immediately disappears into the waste rock approximately 10 m from the adit opening.

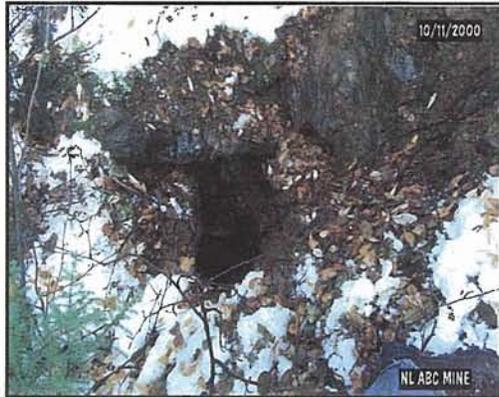
Site #42 is located approximately 300 m northeast of the shaft directly up the slope. It consists of a large trench approximately 15 m long, 2 m wide, and 2 m deep. At the bottom of the trench is an opening that is approximately 0.75 by 0.75 m in size. The trench shows signs of slumping and the overall stability of the area is poor.

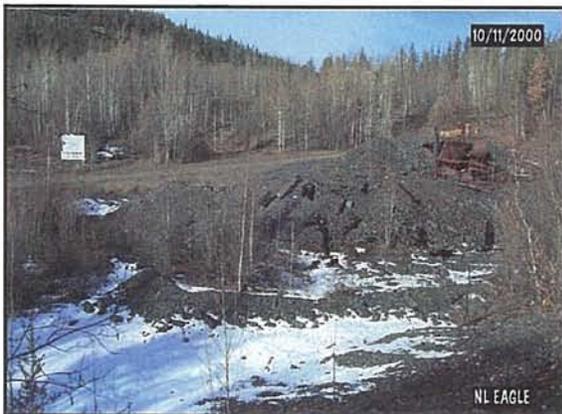
The mine consists of three openings that are of concern. The main shaft (N 59° 34.460'; W 108° 29.521') is sealed with waste rock and the burnt remains of the headframe. The overall condition of the closure is good, but there is some evidence of slumping at the shaft and some immediately north of the shaft pile. There are two cement foundations associated with the headframe that are in stable condition, with a small amount of debris near them.

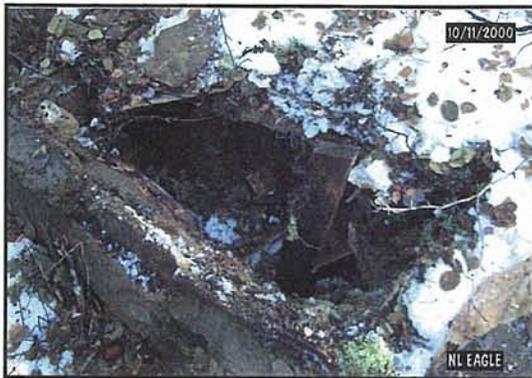
The raise is approximately 120 m northeast of the shaft, up the slope. The raise is immediately above a trench and the cap is in poor condition. The cement cap is badly deteriorated and cracked to the point that access could be easily obtained. The hole itself is approximately 1.5 by 1.5 m and is filled with debris. The debris gives the impression that the raise is not deep. There were no buildings associated with the raise, there was no liquid discharge at the time of inspection and no evidence of previous flooding.

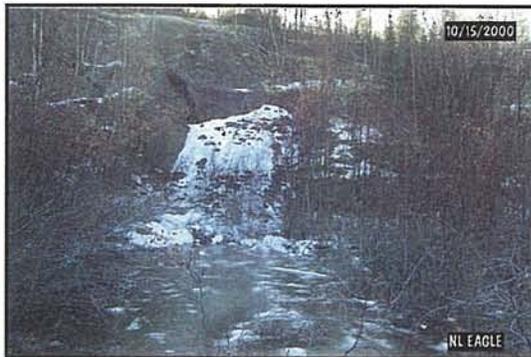
The adit is approximately 50 m south of the shaft. It is sealed with waste rock and the condition of the entrance is good. There are no support buildings near the entrance. There was no liquid discharge at the time of inspection but pooled water immediately in front of the adit entrance suggests that there is water coming out of the adit entrance. The stability of the waste rock is good.

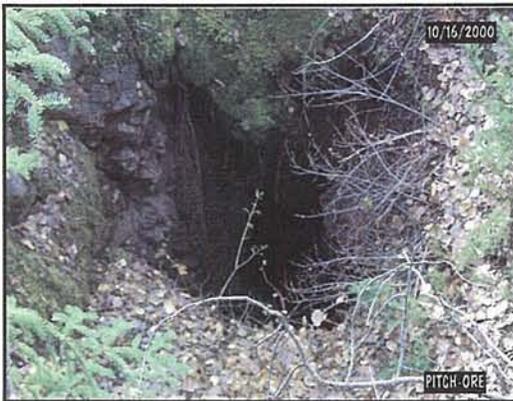
An open raise is located approximately 750 m northwest of the adit #1 entrance. The opening is approximately 4 by 3 m in size and presents an immediate danger to anyone walking in the area.

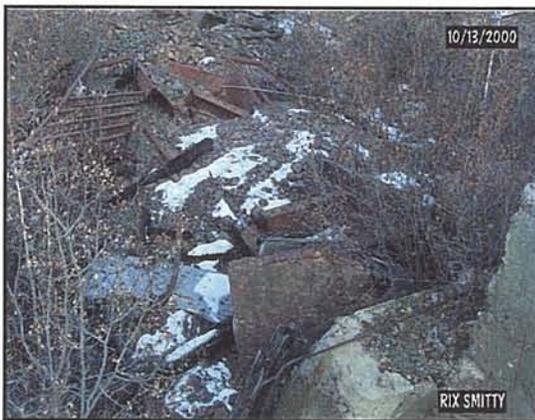
The main shaft is located near the centre of the mine site (N 59° 33.978'; W 108° 41.446'). It is approximately 5 by 5 m in size and is partially open. The opening has been filled in with timbers, rock, and other miscellaneous debris. The stability of the closure is poor, as is the overall condition of the shaft area. There is obvious signs of slumping around the opening. There was no liquid discharge at the time of the inspection and no evidence of previous flooding. There is also a concrete foundation and the remnants of a building in the immediate area of the opening.

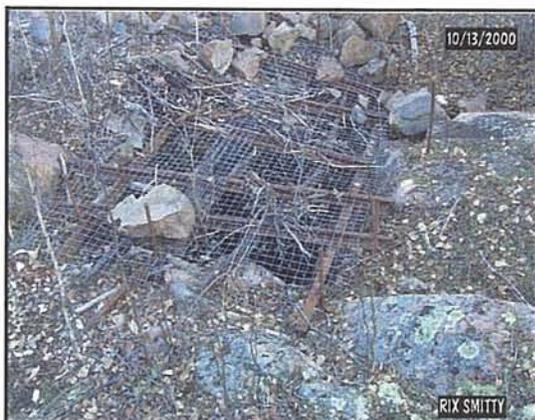
The ventilation raise is located approximately 75 m to the northeast. Global positioning satellite reading of the raise opening was N 59° 33.960' and W 108° 41.386'. The opening is approximately 2 by 3 m in size and is tentatively sealed with a steel grate. The stability of the closure is poor and the overall condition of the opening is not acceptable. The grate that is covering the opening is relatively stable for the time being but should be considered temporary at best. There was no liquid discharge at the time of inspection and no evidence of previous flooding.

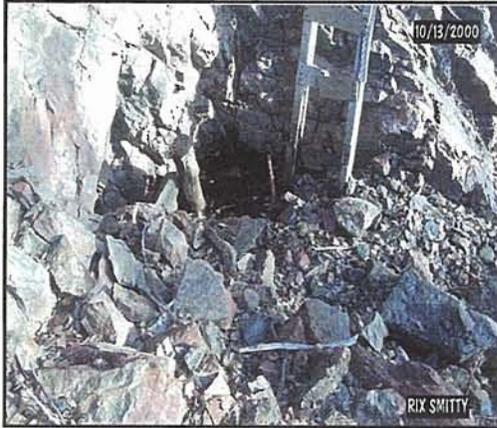
The final opening at the Smitty mine site is a raise (N 59° 33.983'; W 108° 41.454') approximately 100 m to the north of the main shaft. The opening is approximately 0.75 by 0.75 m in size and it has been sealed with waste rock. There was no liquid discharge at the time of inspection, but there was definite evidence of previous flooding. There was no support building in the area but the opening had a wooden ladder protruding from it.

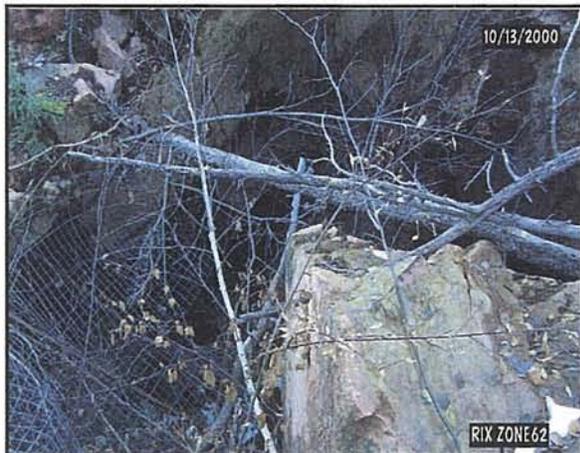
The raise is located approximately 100 m north-northeast (N 59° 34.128' and W 108° 41.512') of the adit entrance. The opening is approximately 4 m wide and 6 m in length. There was definite evidence of slumping and rock falls; these boulders have precariously sealed the opening.

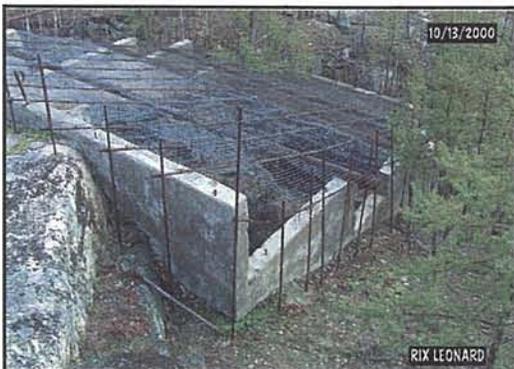
The shaft and trench are approximately 100 m above the adit entrance (N 59° 33.494'; W 108° 40.592'). The shaft opening is approximately 9.6 by 7 m in size and is collared by concrete. The opening consists of two shafts that come together at the surface. The opening is sealed with a drill rod grate and metal screening; all tied to the concrete collar. The grate is in good condition along with the concrete collar. There was no liquid discharge at the time of inspection

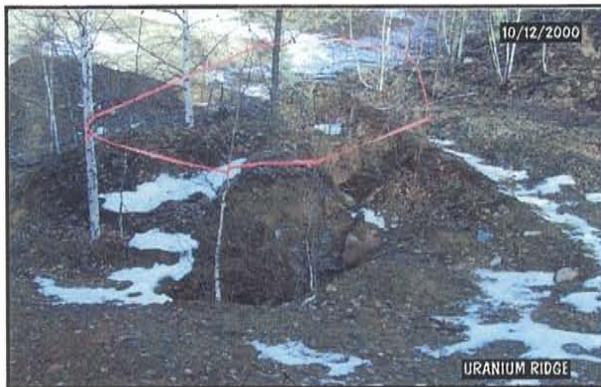
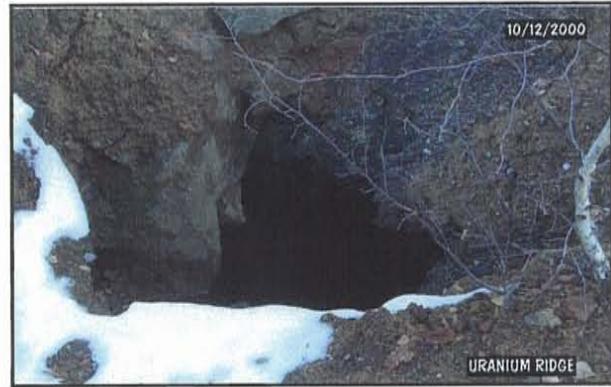
sealed with waste rock and blasted to form a trench down the slope to the adit entrance. At the time of inspection a 1.5 by 1 m hole which provides direct access to the workings was observed. The condition of the raise is extremely poor and there is extensive slumping around the hole. There was no liquid discharge at the time of inspection and there was no evidence of previous flooding.

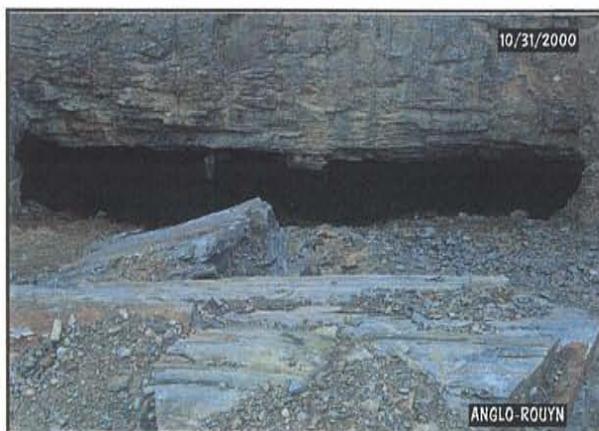
The open pit is approximately 75 m to the north east of the shaft/mill area. The pit is approximately 150 m long, 30 m wide, and 25 m deep. The walls of the pit are unstable and in very poor condition. The walls, primarily the south wall have been undercut making them steep. There is evidence of rock slides and slumping. The pit is flooded with no vegetation growing within the pit or on the walls. There are two openings at the bottom of the pit; one is a cribbed vent raise approximately 3 by 3 m in size, the other is a breakthrough to surface.

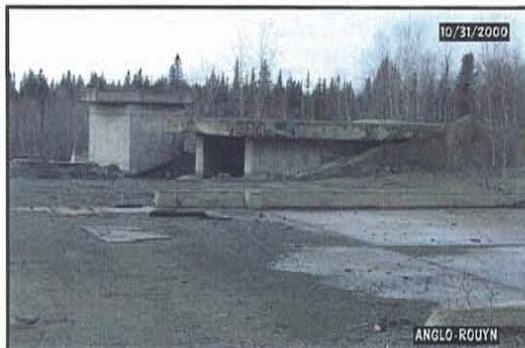
There are numerous concrete foundations within the mill area. They are in stable condition but are showing signs of deteriorating. There are several that are relatively high (approximately 5 m) that could pose a hazard. There are also two structures that have arch ways that could become hazardous as the condition of the concrete deteriorates.

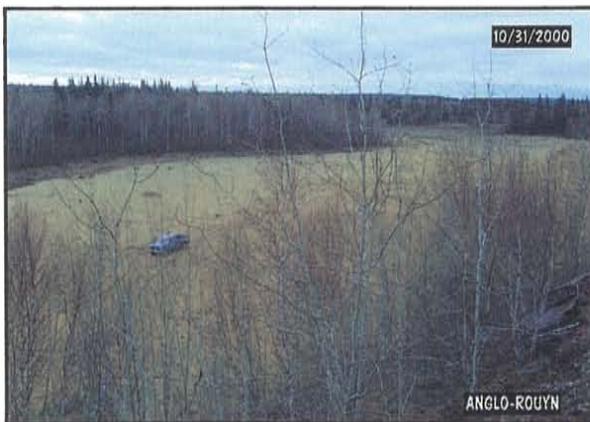
The main tailings disposal area is approximately 500 m to the south of the mill site. The area is poorly vegetated and approximately 500 by 200 m in size. There is a waste rock containment dam along the south boundary. It is in stable condition, although evidence of seeping is apparent immediately south of the dam. The tailings area is showing signs of wind and water erosion.

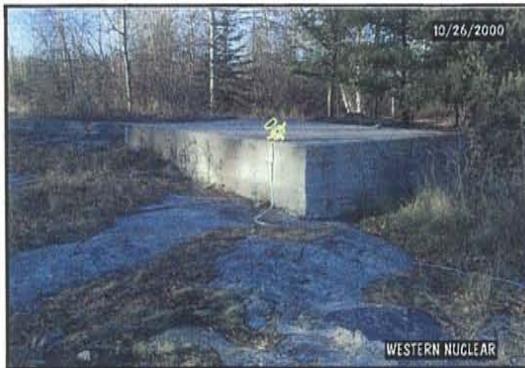
The raise was located directly south of the mill site approximately 8 m from the lakeshore. It is sealed with a concrete cap and in good condition, with a drain pipe exiting the concrete closure. There was no evidence of previous discharge. The closure is approximately 4.3 by 3 m in size. There is an additional concrete foundation immediately beside the shaft closure. It is unknown what the purpose of the foundation is.

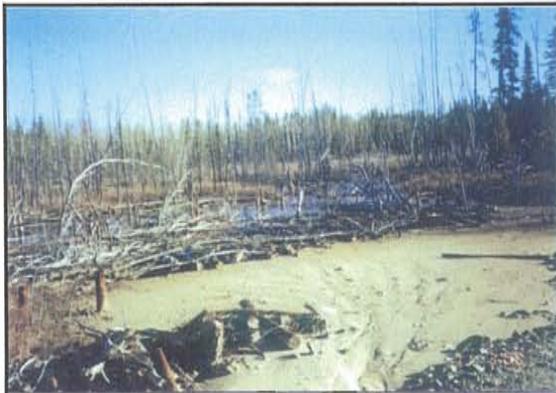
The first area requiring rehabilitation is the tailing management area in general as it has not been decommissioned and is showing significant signs of water and wind erosion with little containment on the southern perimeter.
