**AN ASSESSMENT OF
ABANDONED MINES IN
NORTHERN SASKATCHEWAN
(YEAR 2)**

**GULCH MINE ADIT-URANIUM CITY AREA
SEPTEMBER 29, 2001**

An Assessment of Abandoned Mines in
Northern Saskatchewan

Prepared by: Clifton Associates Ltd.
on behalf of
P.A.N.S. Joint Venture

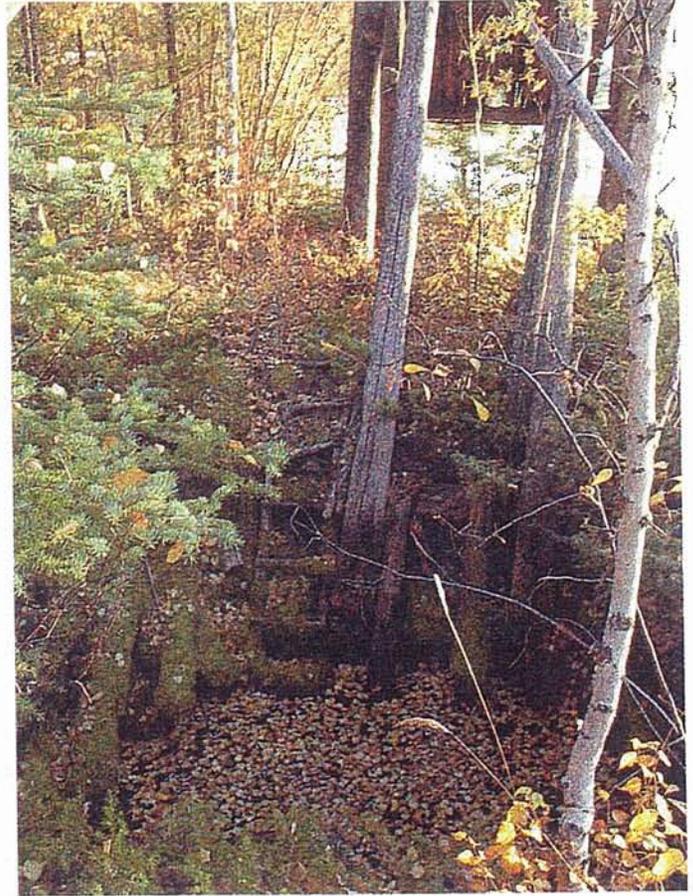
The mine workings consist of a shaft located about 20 m from the shore of Tazin Lake. The shaft is about 4 m in diameter and is filled with water to about 5 m below surface. The water level appears to correspond to the water level of Tazin Lake which suggests a hydraulic connection between the lake and shaft. It was not possible to acquire a water sample due to dangerous conditions at the edge of the shaft. A dilapidated ladder extends from the surface into the shaft.

Photo 6.2-2 Caba Shaft Opening
September 26, 2001

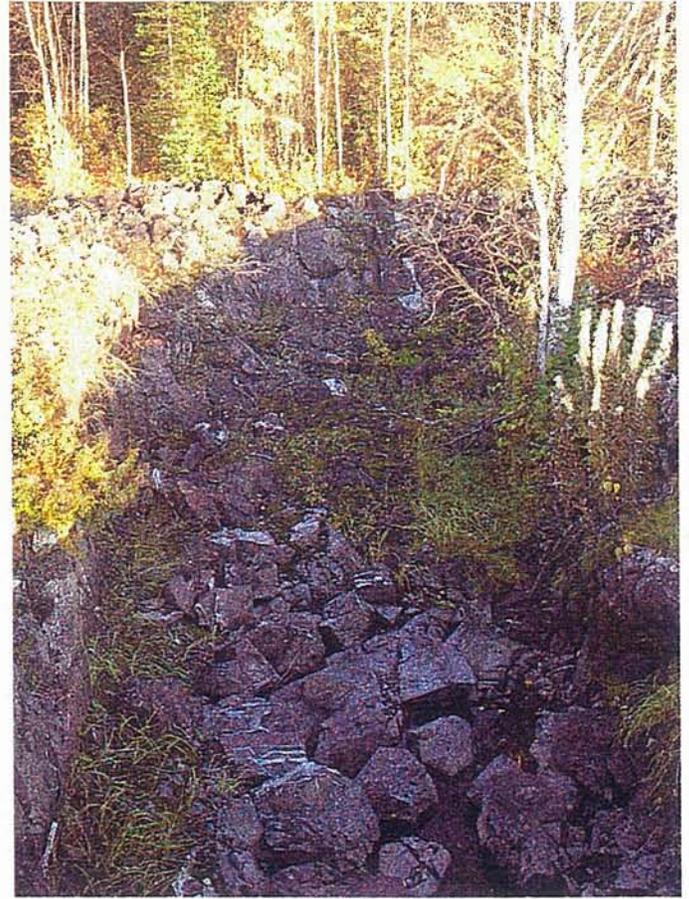
Photo 6.2-5 Caba Trench
September 26, 2001

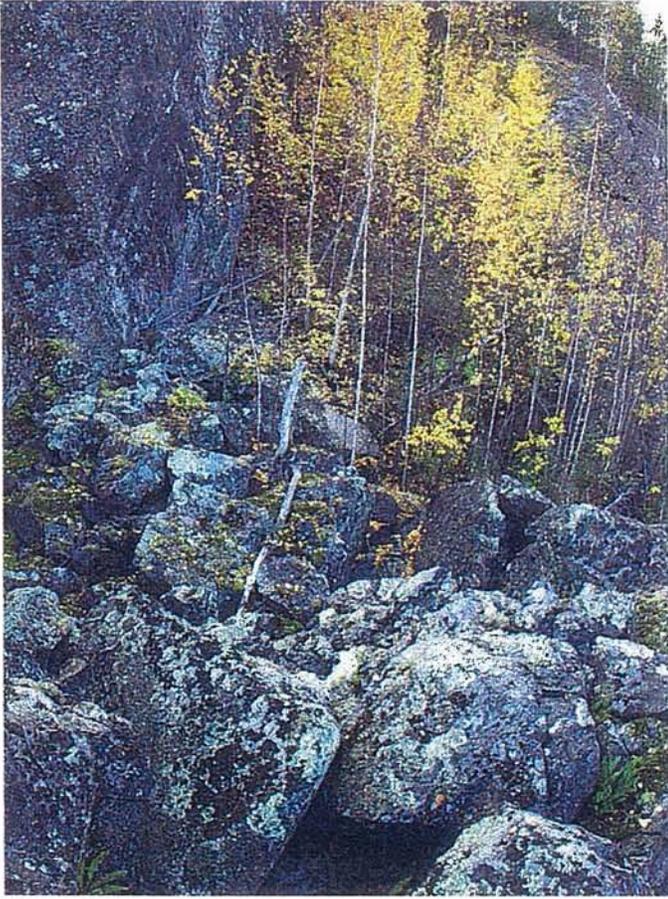
Assuming that the site has in fact been covered by the rock fall, there is no follow-up required. A follow-up inspection of the area should be done in the future to confirm that the site has been covered.

Photo 6.3-1 Rock Fall at Pitch Ore Site
September 27, 2001

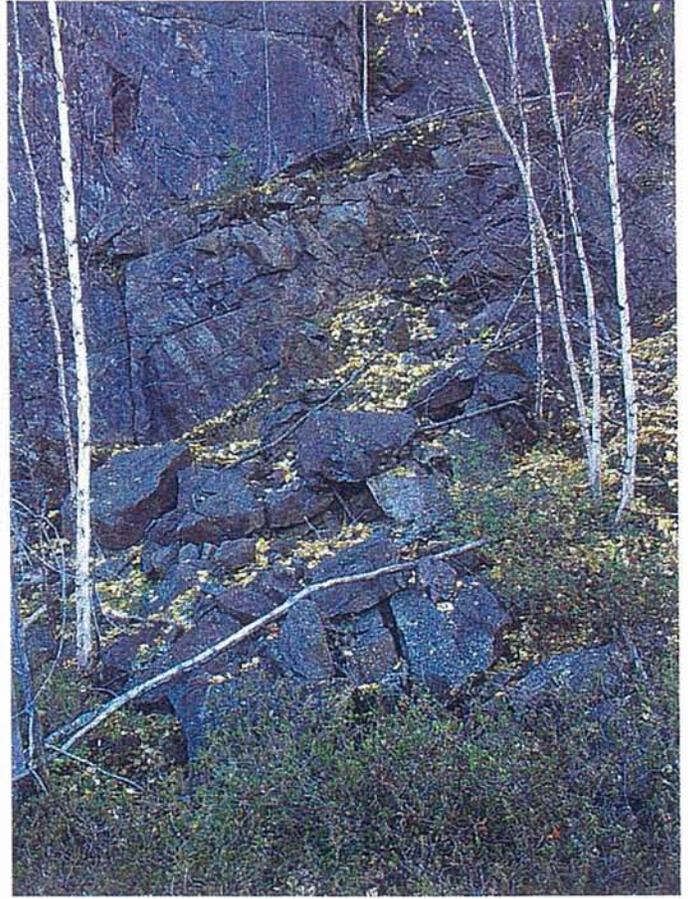
Photo 6.3-2 Rock Fall at Pitch Ore Site
September 27, 2001

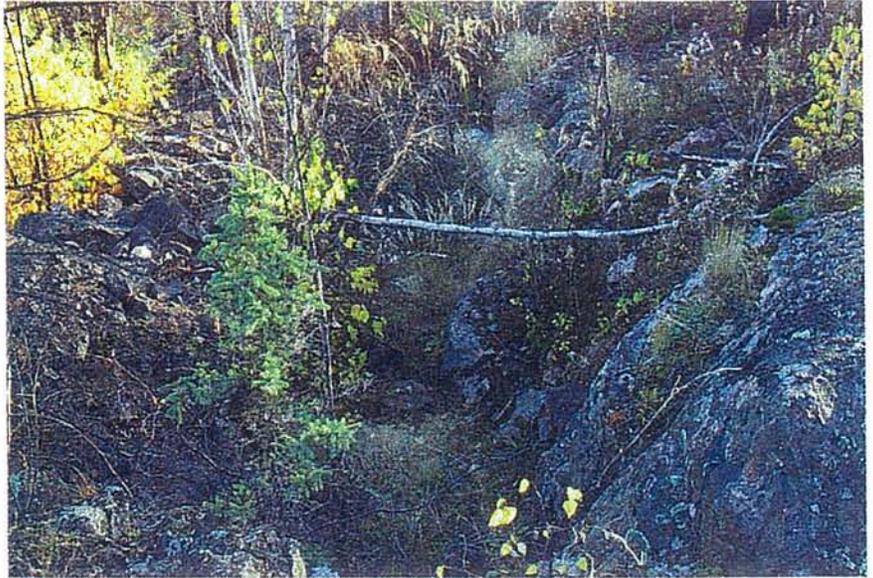
Photo 6.5-2 Trench at Don Henry Site
September 27, 2001

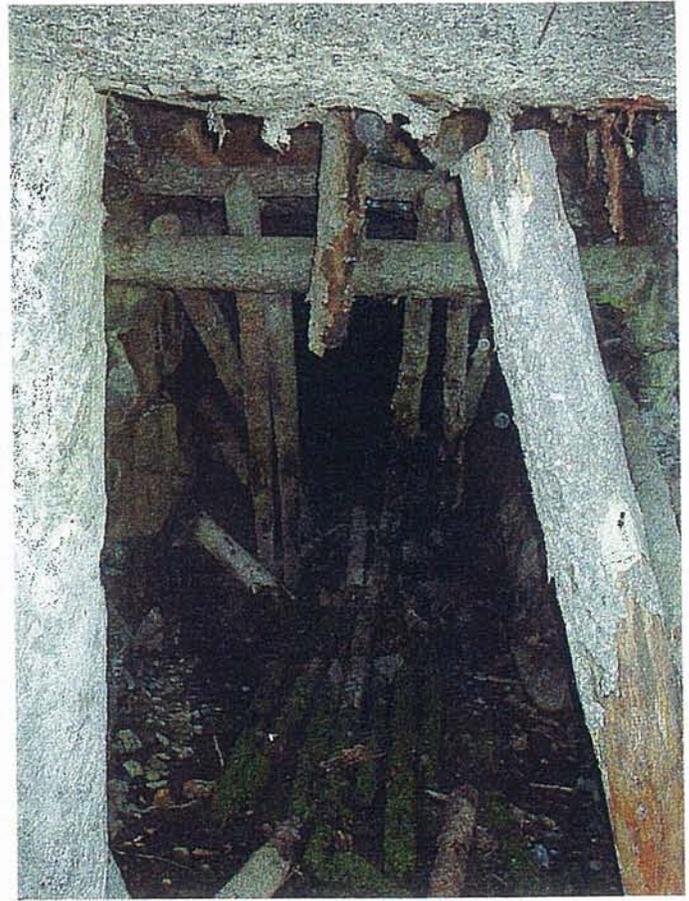
Photo 6.6-5 Adit Closeup-Homer Yellowknife
September 28, 2001

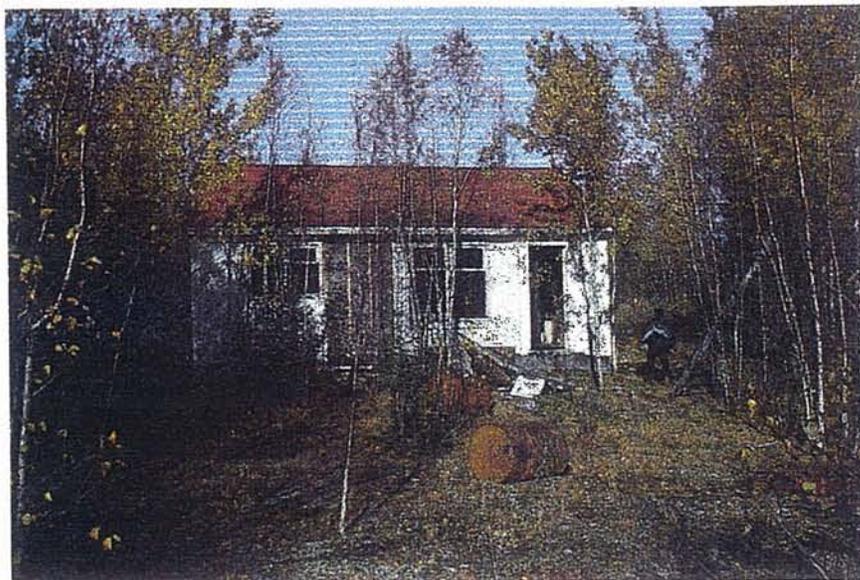
**Photo 6.7-1 Camp Building on Trail
Leading to Mine Site
September 28, 2001**

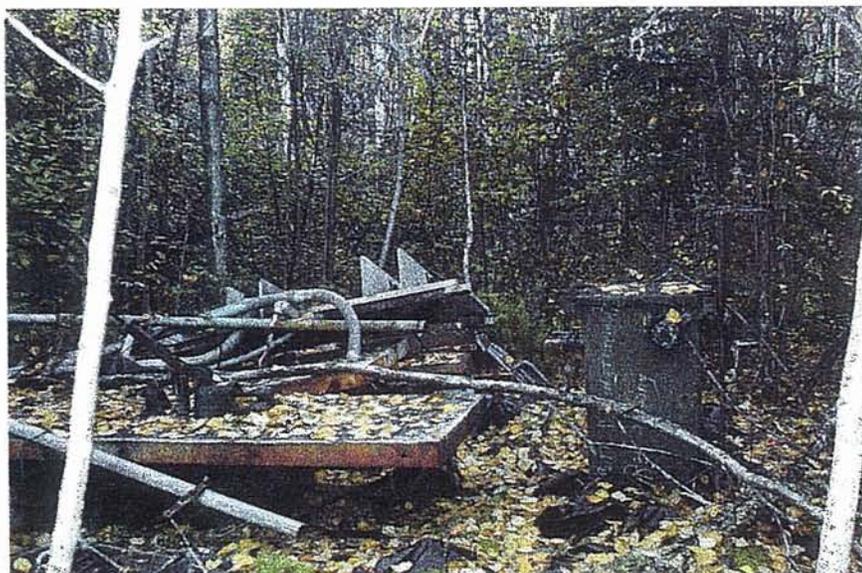
**Photo 6.7-2 Electrical Station and
Transformer on Trail Leading to Mine
Site
September 28, 2001**

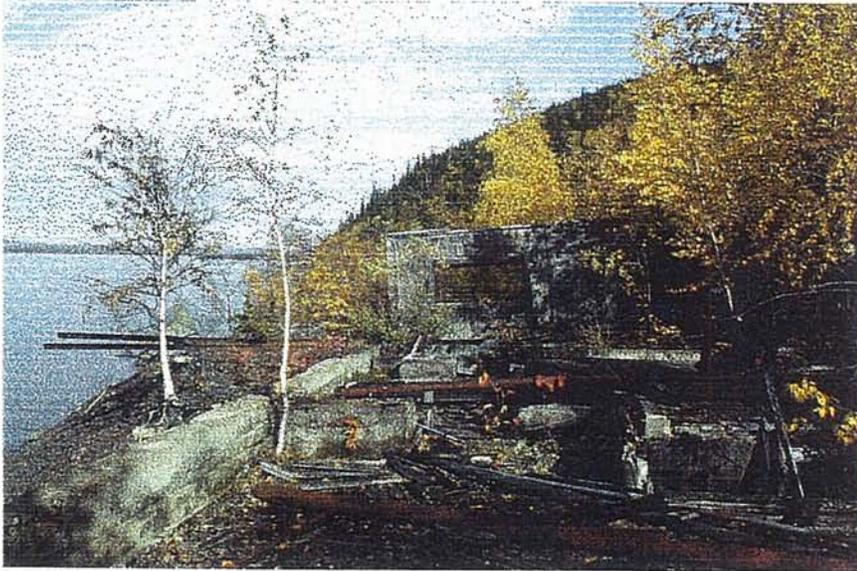
Phot 6.10-3 Dilapidated Wooden Building
September 29, 2001

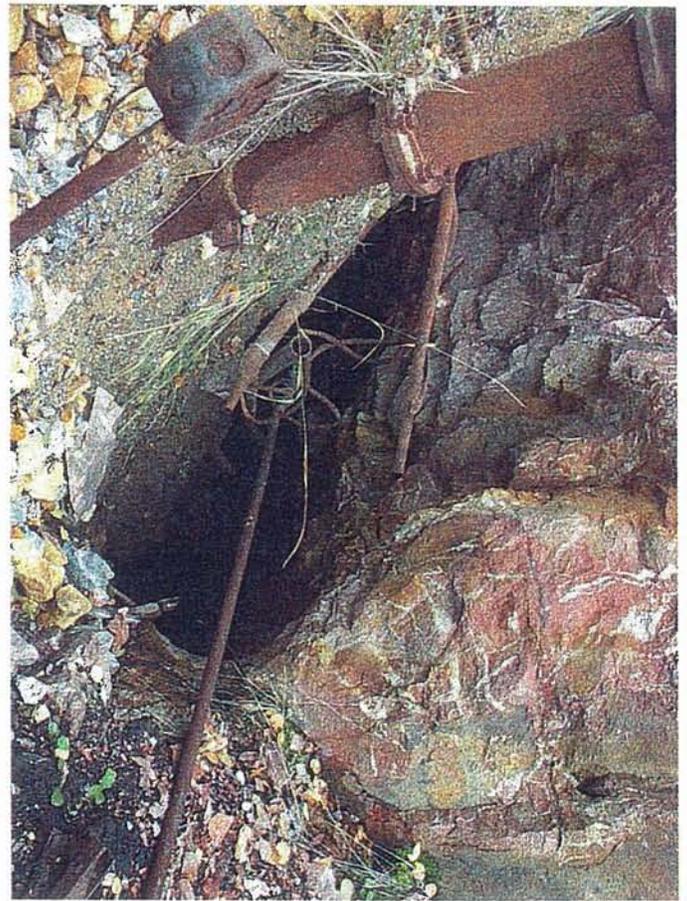
Photo 6.16-2 Box Mine Shaft Opening
October 01, 2001

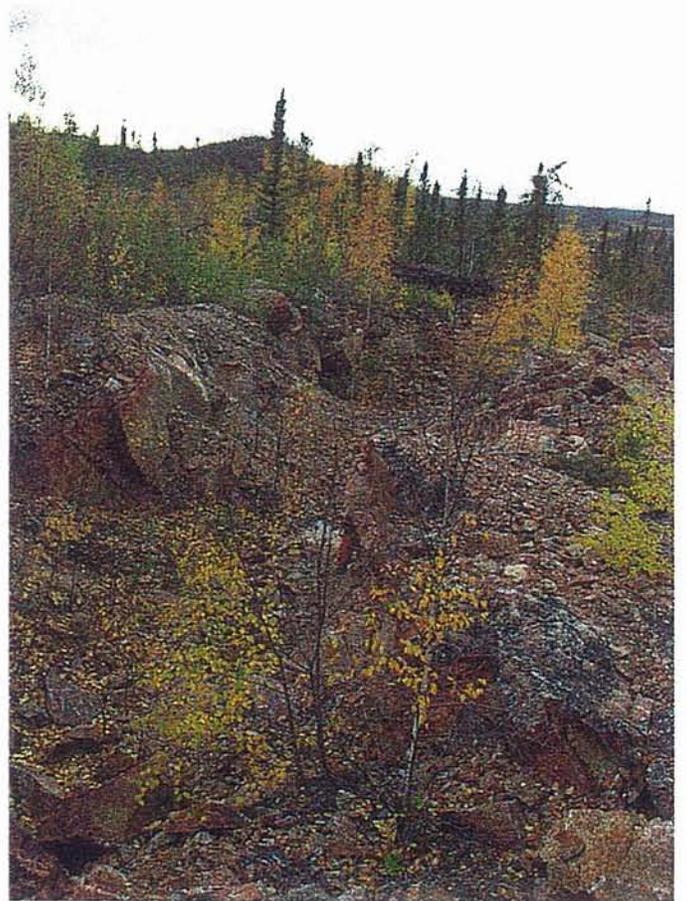
Photo 6.16-8 Trench Near Box Mine Shaft Area
October 01, 2001

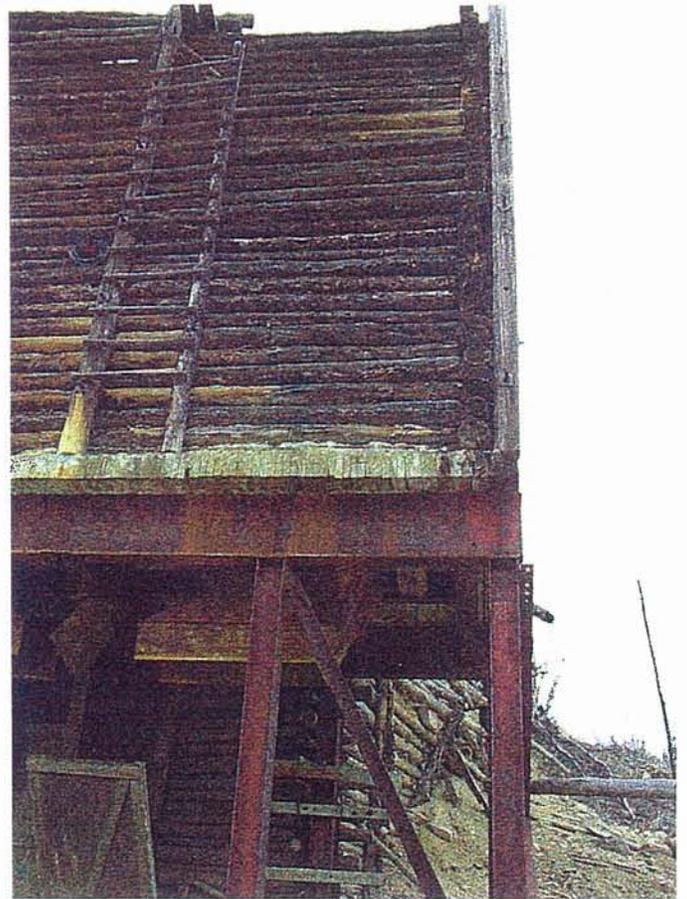
Photo 6.18-11 Close-up of Mill Remnants
October 17, 2001

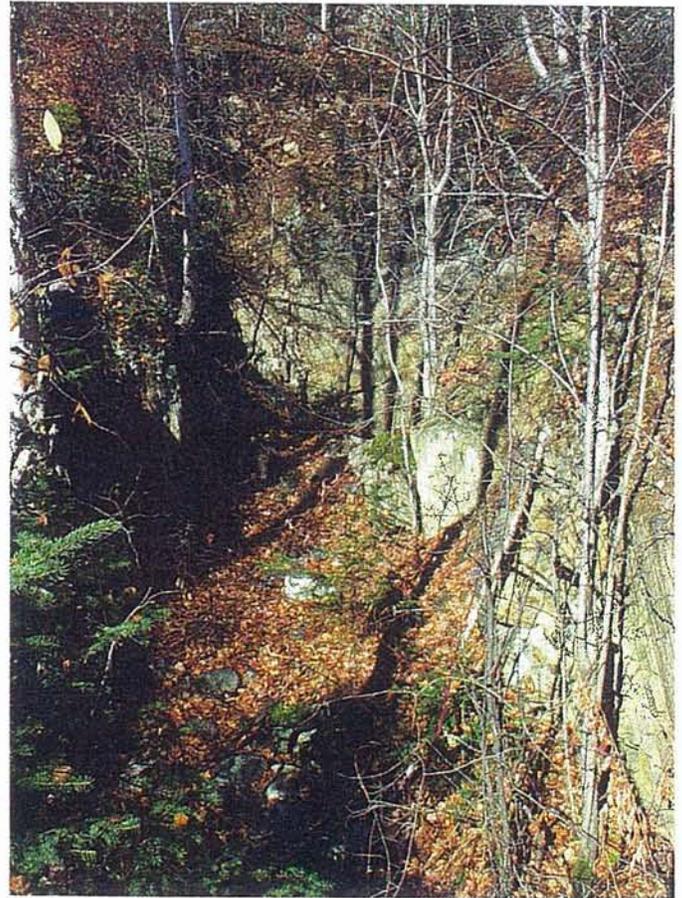
Photo 6.19-5 Preview Trench Upslope From Adit
October 18, 2001

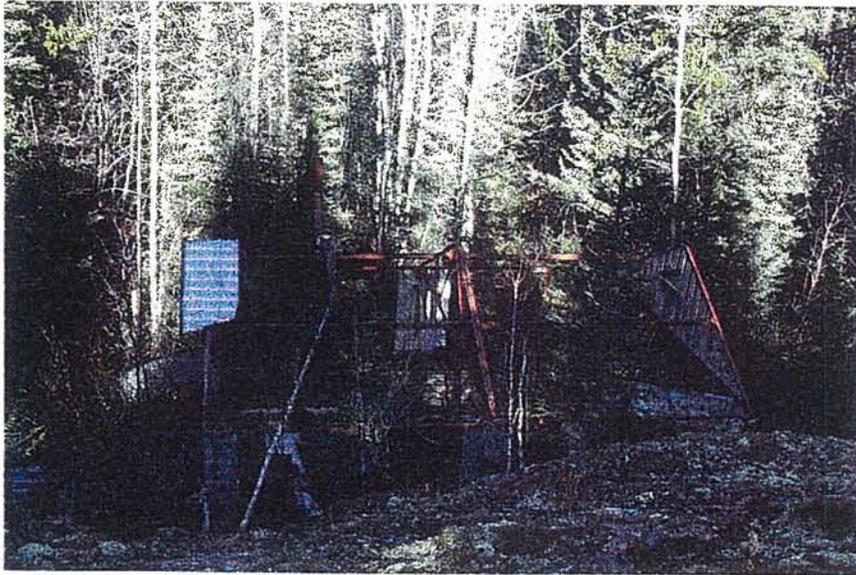
Photo 6.20-6 Dilapidated Building and Concrete Foundation
October 18, 2001

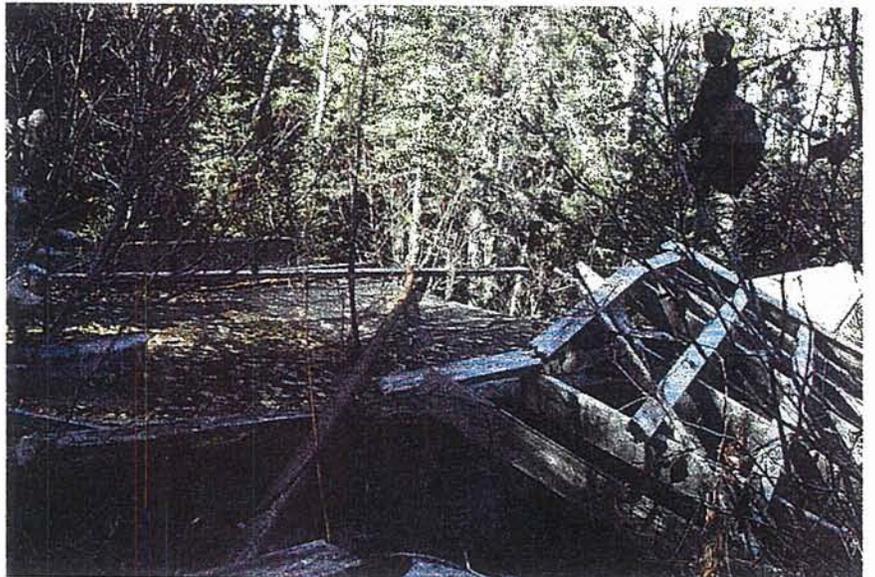
Photo 6.20-7 Pressure Vessel
October 18, 2001

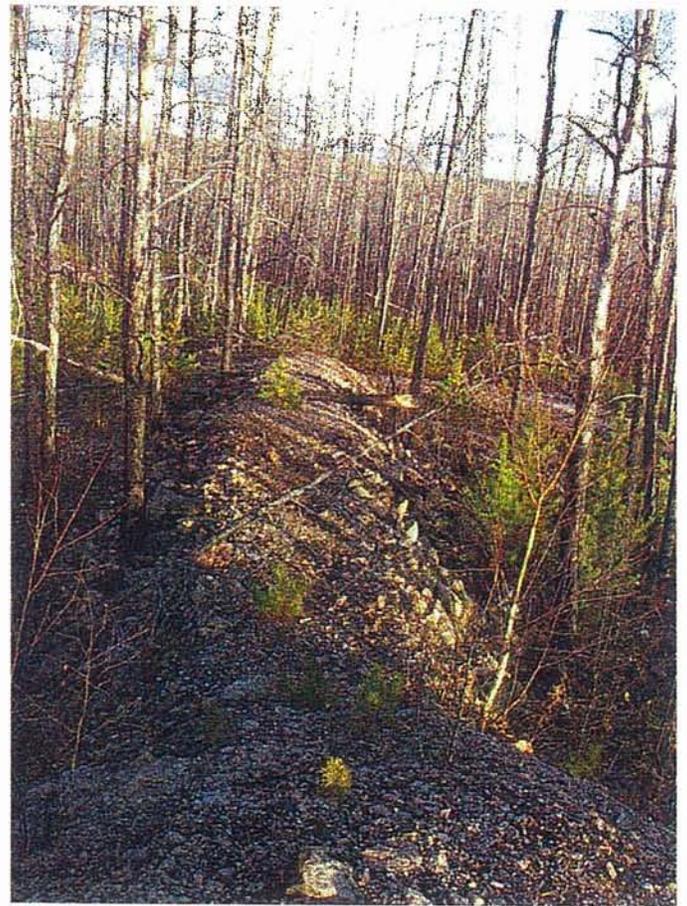
Photo 6.22-5 Main Waste Rock Pile
October 18, 2001
