APPENDIX C – PlanGrid Task Report

PlanGrid Task Report - Aug 19, 2020

Prepared by James Holtom

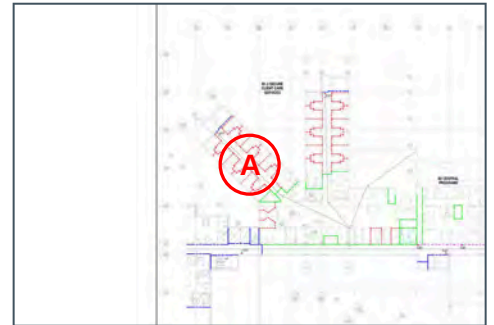
E2-140. Outside of room in access panel. Insulation is loosely installed. Needs to be tight for sound attenuation and insulation.

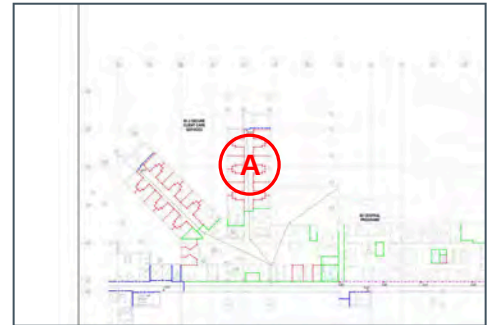
Hallway - discolouration in the flooring. Defect or maybe a stain?

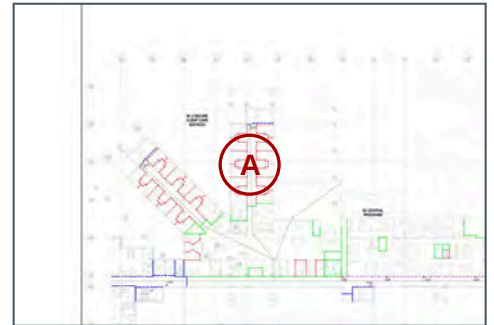
Signs of water damage in ceiling tiles

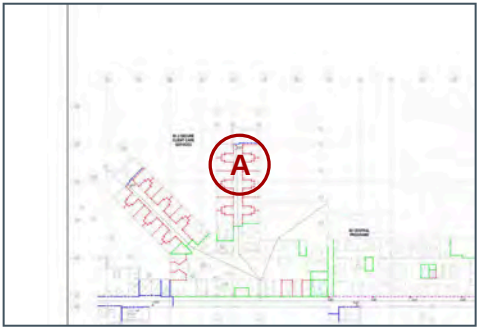
Description
Floor stain

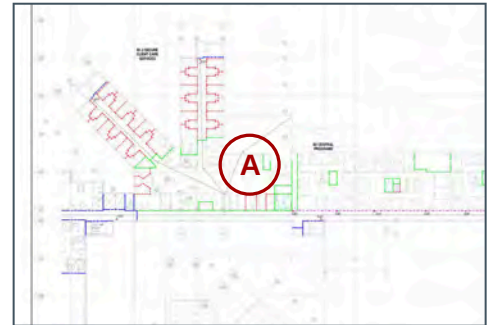
Missing wall protection in lounge area w2218

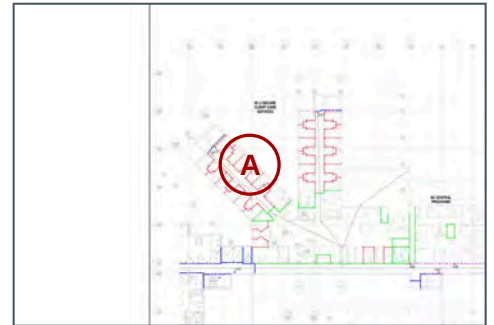
Wall protection bubbling off, leak to the soap holder

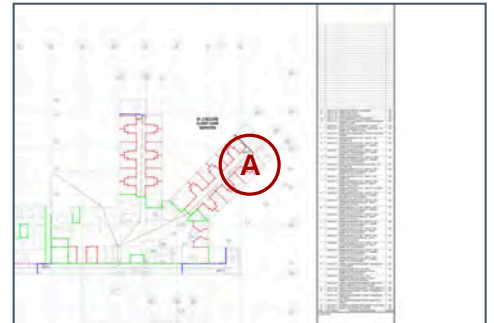
May be evidence of moisture behind

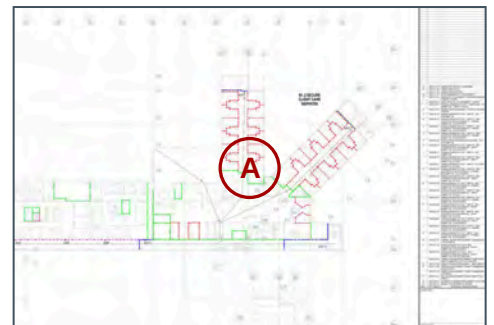
Generally, use of sweeps inconsistent and inadequately provided

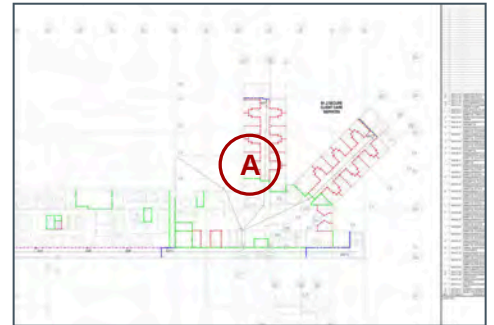
May be evidence of a leak

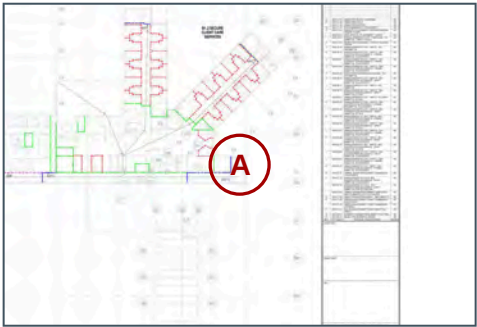
Description
Limited sprinkler coverage, one head noted near door in picture but none on the half landing or under the stairs

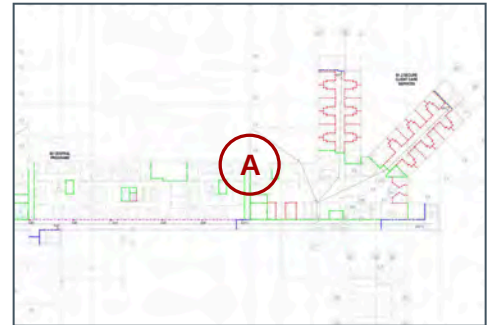
Low door threshold, recommend
8" min

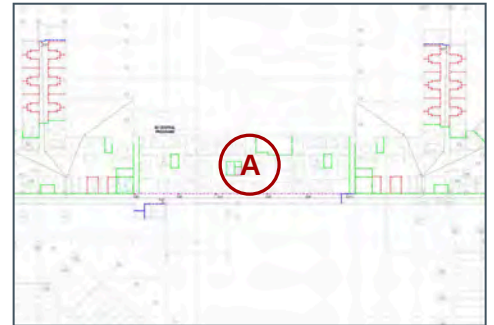
Inappropriate door stop, wall damaged

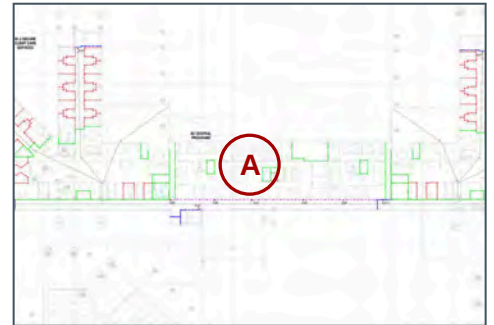
Drywall section missing, reheat coil recessed into the wall

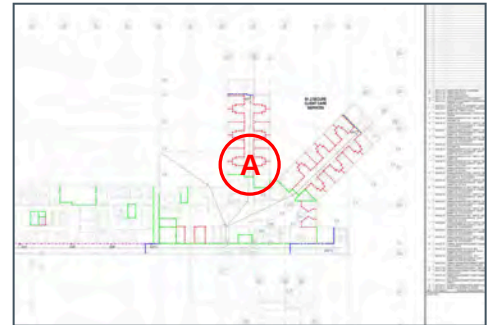
Inconsistent insulation installation. Missing or just left at bottom. Some you hung the pup and valves. Outside room E2-440.

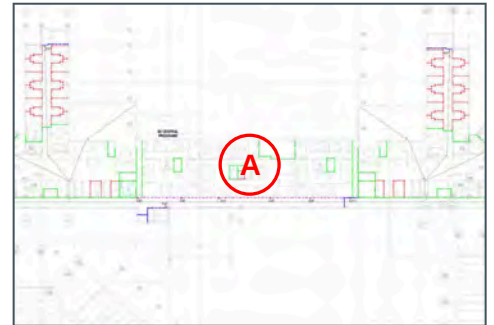
Bumper rails are loose in hallway. Might be missing connection bolts, some are loose. Outside E2-252.

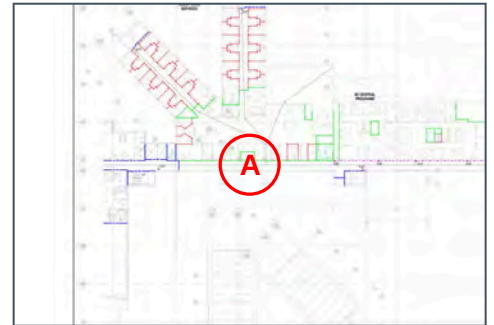
Sensor is loose. Ceiling tile is loose.

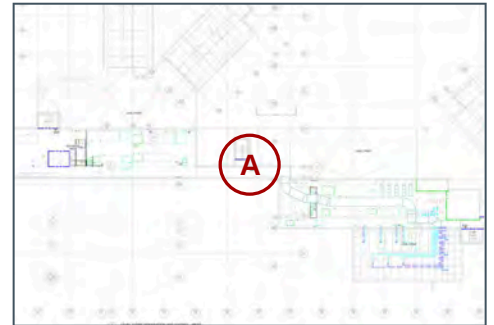
Noticeable air leakage

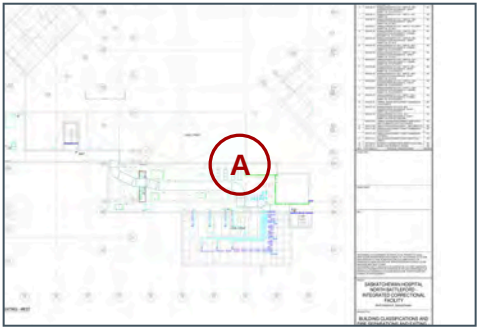
Description
Corrosion to pump p5 May be an issue

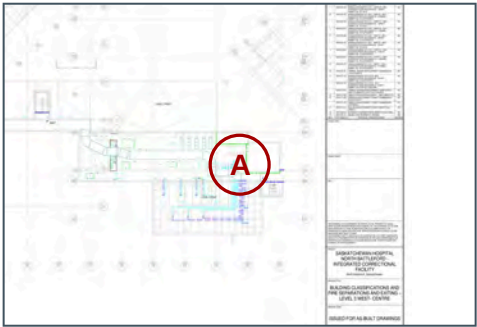
Description
Corrosion for mech to review

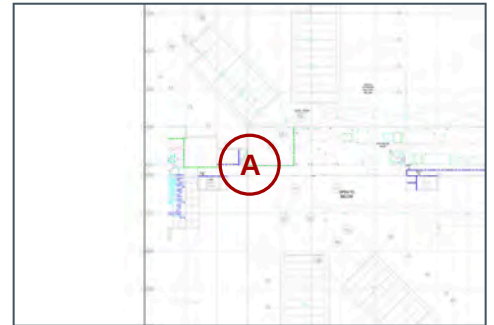
Crack in wall to u/s of deck, expansion/construction joint should be used here. This wall is a fire separation

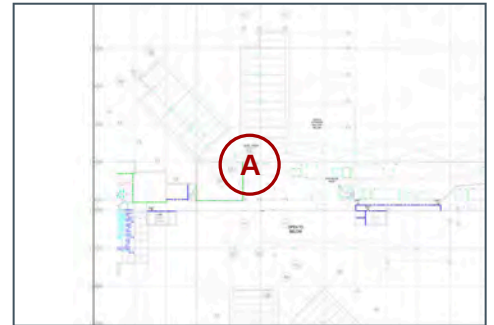
Mech to review, canvas wrap missing to duct

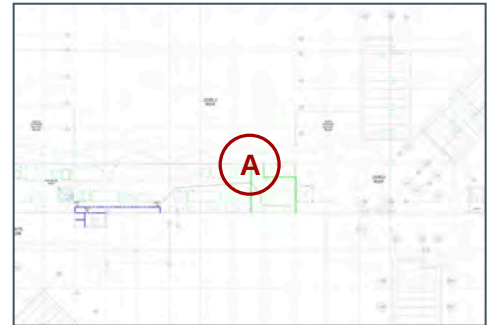
Fire sealant missing

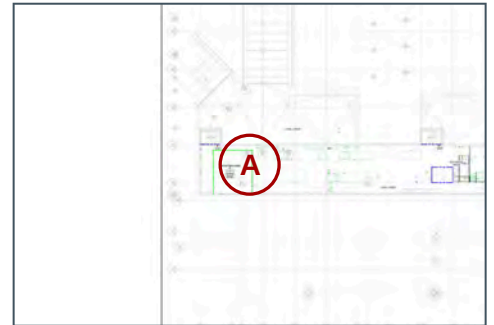
Crack to drywall, expansion joint required

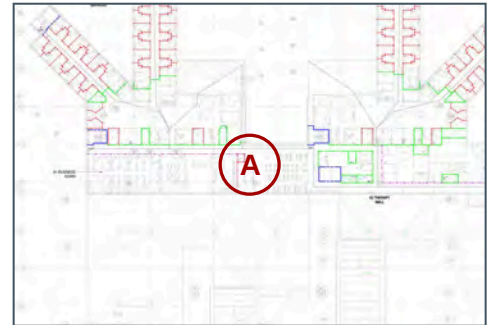
Flooring not sealed around grates. Welds broken.

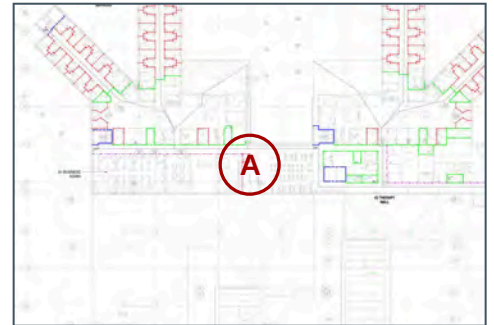
Excessive wear and tear on dishwasher and presumably other equipment

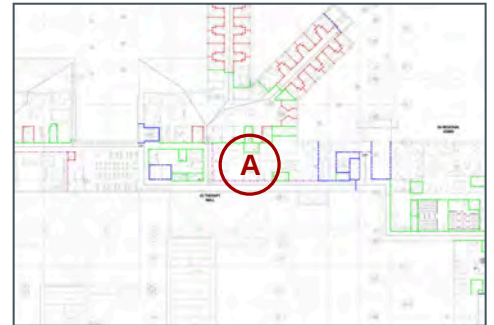
Missing caulking around frames

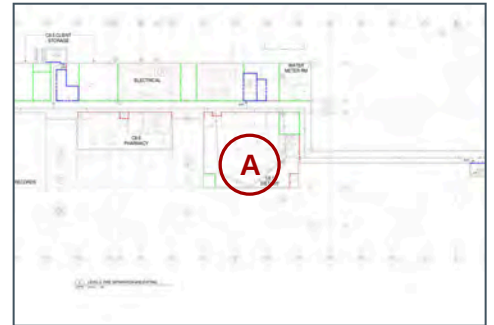
Pointless condition collects moisture & dirt

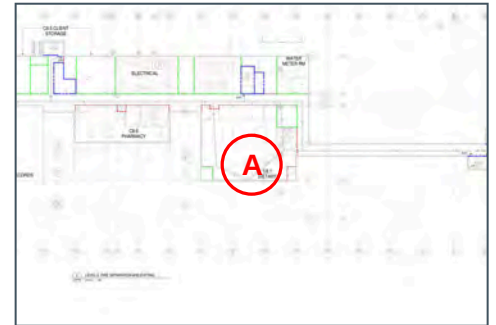
Pounding near grate. Uneven slope. Caulking is cracked.

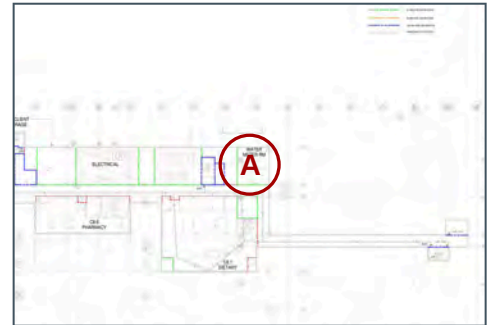
Suspected sewer gas aroma,
trip hazard to my cover

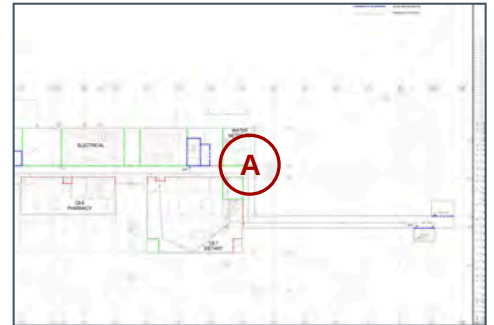
Fire sealant missing to floor/wall connection

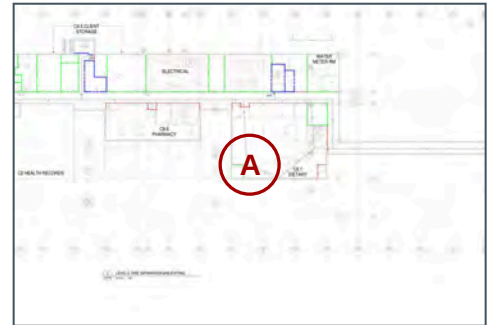
Failure of floor weld

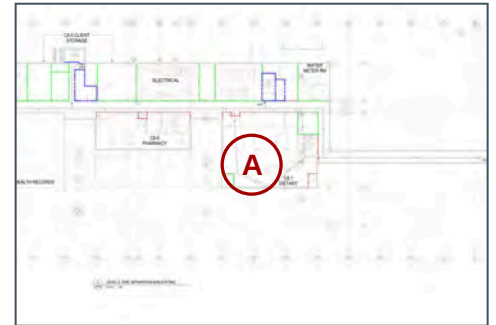
Failure to floor drain edge weld

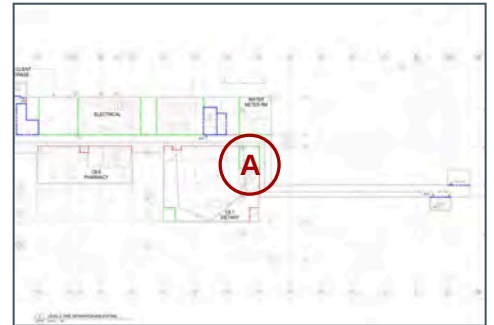
Missing fire sealant above door

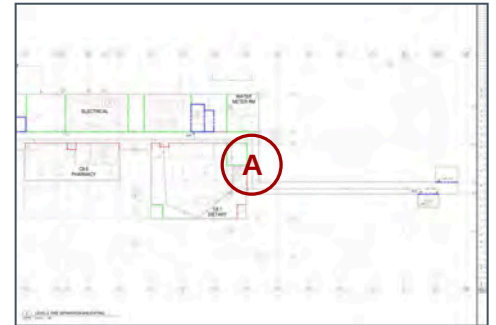
Evidence of moisture penetration at construction joint

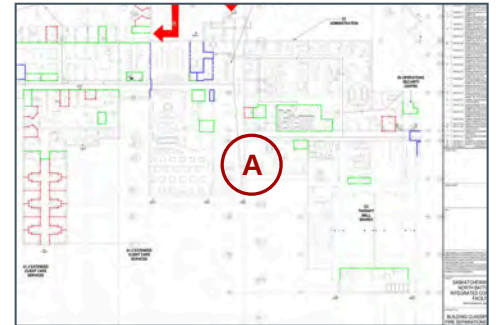
Flooring missing near counter

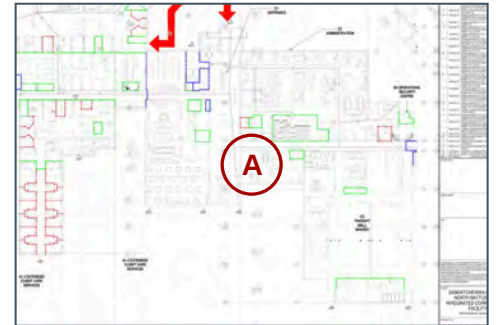
None of the stainless steel is caulked to floor but it is caulked to walls.

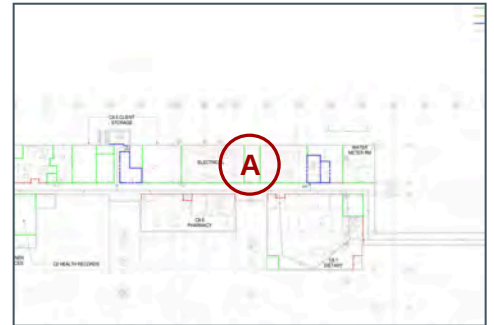
Rating required to structure if failure will cause the floor above to fail. Structure to confirm

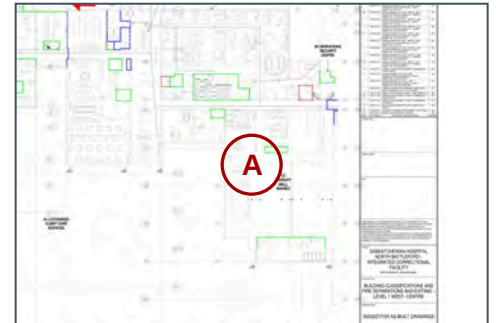
Missing fasteners at water fountains

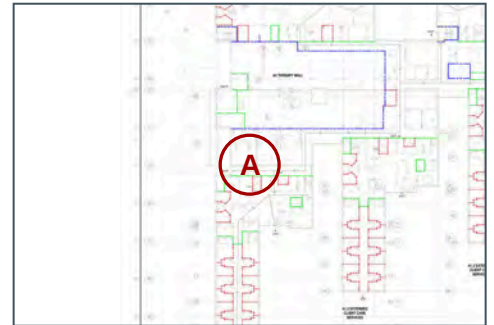
Cracked slab

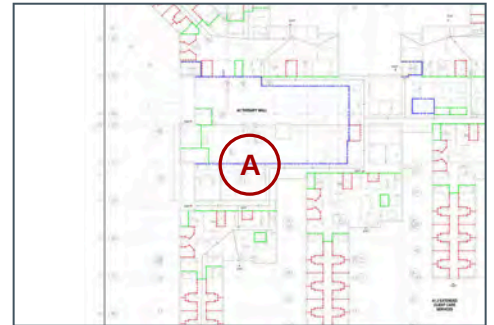
Wall protection seam failure in shower.

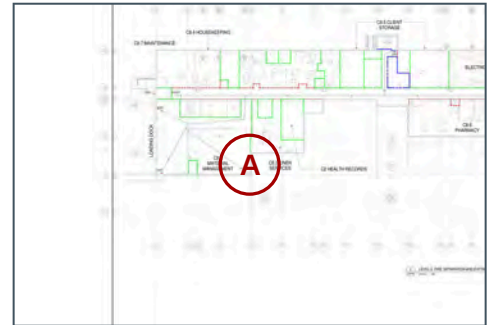
Paint peeling potential moisture problem

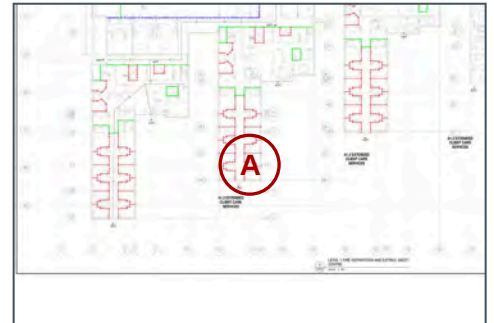
Failed seam

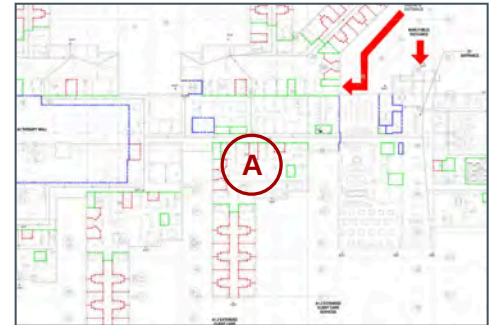
No cart rail and significant damage

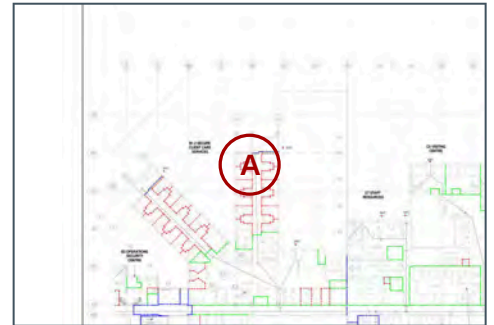
Rust already apparent on niche

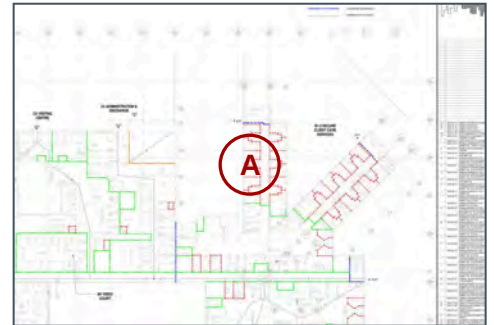
Wall imperfection will lead to waterproof failure

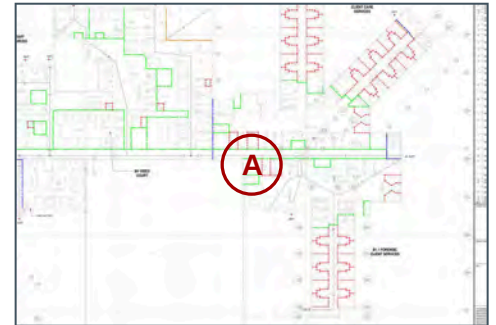
Possible fire rating issue, failure of these structural members may cause failure of beams with fire spray to north supporting the second floor

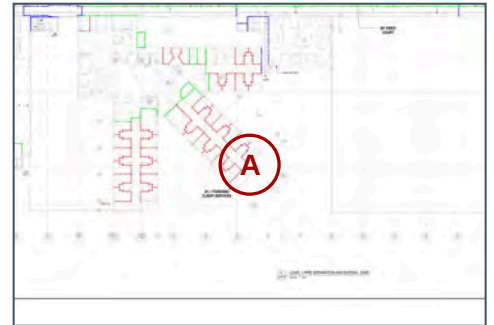
Paint failure maybe evidence of damp

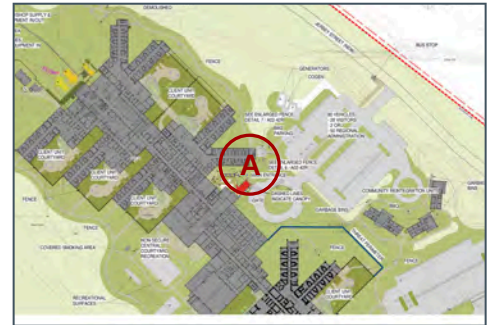
Appears to be a horizontal expansion joint cut in retrospectively, structural to comment. Poor finish from an architectural standpoint, additional coloured sealant required. Appears to be a typical condition.

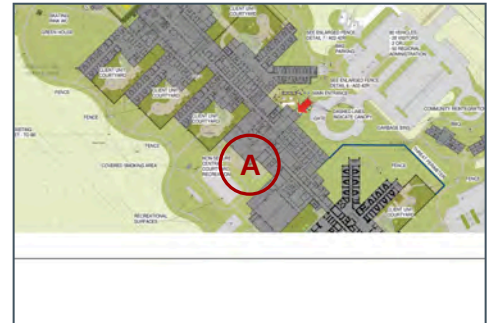
Poor quality ramp/transition
creating trip hazard

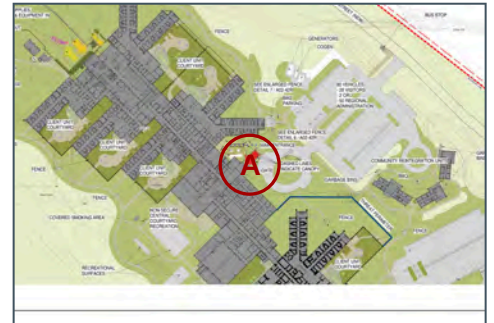
Unconventional approach
condition to the building

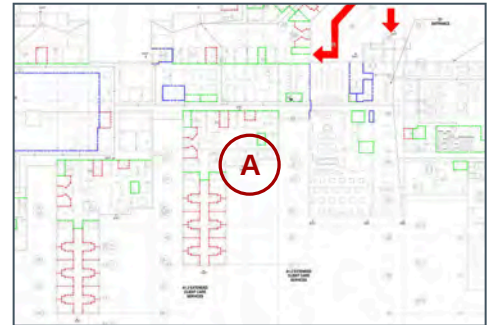
Sills taking damage. A wood sill or corner guard might have helped the, hold up over time.

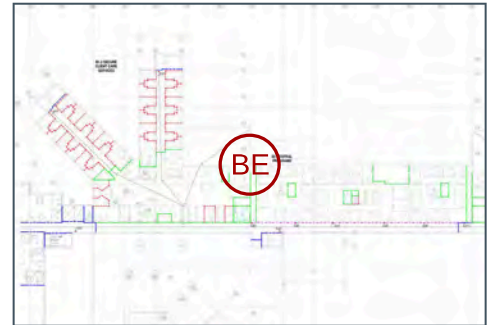
Frost on metal cladding at roof level. Indicative of air leakage.

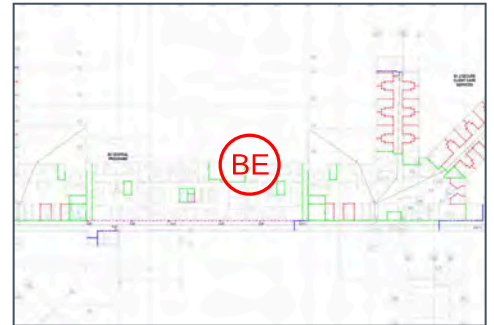
Exploratory hole near base of wall - daylight visible and draft indicating air leakage into wall cavity. Similar conditions likely exist all along this exterior wall based on thermal scans. Mould was also evident, as well as a small hole in the wall board.

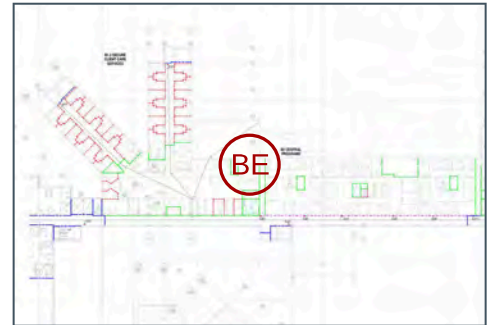
Exposed damaged Blueskin noted along base of wall above balcony deck

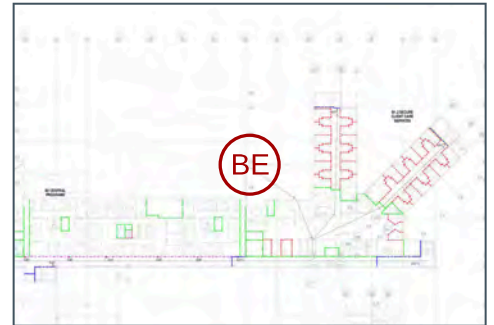
Stains on balcony soffit

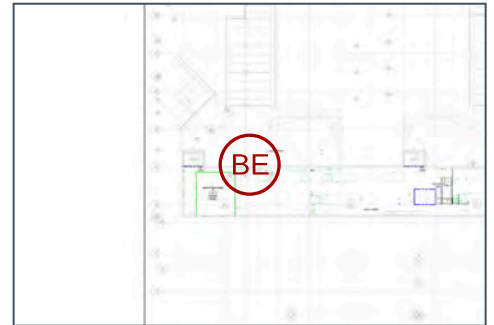
Missing sill flashing below
exterior door above roof

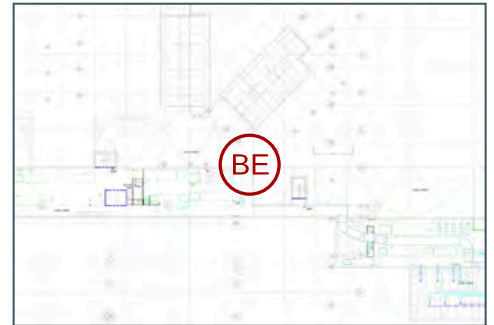
unaddressed roofing
deficiencies

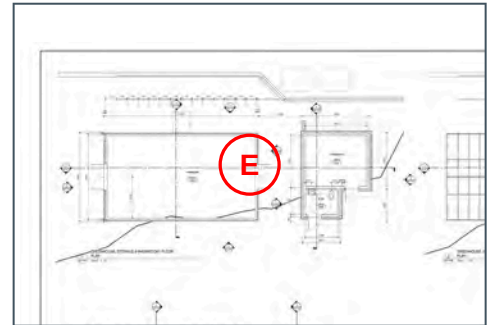
fire alarm pullstation missing
splash cover

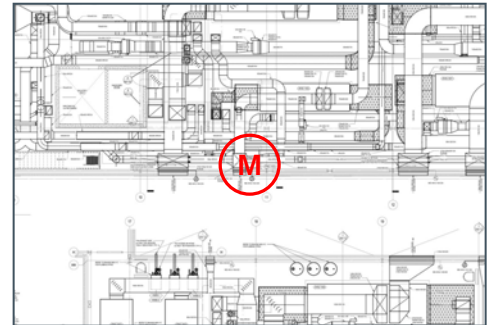
Penthouse - Premature rusting if union. Joint failure.

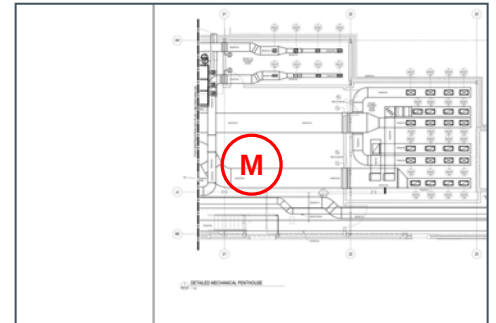
Penthouse - Pump seals failing,
many noted during review.
Noted to be a frequent issue.
Concern to have a high number
of failures this early.

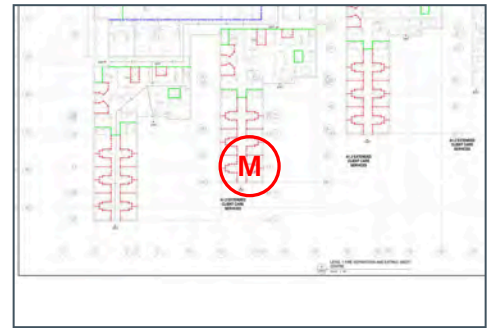
Vacuum toilet causes knocking noise. Pipe not appropriately secured and/or noise attenuation not sufficient through PVC pipe. Applies to entire wing.

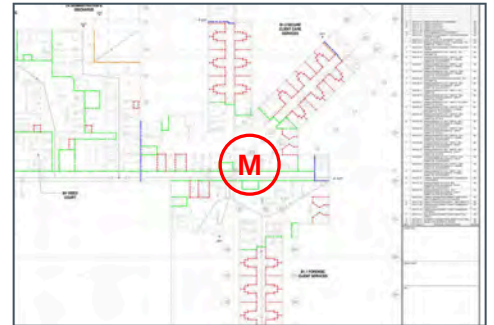
E1-427B - faucet isn't very loose. Faucet ran for over 30 second.

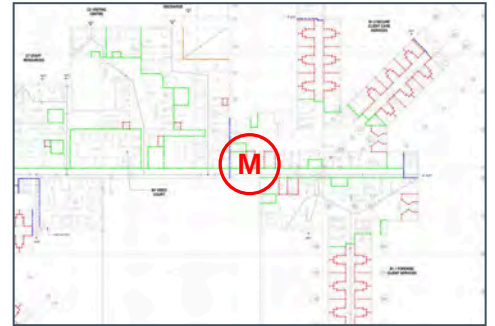
Faucet was tight, made it loose simply by moving back and forth.

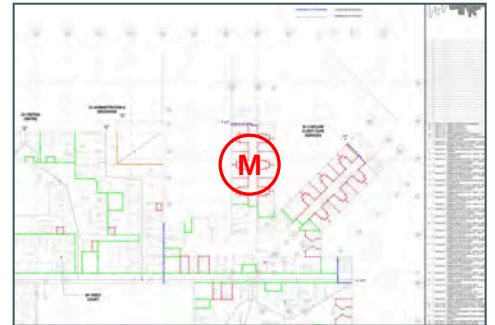
Access panel. Pipe is corroding.

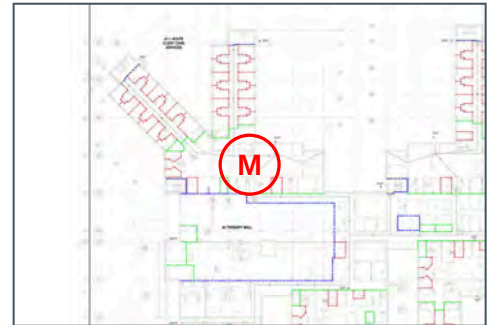
Very humid conditions. West
PrairieView B

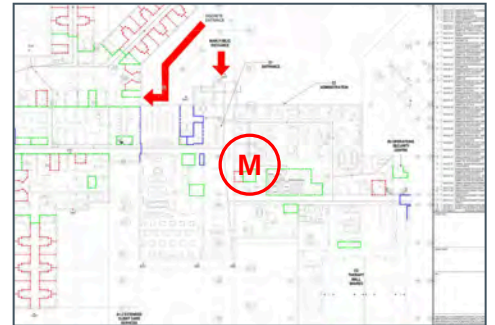
Leakage on duct main.
Insulation ripped away.

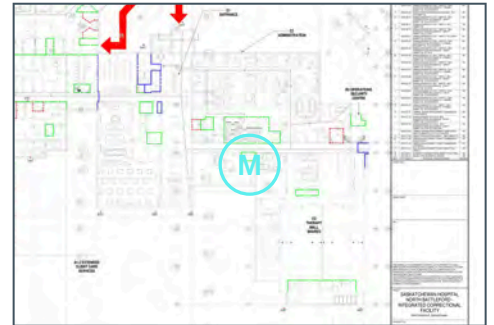
High copper content in domestic water causing discolouration and wear on floor drain.

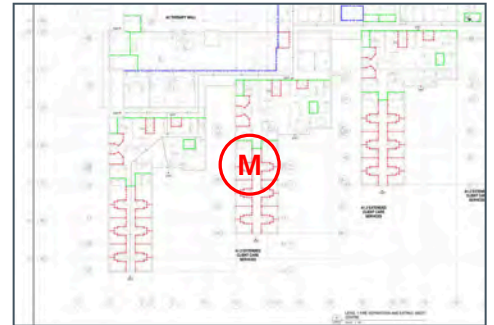
Vacuum water closet valve takes extended time to close. WC visibly scuffed / damaged.

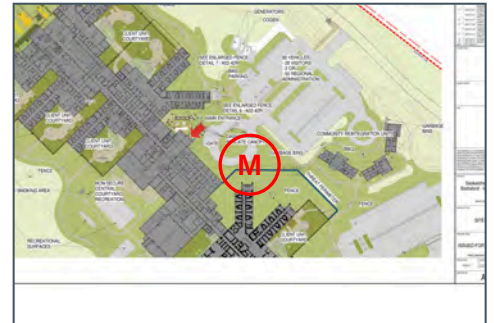
Main entrance. Grease interceptor vents near main entrance cause sewer gas smell.
