Asphalt Concrete Surface Inspection Guide

November 2023

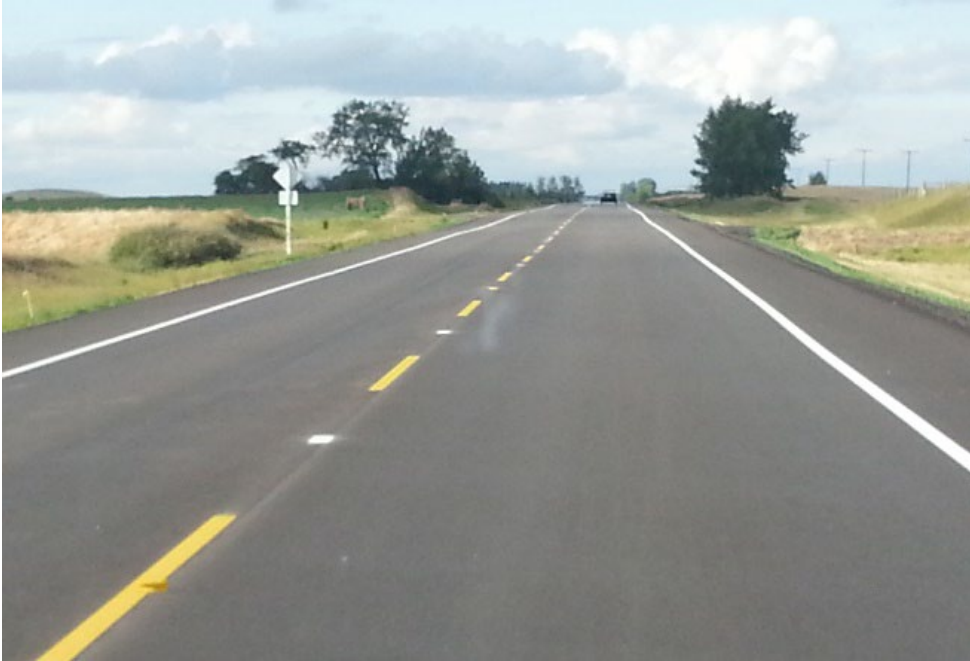
Figure 1: No segregation

Segregation is not observed in Figure 1. The surface texture is consistent throughout the full lane width.

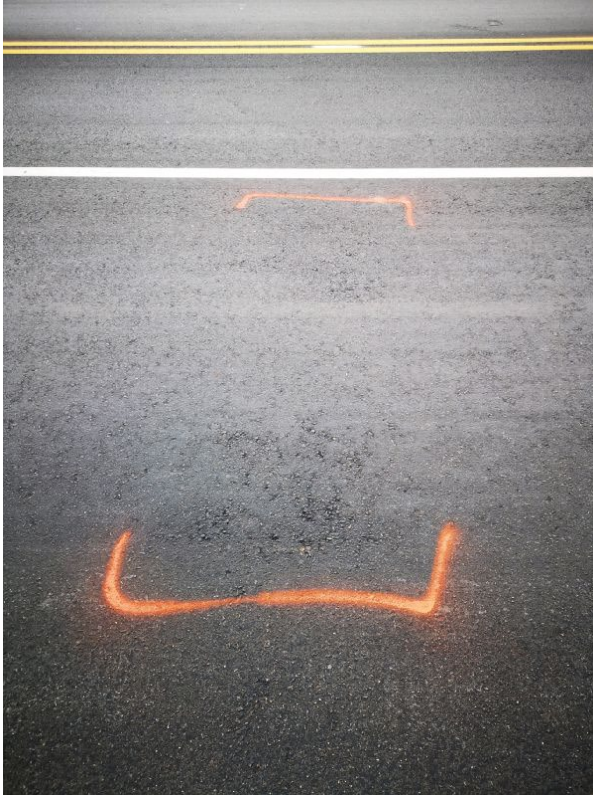
Figure 2: Slight Segregation

Figure 2 shows a localized area larger than 0.1 m².

More stone is observed in areas when compared to the surrounding asphalt concrete. The matrix is in place between the coarse aggregate.

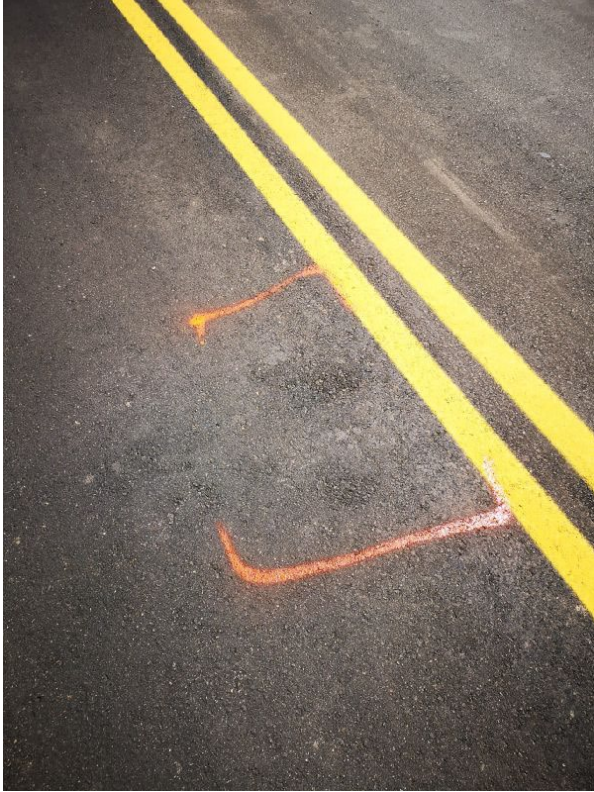
Figure 3: Slight Segregation

Figure 3 shows localized, slight segregation but the area is less than 0.1 m².

In accordance with applicable specifications, this may be classified as a Surface Defect.

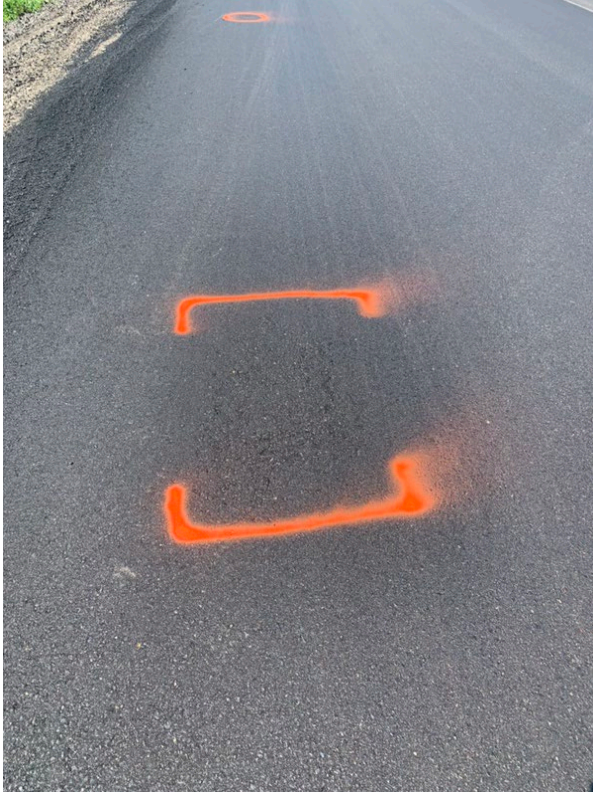
Figure 5: Slight Segregation

Figure 5 displays a slightly segregated area of approximately 1.0 m².

Matrix and fine aggregate components are in place, but the affected area has a more stony appearance than the surrounding asphalt concrete.

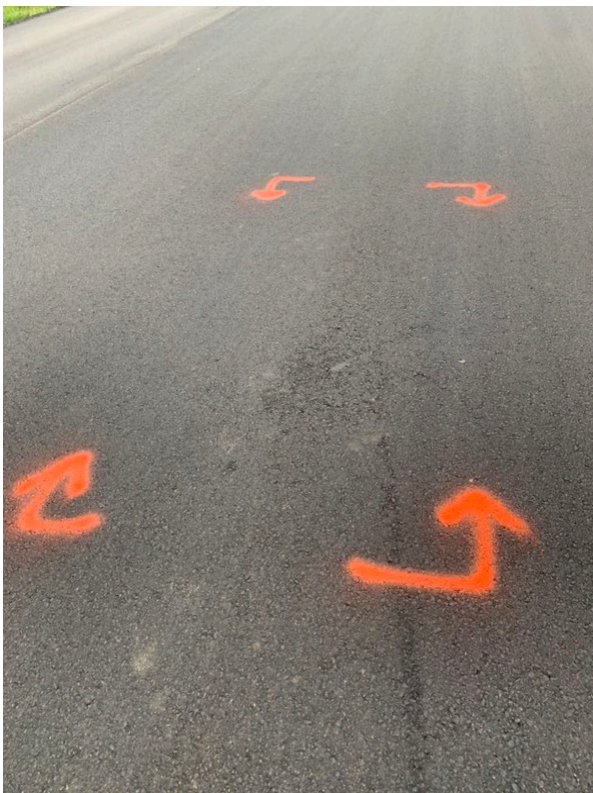
Figure 6: Slight Segregation

Figure 6 displays an area of slight segregation. Although the area is larger, than previous examples, the severity is slight.

Matrix and fine aggregate components are in place, but the affected area has a more stony appearance than the surrounding asphalt concrete.

A roller mark and areas of concentrated fines are also evident on the surface.

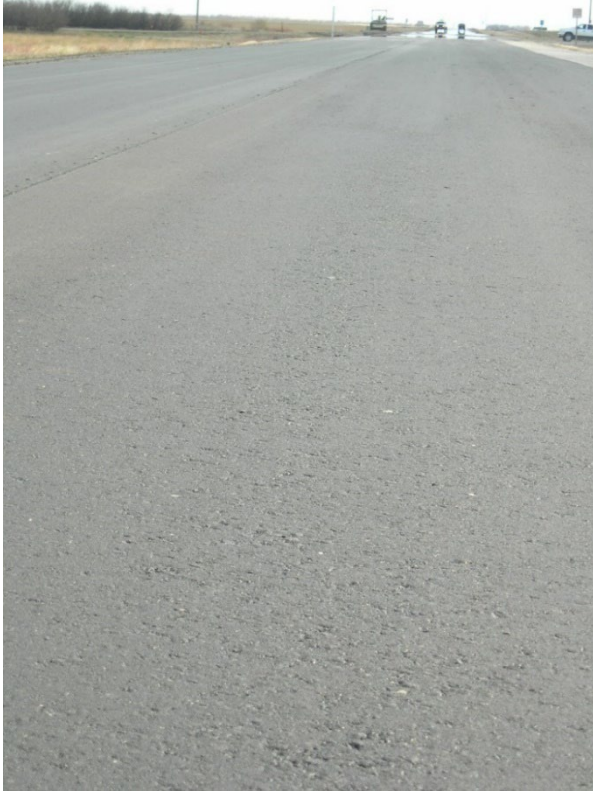
Figure 7: Slight Segregation

Figure 7 shows an area of slight segregation.

The coarse aggregate is more concentrated, but the matrix and fine aggregate is intact between the coarse aggregate.

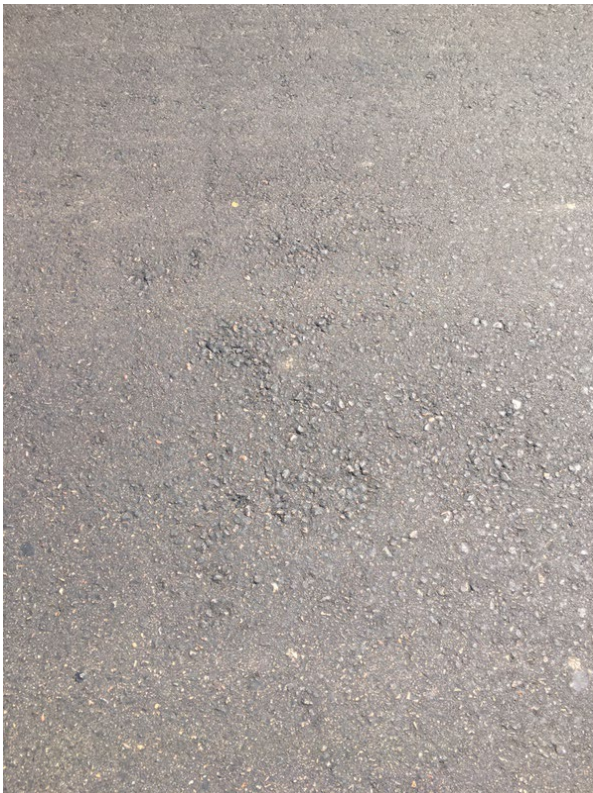
Figure 8: Slight Segregation

Figure 8 shows a localized area of slight segregation.

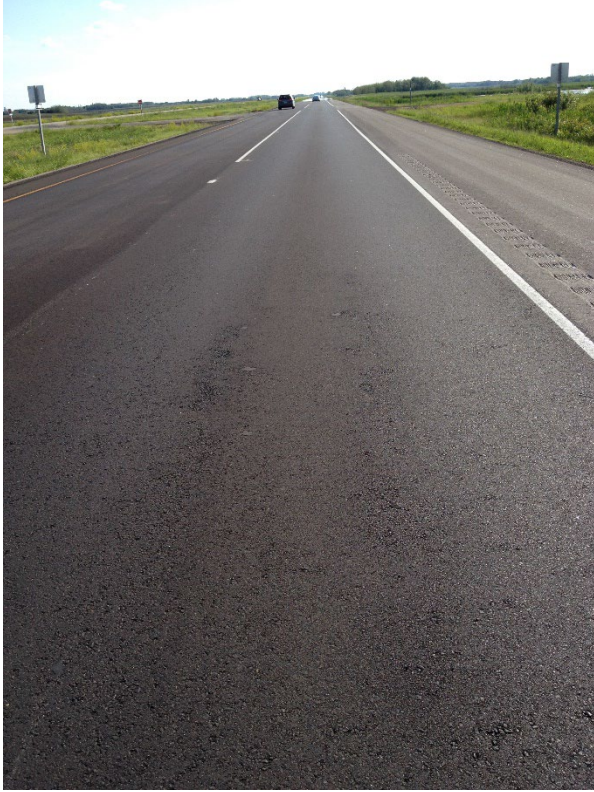
Figure 10: Moderate and Severe Segregation

Figure 10 shows a larger area of moderate severity segregation, and some areas of severe severity segregation within this larger area.

The coarse aggregate is exposed, and the matrix between the coarse aggregate is reduced.

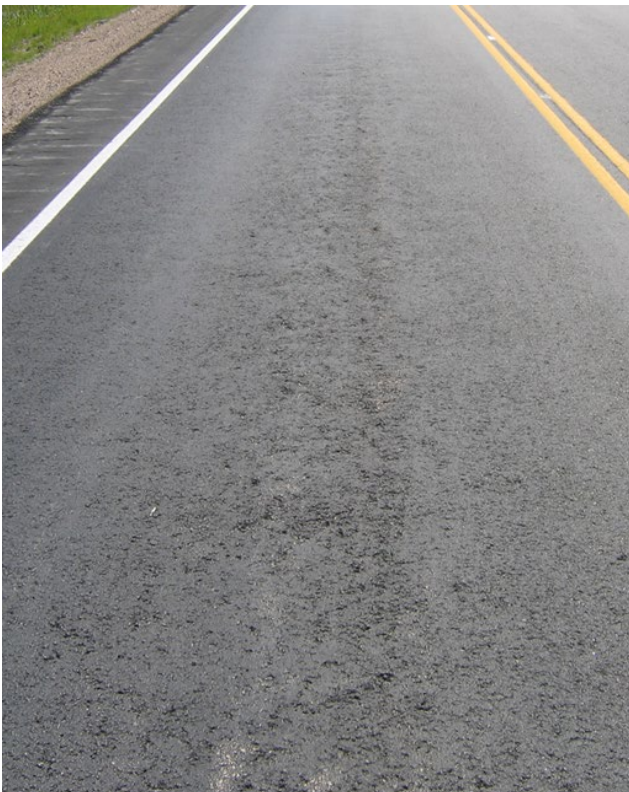
Figure 11: Moderate Segregation

Figure 11 displays moderate segregation severity, and may also be classified as Centre-of-Paver Streak.

The surrounding matrix is consistently reduced within the streak. The surface, in this example, also looks open textured.

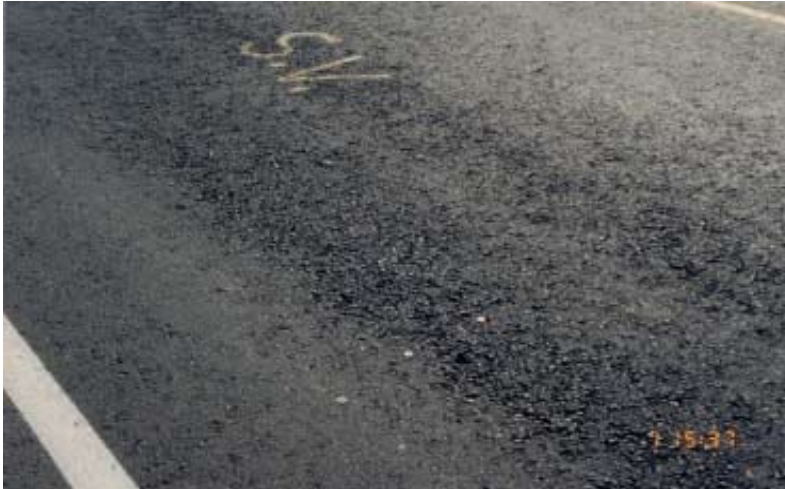
Figure 12: Severe Segregation

Figure 12 shows areas of severe segregation.

The asphalt concrete appears very stony and is missing much of the matrix.

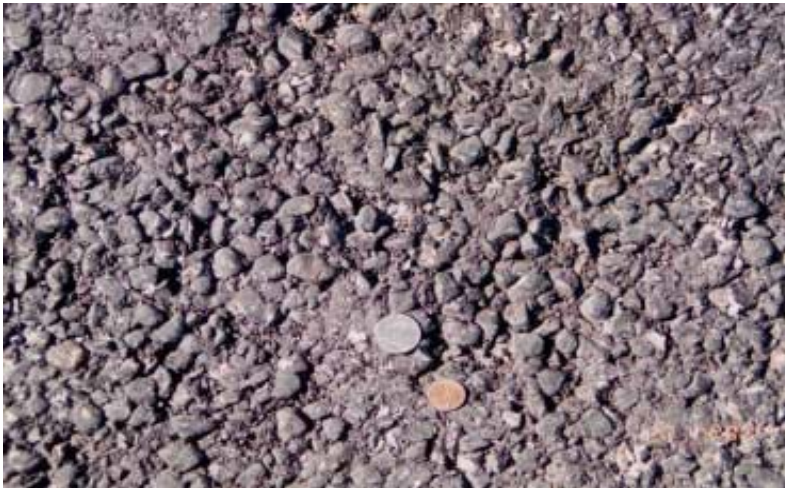
Figure 13: Severe Segregation

Figure 13 shows severe segregation.

The texture appears to be stone against stone, with the supporting matrix being much diminished.

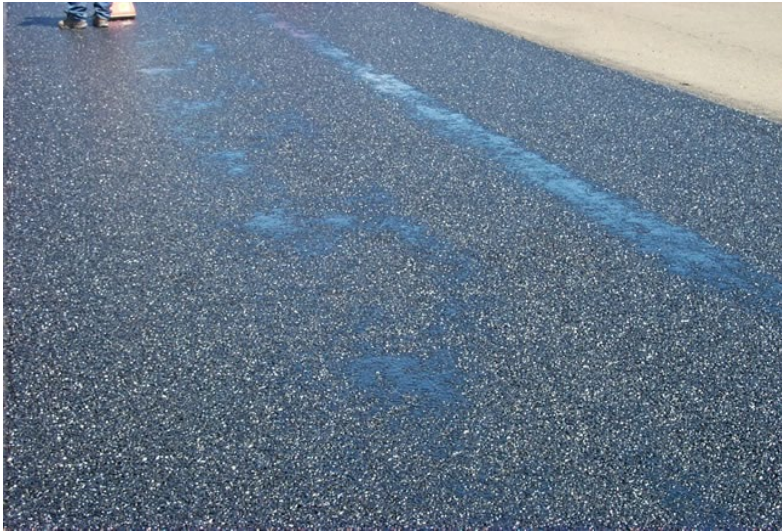
Figure 15: Excess Asphalt Binder

Figure 15 displays a surface with excess asphalt binder with bleeding occurring in areas.

An asphalt binder film is evident, which may appear shiny, smooth or reflective.

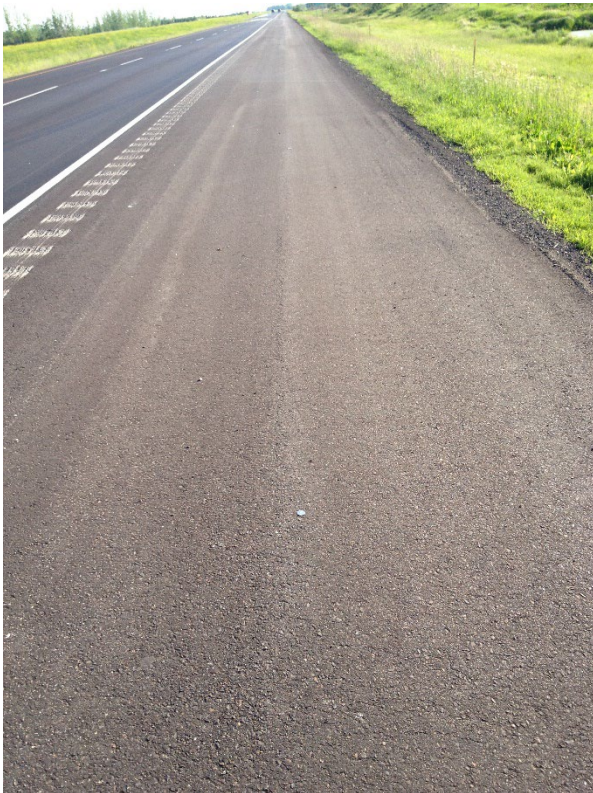
Figure 16: Insufficient Asphalt Binder

A surface with insufficient asphalt binder is shown in Figure 16.

The surface has a lighter colour than the adjacent lane and the exposed faces of some of the coarse aggregate have little or no asphalt film. Pneumatic roller marks are also visible.

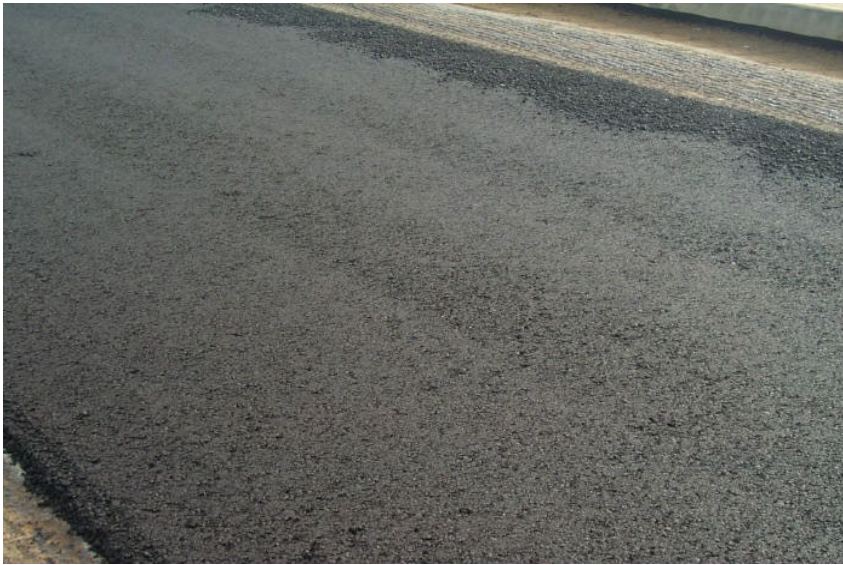
Figure 17: Open Texture

An open textured surface is displayed in much of the lane width in Figure 17.

Centre-of-paver streak is also observed. The streak has a more open texture than the remainder of the surface.

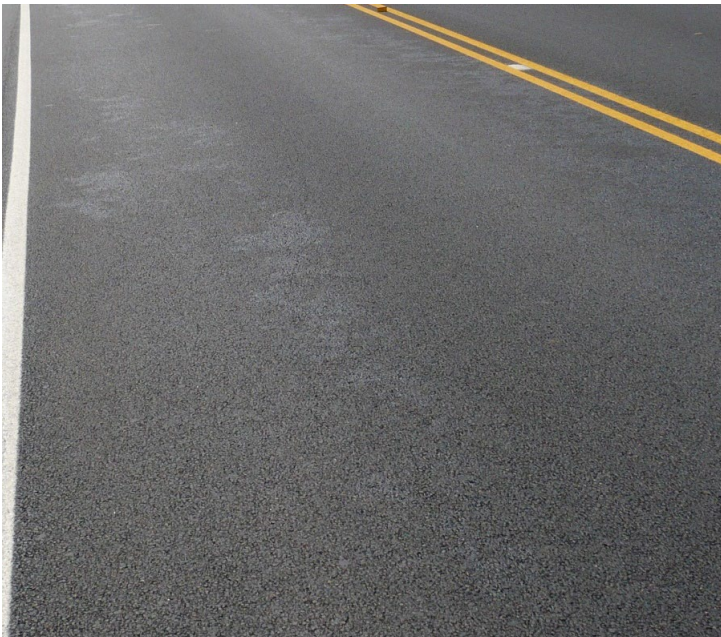
Figure 18: Open Texture

Figure 18 shows a surface with a consistently open textured surface across the lane width.

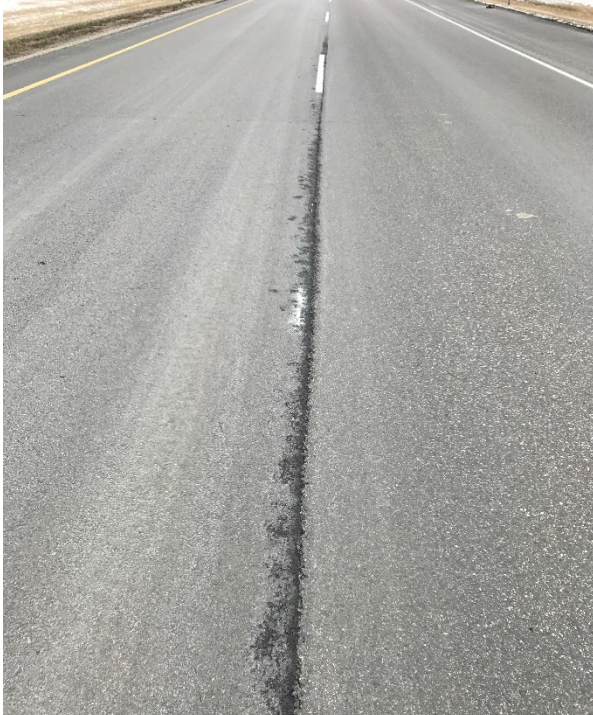
Figure 19: Improper Matching of Longitudinal Joint

Figure 19 shows a longitudinal joint that is not matched well. A gap is evident on the centerline seam.

The vertical edge at the centreline seam is also damaged.

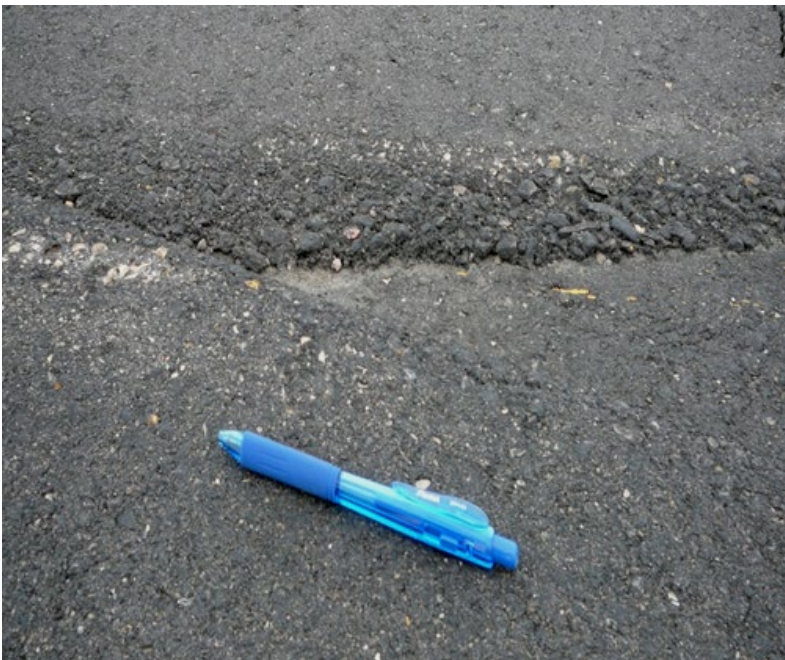
Figure 20: Improper Matching of Longitudinal Joint

Figure 20 shows a gap along the centerline.

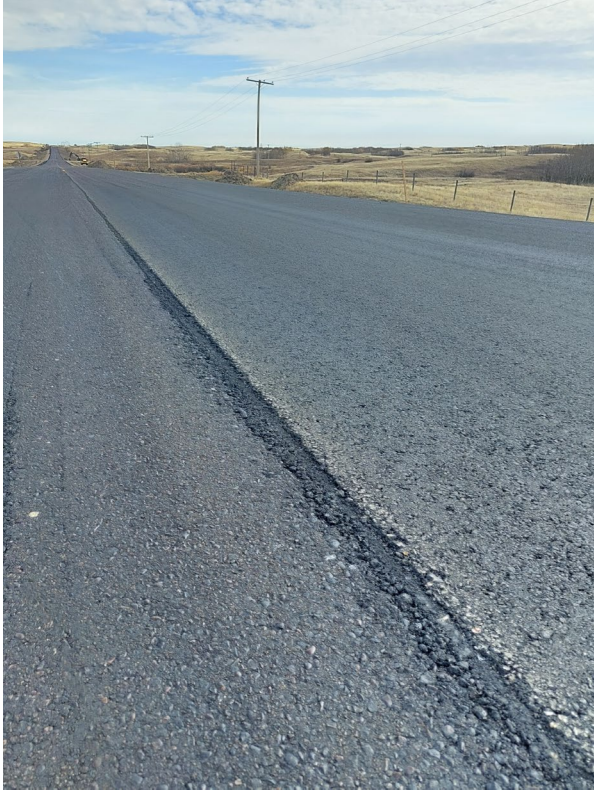
Figure 21: Improper Matching of Longitudinal Joint

The centreline joint in Figure 21 shows a visibly distinct area with poor compaction.

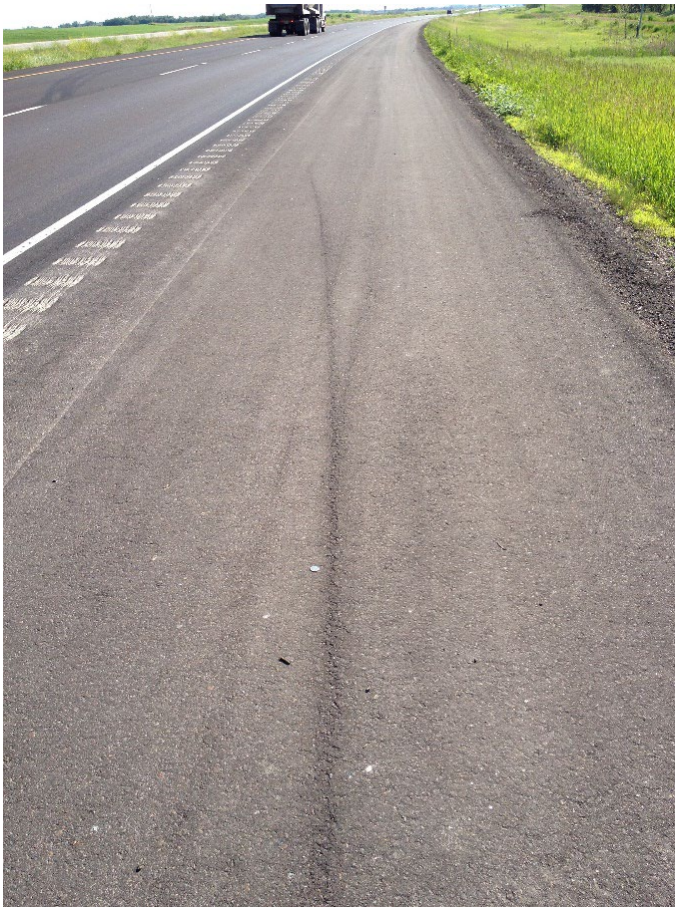
Figure 22: Arc-shaped Roller Mark, Tearing/Discontinuity

Figure 22 showing an arc-shaped roller mark created by the turning motion of a steel drum compactor.

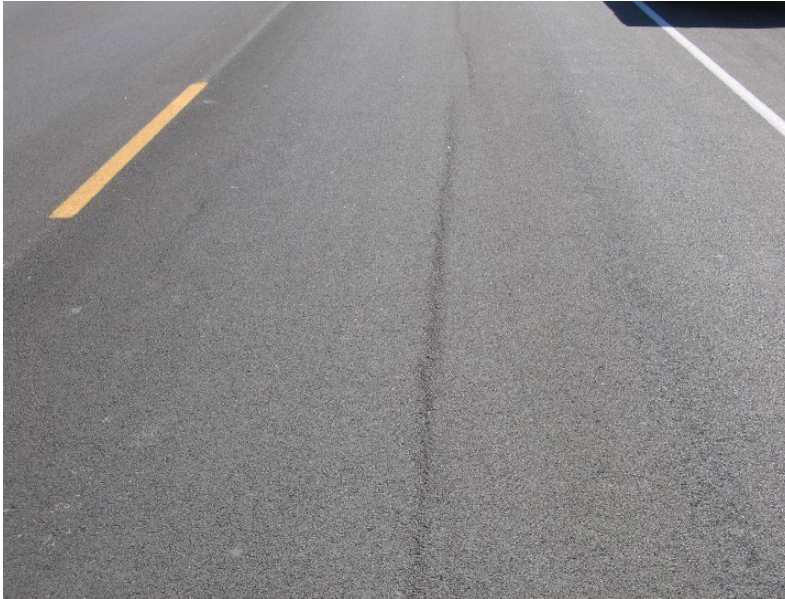
Figure 23: Longitudinal Roller Mark, Tearing/Discontinuity

Longitudinal roller marks are seen in Figure 23, created by a steel drum roller.

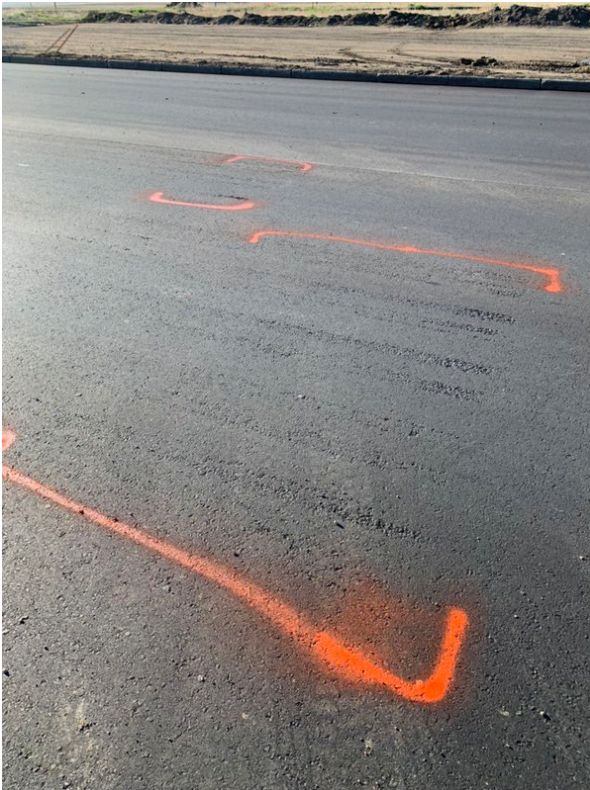
Figure 24: Pneumatic Tire Pick-up

Pneumatic tire pick-up marks are shown in Figure 24.

Some of the matrix has been removed from the surface leaving an open textured or segregated appearance.

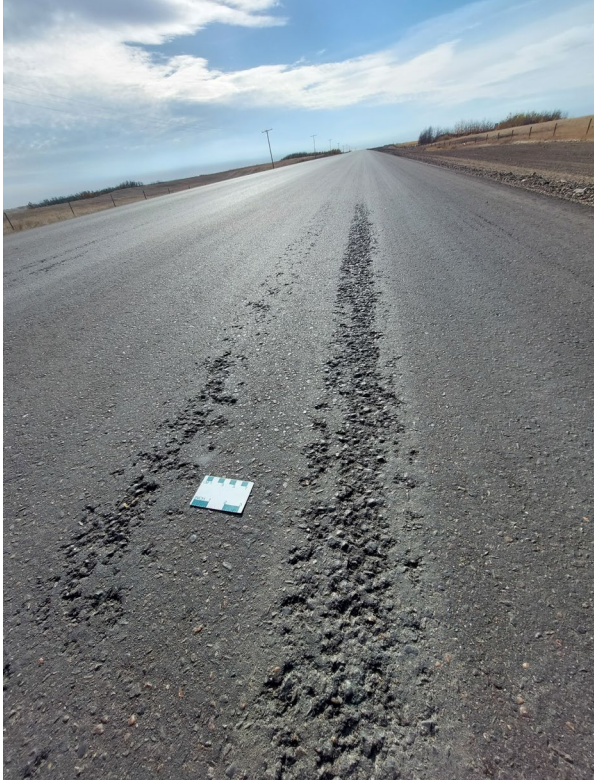
Figure 25: Pneumatic Tire Pick-up

Figure 25 shows pneumatic tire pick-up marks. The asphalt concrete matrix has been removed, exposing the larger sized aggregate.

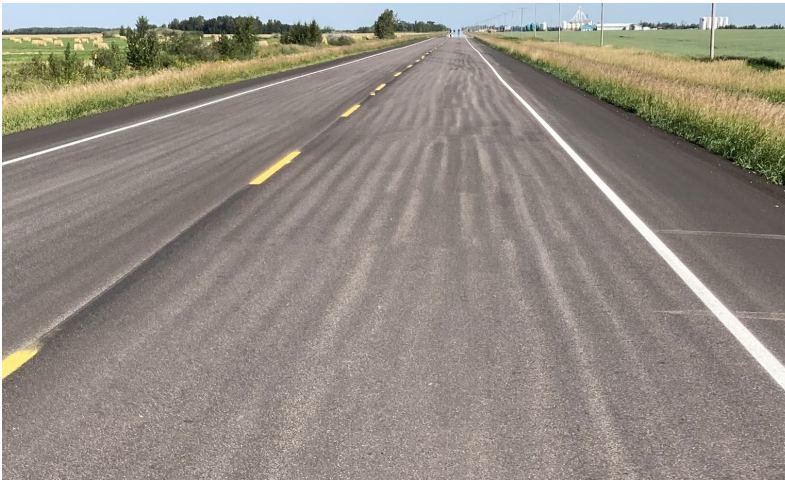
Figure 26: Roller Marks, Asphalt Film Loss

Figure 26 shows roller marks with a loss of asphalt film and exposed aggregate surfaces.

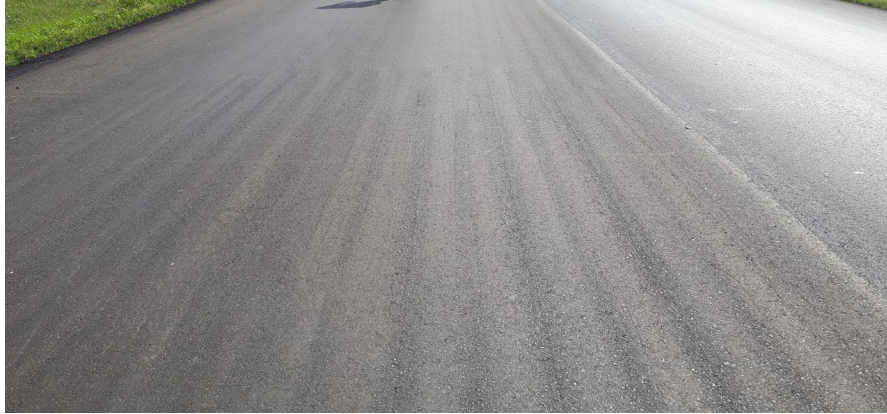
Figure 27: Roller Marks, Ridges and Depressions

Figure 27 shows an uneven surface, with ridges and depressions formed by compaction with pneumatic tire rollers.

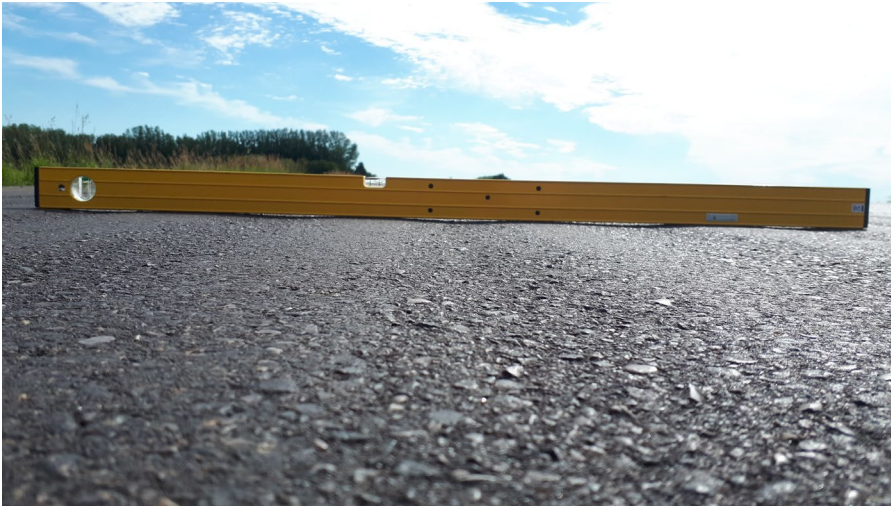
Figure 28: Roller Marks, Ridges and Depressions

Figure 28 shows an uneven surface, with ridges and depressions formed by compaction with pneumatic tire rollers.

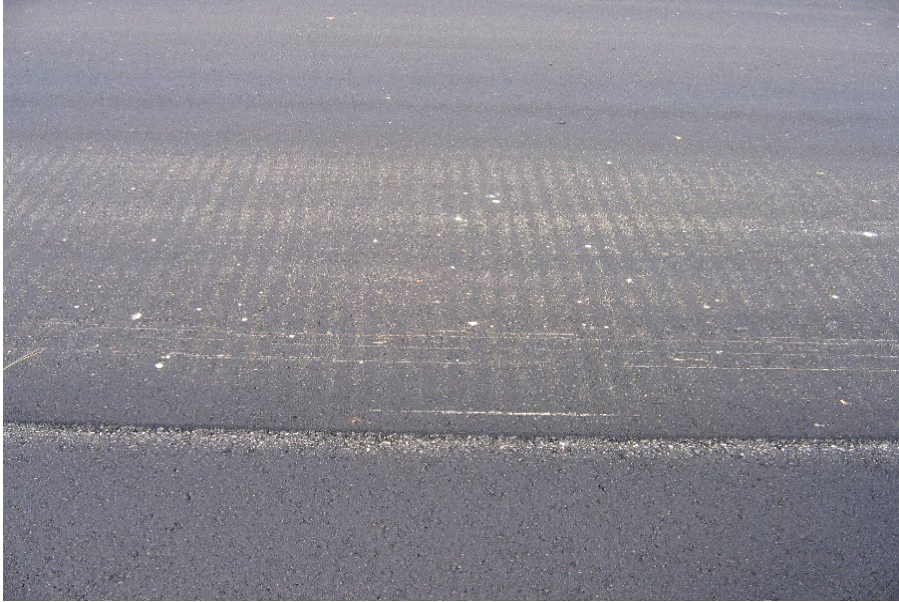
Figure 29: Roller Marks From Vibrating Steel Drum

Figure 29 shows roller marks created by a vibrating steel drum.

Potential causes for this type of roller mark are incorrect vibration amplitude and frequency, over-densification, and compaction on a cool mat.

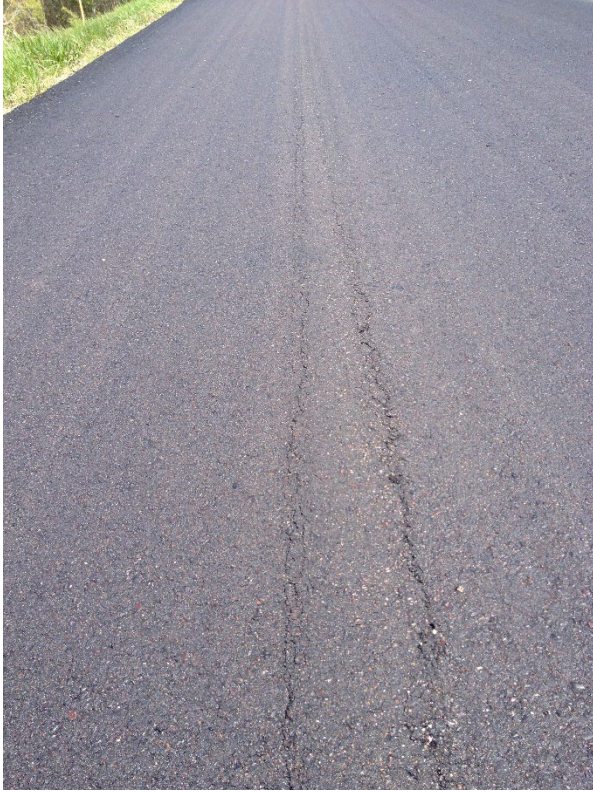
Figure 31: Longitudinal Cracking

Longitudinal cracking is visible in Figure 31 at the interface of a change in cross slope on the shoulder.

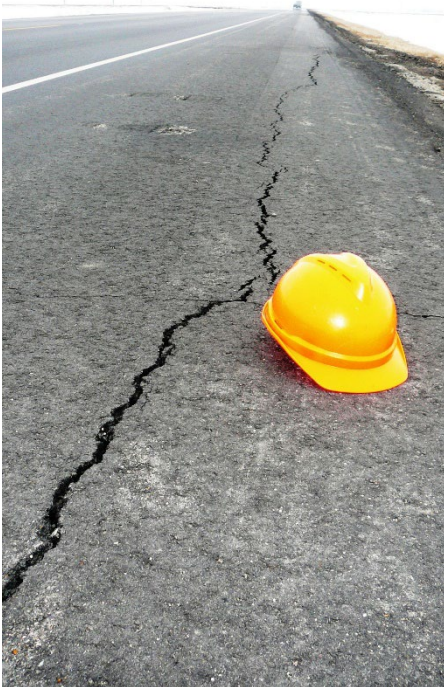
Figure 32: Longitudinal Cracking

Figure 32 shows longitudinal cracking along the shoulder edge and at the interface of the cross slope change on the shoulder.

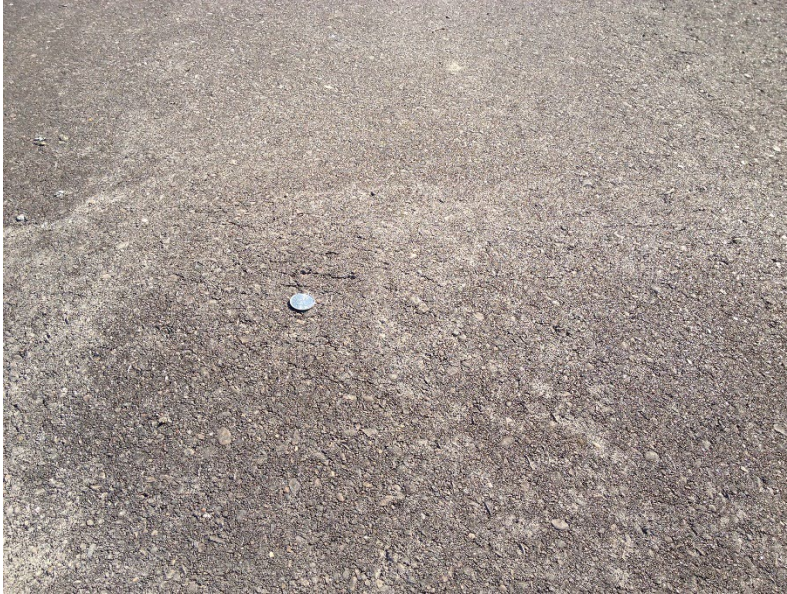
Figure 33: Micro-cracking

Micro-cracking is shown in Figure 33.

The cracking appears to be near the starting or stopping point of the compactor path, which could indicate a tender asphalt mix.

The asphalt mix also appears to have insufficient asphalt binder content.

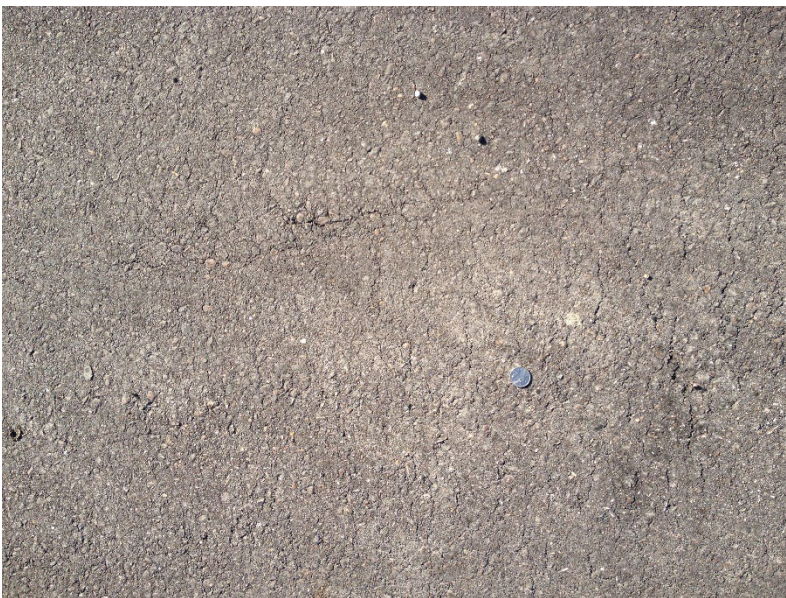
Figure 34: Micro-cracking

Figure 34 shows micro-cracking.

The asphalt mix also appears to have insufficient asphalt binder content.

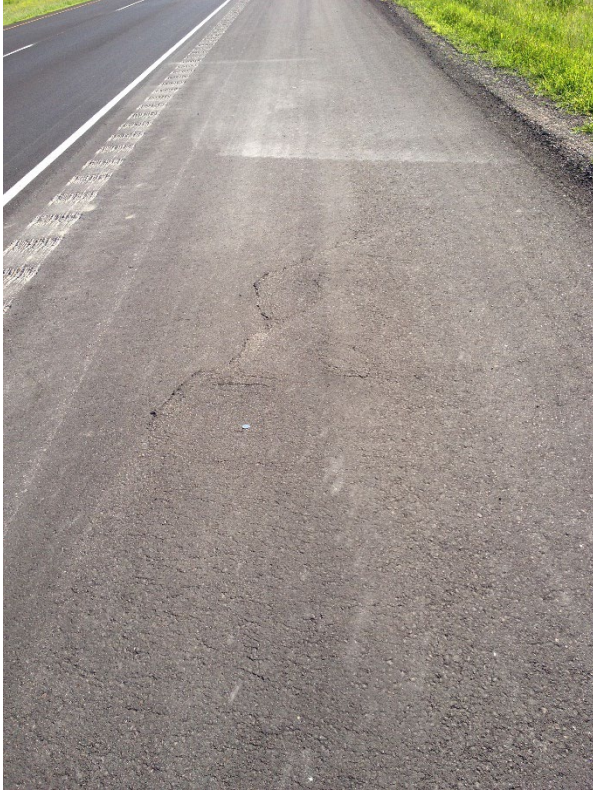
Figure 35: Slip Failure

Figure 35 shows a slip failure.

A tender asphalt mix may also be contributing to the slip failure.

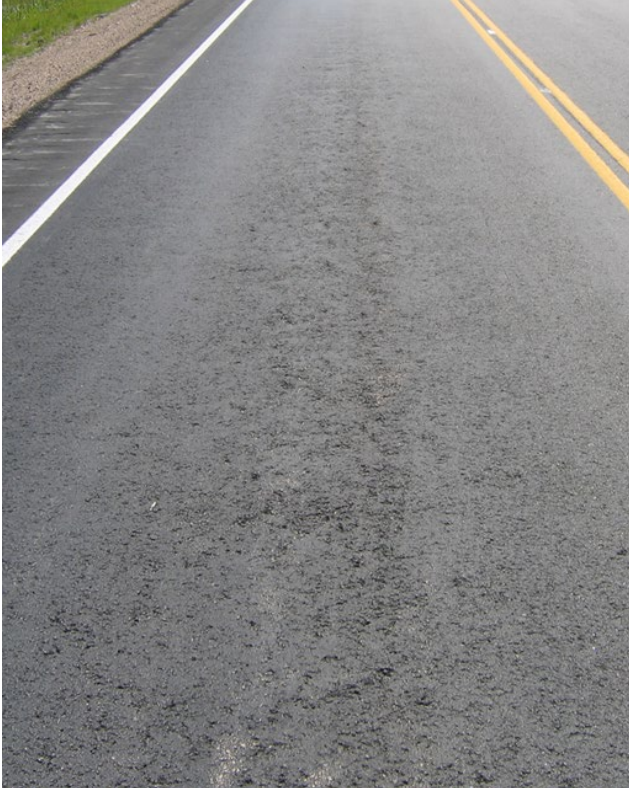
Figure 36: Tearing

Tearing is seen in Figure 36.

In this case, the tearing appears as Centre-of-Paver Streak and may have been caused by insufficient quantity of asphalt mix near the paver's auger gear box.

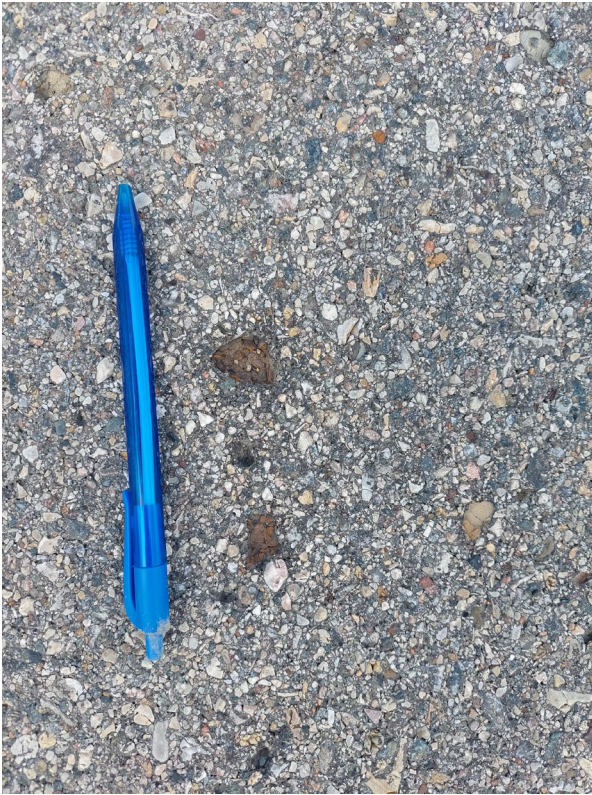
Figure 37: Shale and Ironstone Pick-Outs

Figure 37 shows shale and ironstone pick-outs.

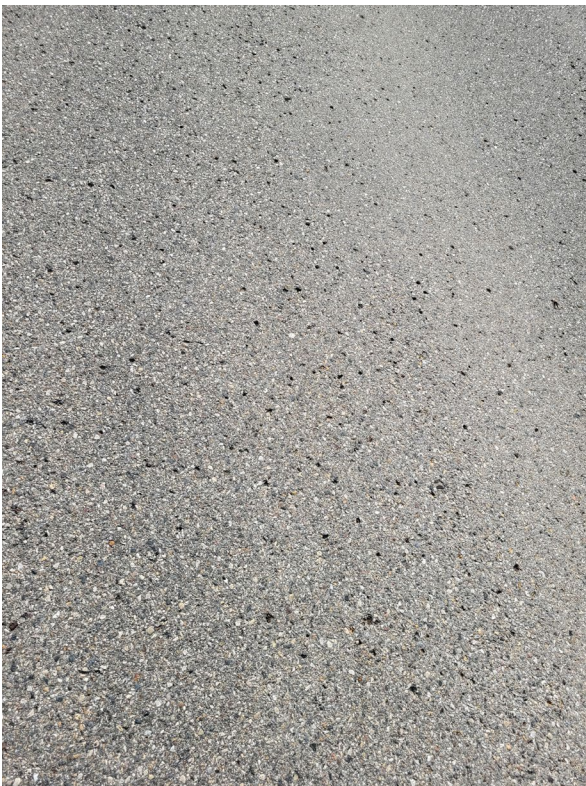
Figure 40: Single-Stone Pick-Outs

Figure 40 shows a high extent of single-stone pick-outs.

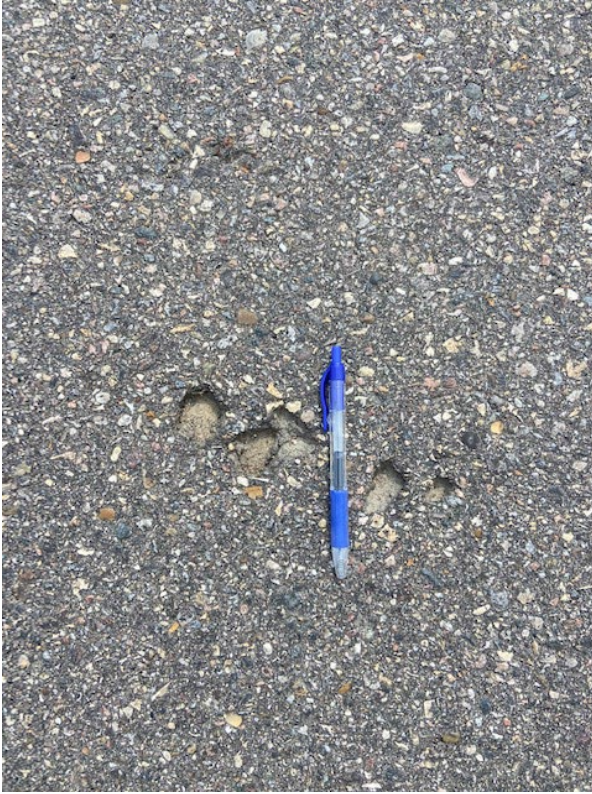
Figure 41: Multi-Stone Pick-Out

Figure 42 shows a multi-stone pick-out.

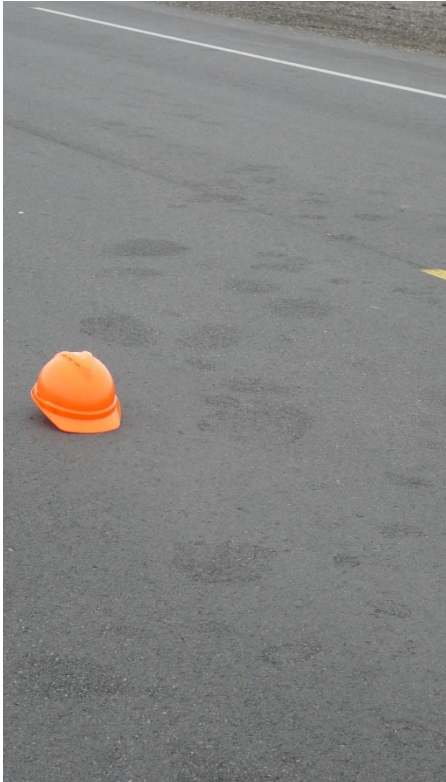
Figure 42: Contaminant Leaks on Surface

Figure 43 shows contaminant leaks on the road surface, likely hydraulic fluid.

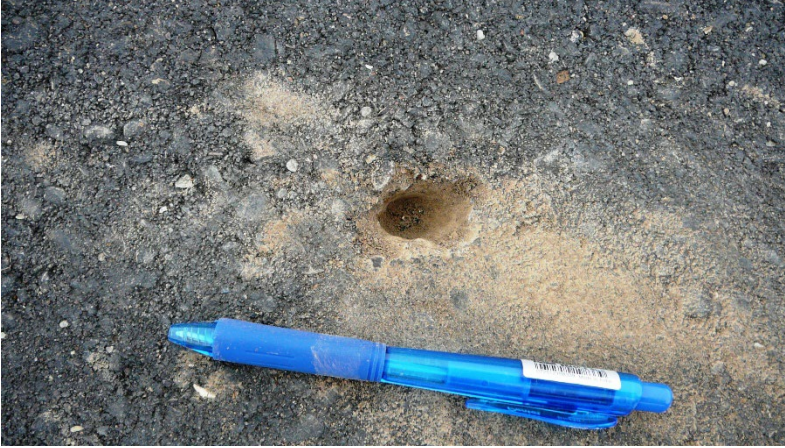
Figure 44: Inclusion of Clay Ball

Figure 45 shows the remainder of a clay ball that was in the asphalt concrete surface.

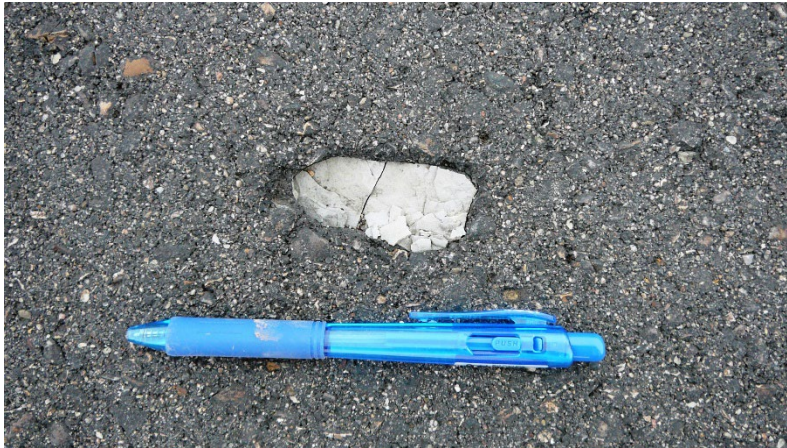
Figure 45: Inclusion of Oversize Aggregate

Oversized aggregate is evident within the asphalt concrete surface in Figure 46.

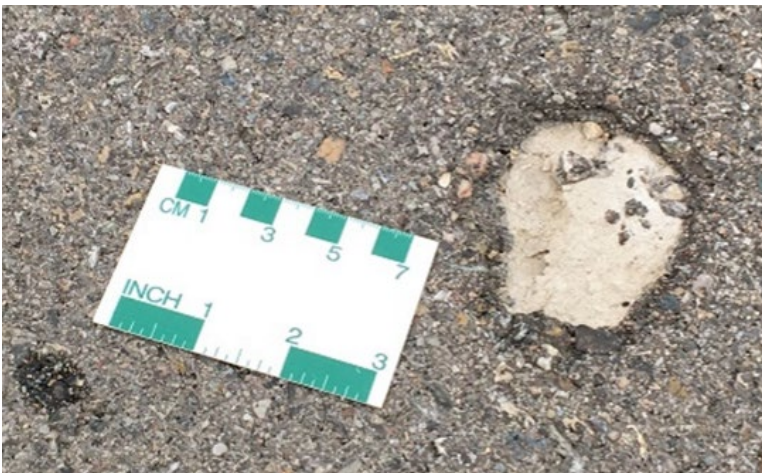
Figure 46: Inclusion of Lime Clump

Figure 47 shows a clump of hydrated lime in the asphalt concrete surface. A pothole will form after the lime clump breaks apart.

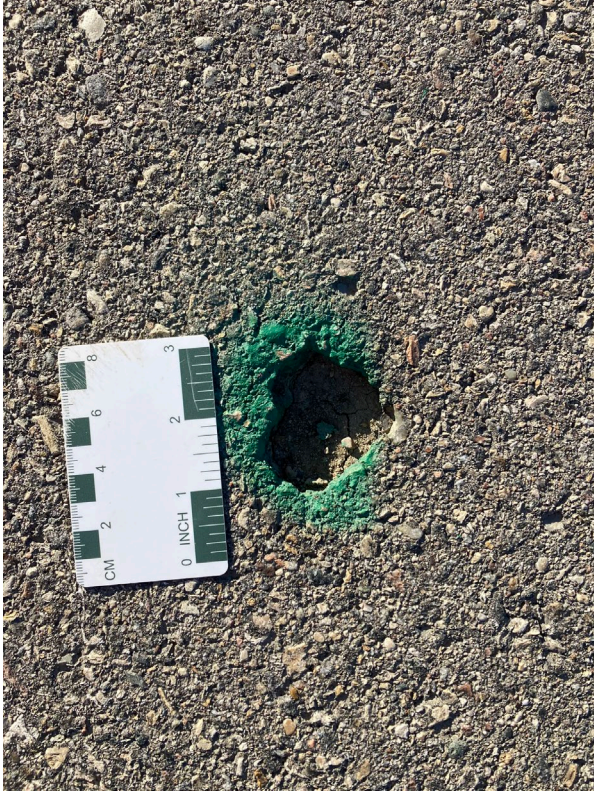
Figure 47: Pothole/Void

Figure 48 shows a pothole/void formed in the surface after deleterious material dislodged.

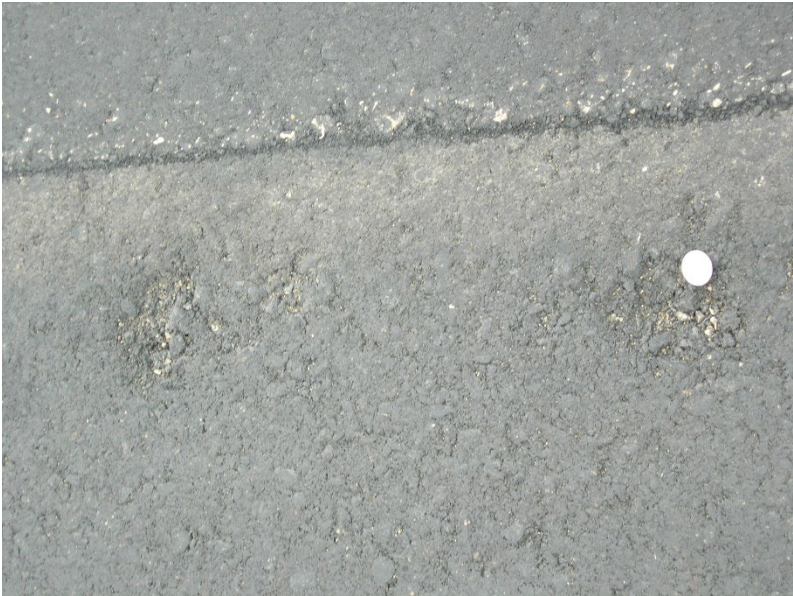
Figure 48: Surface Contaminated With Aggregate

Figure 49 shows pockets of dry aggregate within the surface.

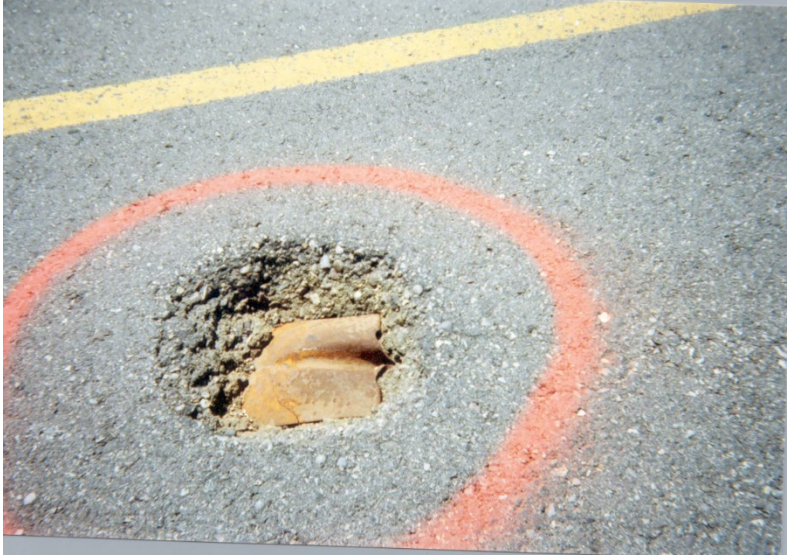
Figure 49: Inclusion of Foreign Object

A foreign object is depicted within the surface in Figure 50.

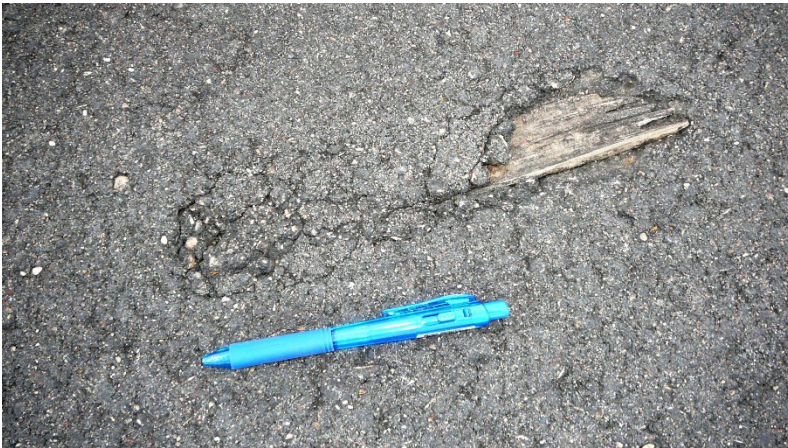
Figure 50: Inclusion of Foreign Object

Figure 51 shows inclusion of a foreign object.

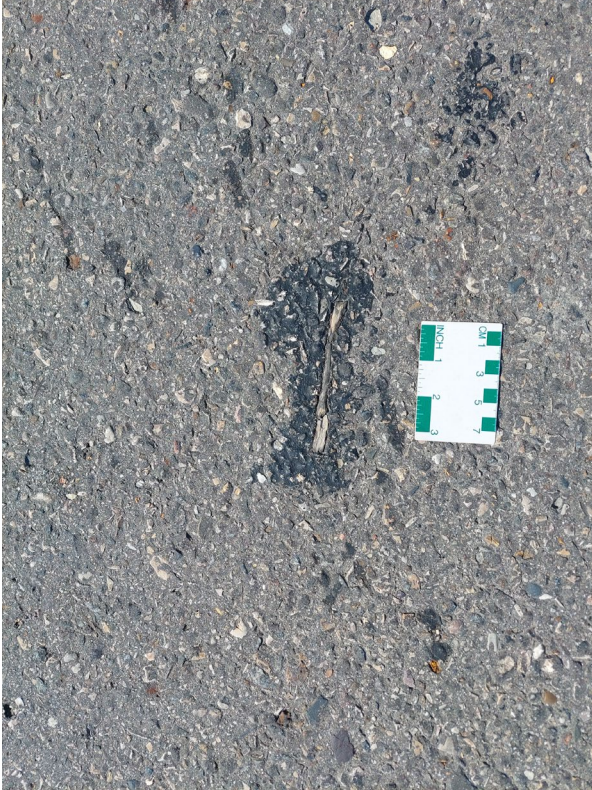
Figure 51: Inclusion of Tree Root

A tree root in the asphalt mat is shown in Figure 52.
