Orano Canada Inc.

Cluff Lake Project

End State Report for Provincial Institutional Control

September 2022

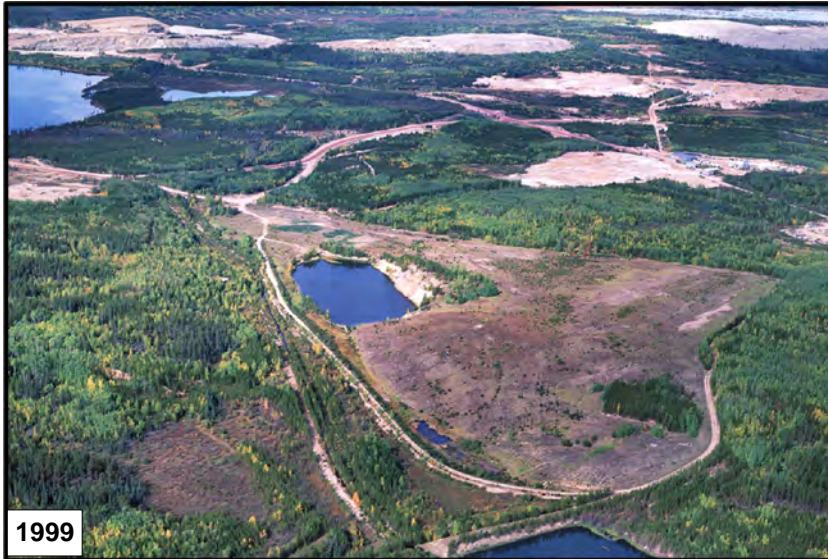
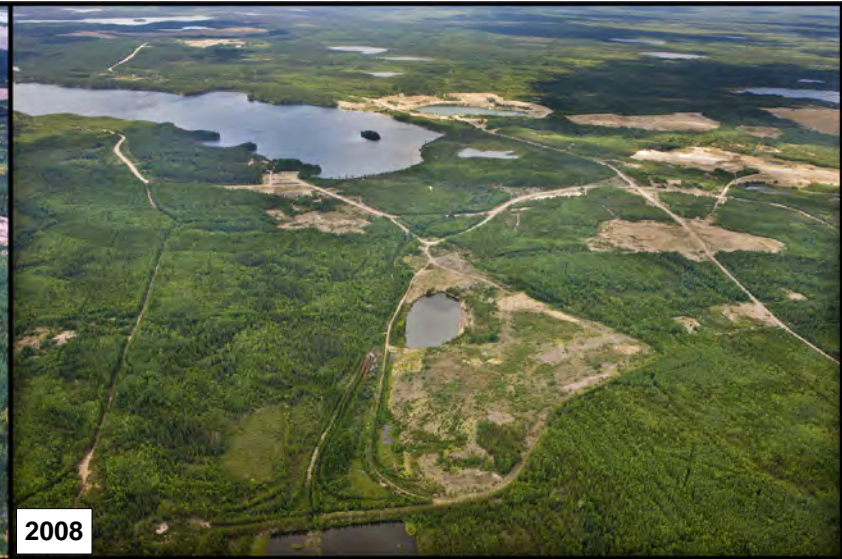
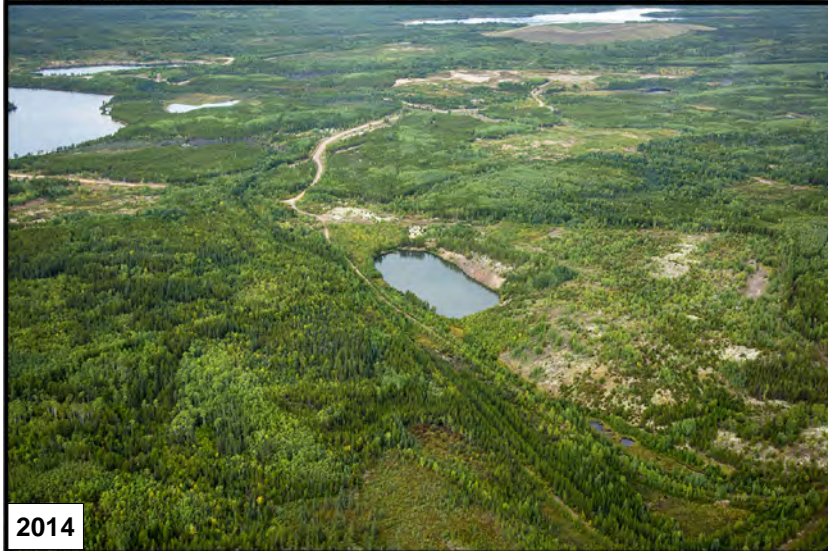
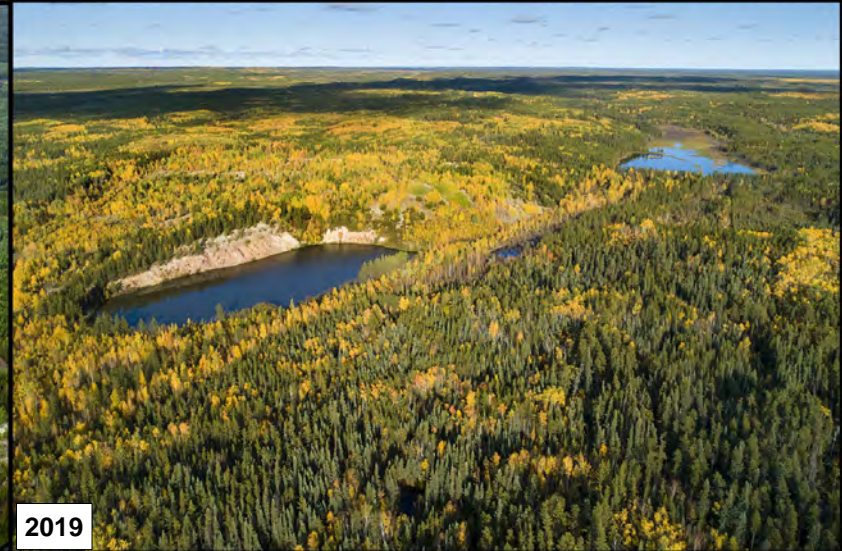
Aerial photographs of key areas which show operational, decommissioned, and recent conditions are presented in Figures 2.1 to 2.6.

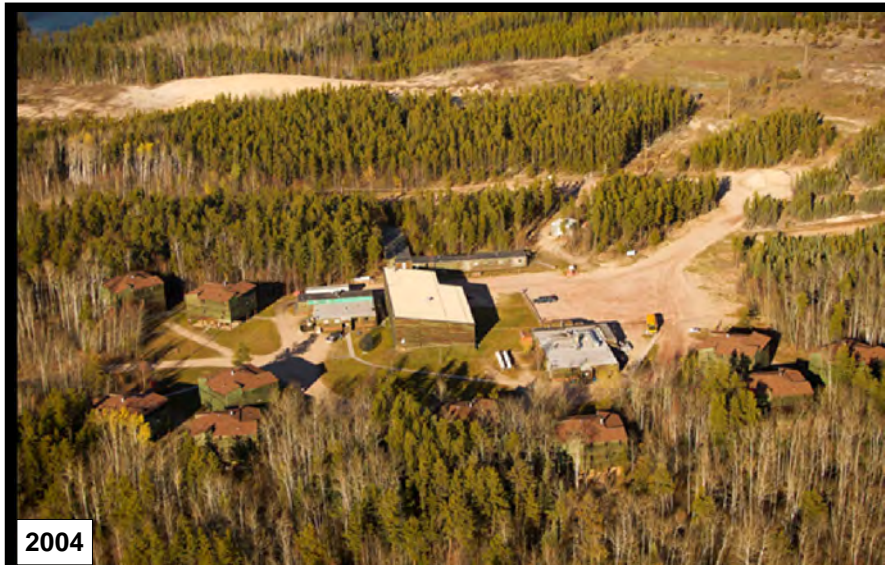
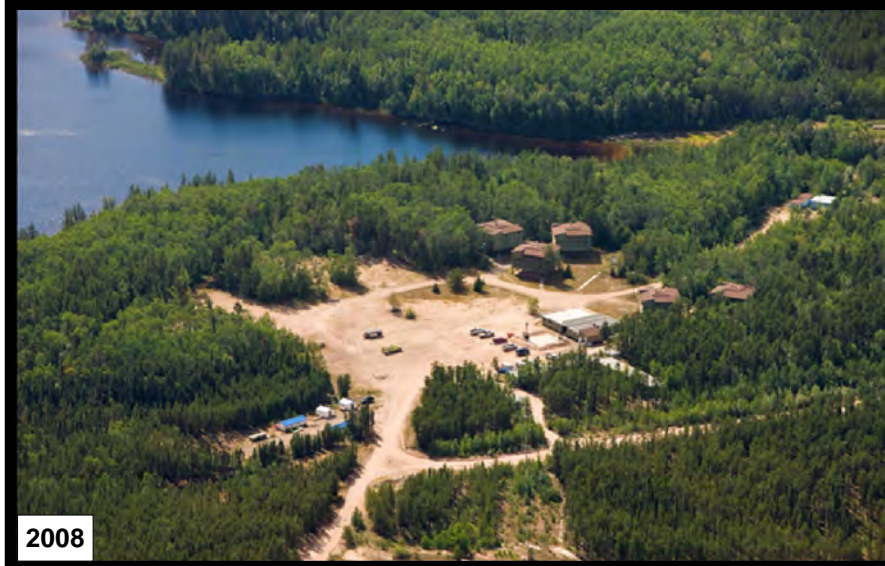
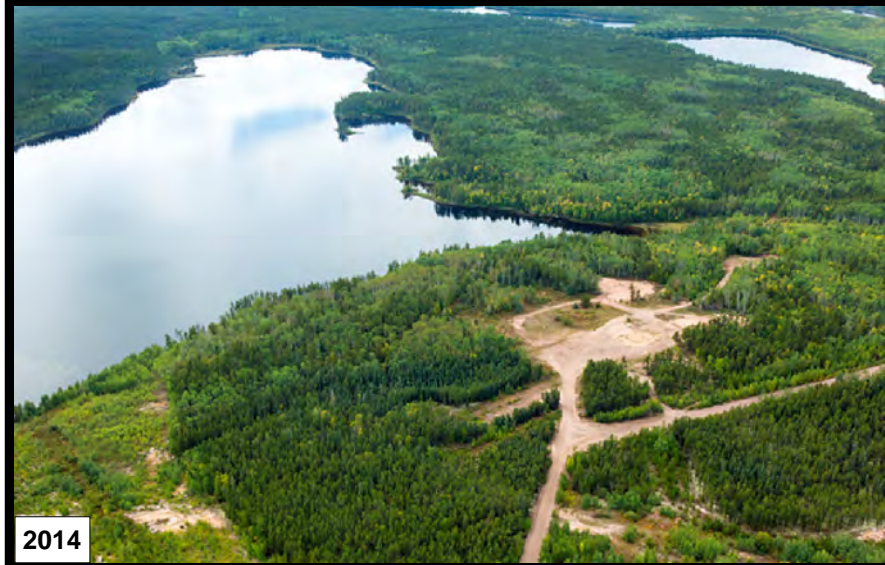
2004

2008

2014
