An Assessment of Abandoned Mines in Northern Saskatchewan

March, 2001

Prepared for:
***Saskatchewan Environment
and Resource Management***

Prepared By: ***(KHS) Environmental Management
Group Ltd.***

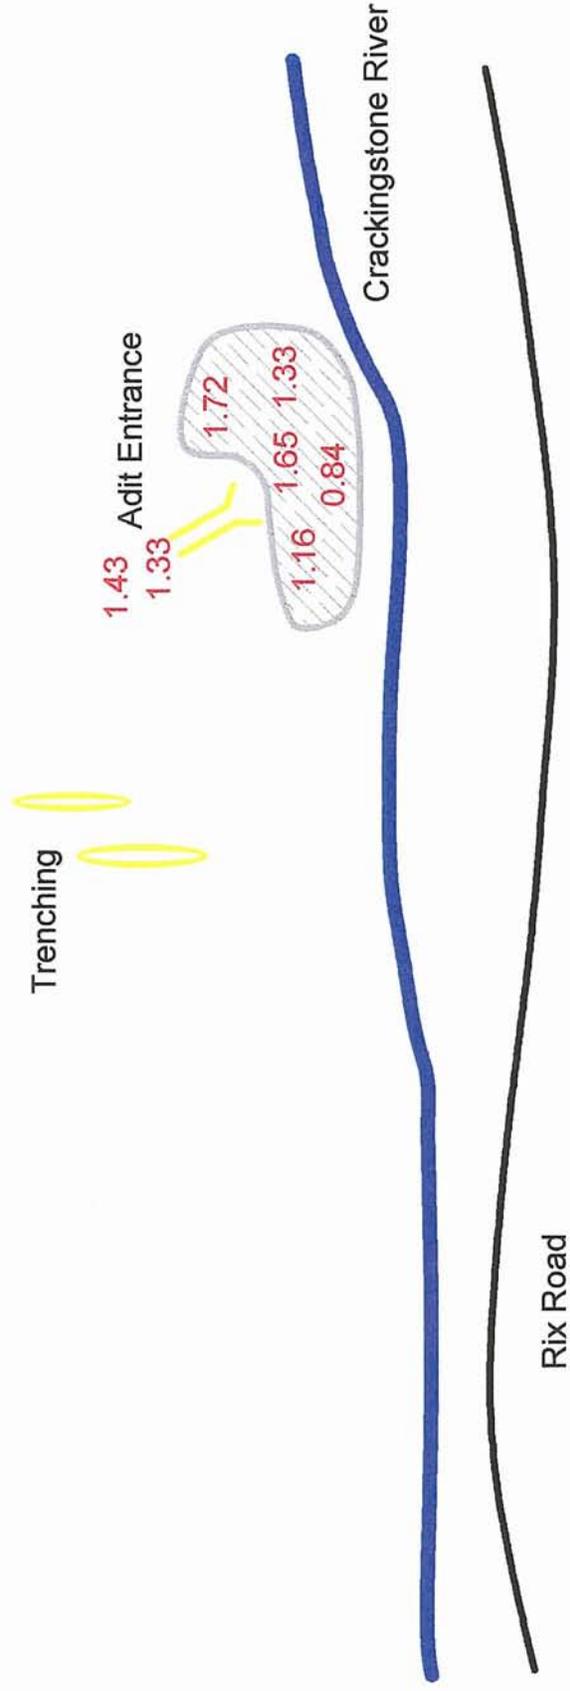
The adit entrance is showing early signs of slumping. There appears to be no immediate hazard, however the trench caused by blasting the adit entrance shut is likely to become a hazard in time due to the slumping and instability of the closure method.

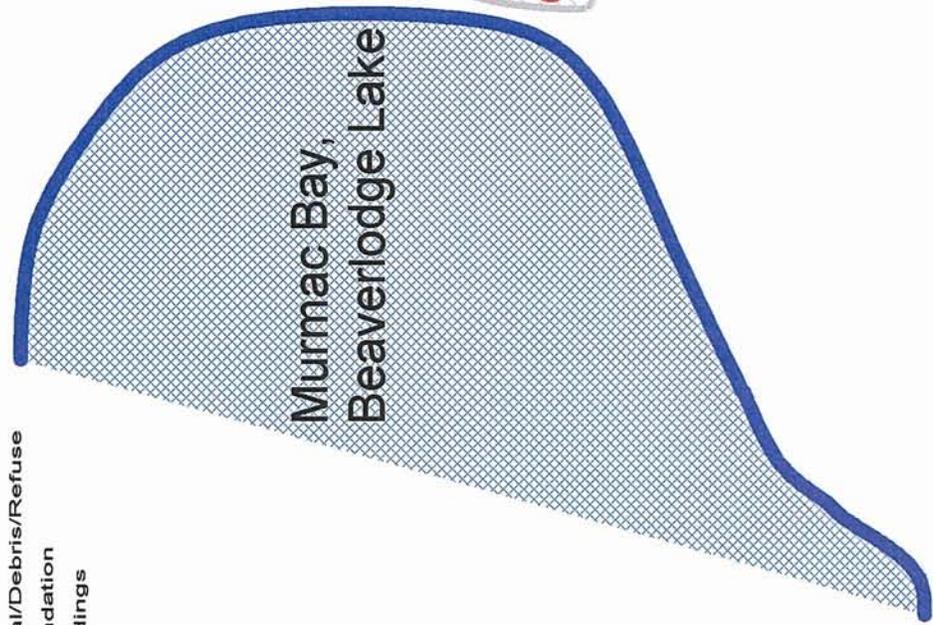
The underground workings of the mine consist of an adit approximately 100 m from the shore of Beaverlodge Lake. The adit has been closed with waste rock and appeared stable at the time of the inspection.

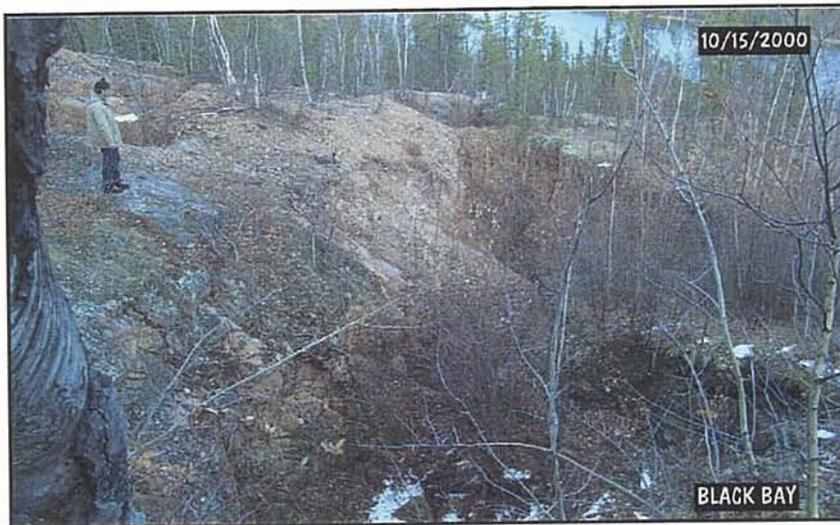
Along with the adit there are several areas where mining from underground has broken through to the surface or where trenching has mined through to the adit. These areas are concentrated approximately 50 meters up the slope from the adit entrance at GPS - N59° 30.280'; W108° 28.984'.

This entire area covers approximately 30 by 30 m

Filling or collapsing the holes by blasting would be the most effective method of

addressing the issues posed by the site.

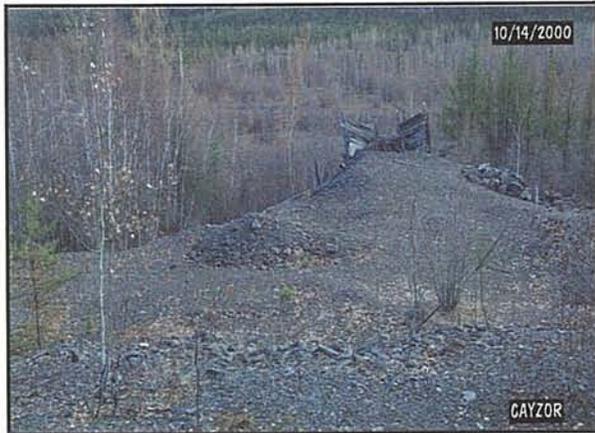
This ventilation raise is located approximately 150 m south east from the main shaft area and is sealed with waste rock . The stability of the closure is good and there were no liquid discharges or evidence of previous flooding.

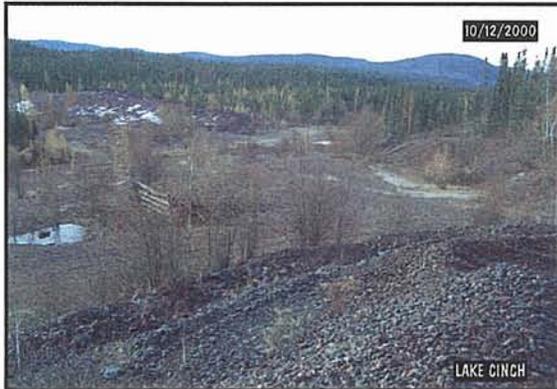
The site has extensive areas of waste rock. The stability of the waste rock is good, with the majority being shallow and used for roads.

There is little vegetation on large amounts of the waste rock, limited mostly to a number of small willows and alders.

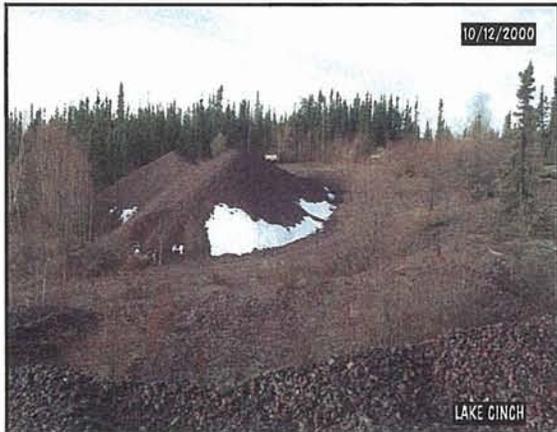
There are also three small ore piles associated with shaft #3. These piles are steep sided but relatively small.

Gamma survey of the site resulted in readings that ranged from background to as high as $5 \mu\text{S/hr}$. The later were restricted to small areas that are considered to be the ore piles from past sorting.

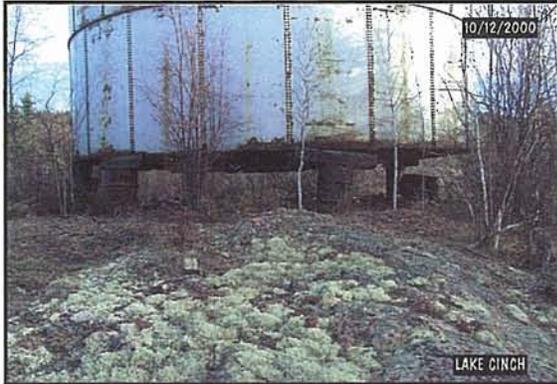
The primary concern associated with debris on the site would have to be the large water tank on the south end of the site.

The tank is approximately 9.5 m in diameter and 7 m high and is currently precariously standing on 45 gallon drums. Some of the drums have collapsed and the obvious lean to the tank is a concern.

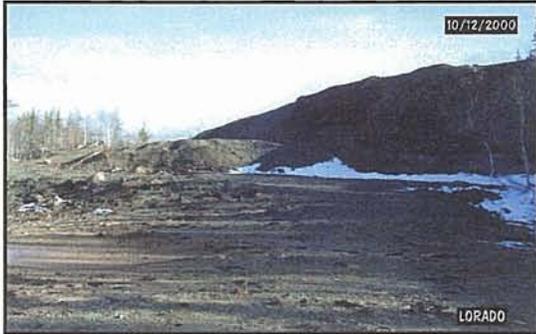
Along with the shaft there appears to be some excavating into the hillside south of the shaft. The bottom of the pit is at shaft level while the south side extends to a height of approximately 5 m. The south wall is in poor condition and shows signs of slumping and rock slides. The pit supports no significant vegetation.

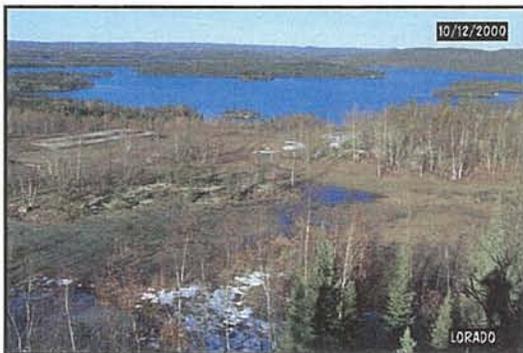
The local topography and location of the waste rock indicate that all runoff from the waste rock is fed to a muskeg below the mine site to the north. From this area all water flows through two culverts into Beaverlodge Lake.

A gamma survey of the waste rock was conducted with measurements ranging from 0.20 to 1.60 $\mu\text{Sv/hr}$. (see Site Map 10)

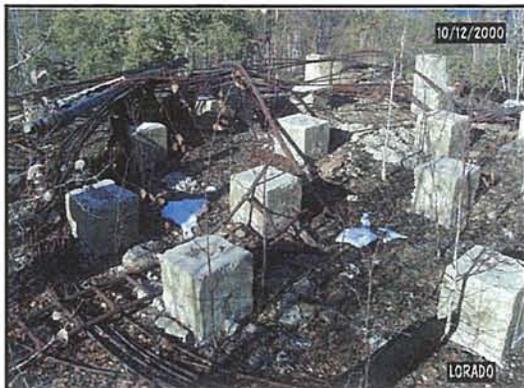
east of the shaft that appears to be the remnants of an old water tower. Otherwise the debris is limited to small amounts of scrap material and some old wooden water lines.

From the remnants of the water tower, the remains of the fresh water line are found all the way to Beaverlodge Lake.

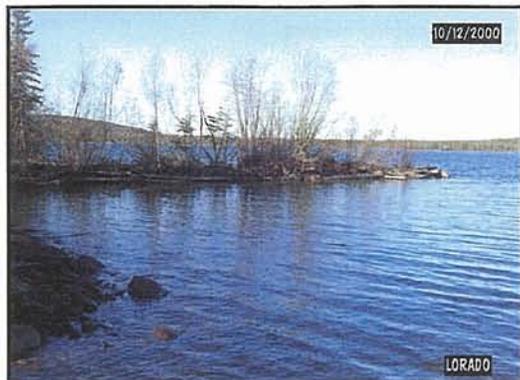
The fresh water intake weir remains in Beaverlodge Lake. The weir was constructed of rock and concrete however the only rubble remaining from the actual pump house is two steel doors and some wooden structural materials.

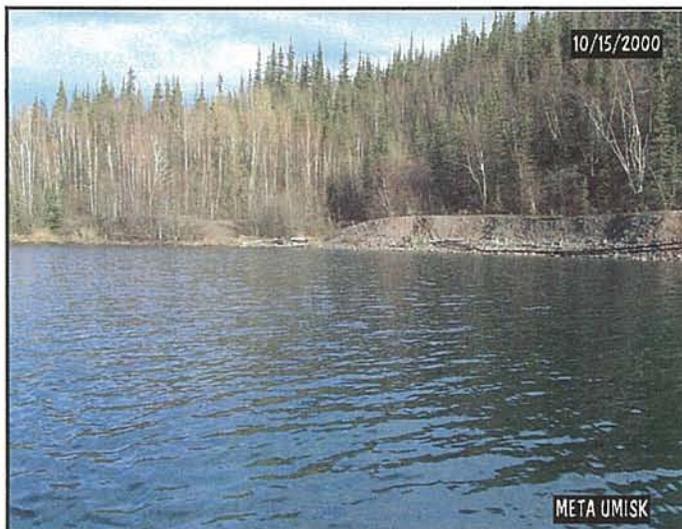
11.6.2 Waste Rock

There is a relatively large amount of waste rock on the site. A 42 m long stretch along the shoreline as well as a loading area into the water are easily recognizable from the water. The stability of the waste rock is good. It supports sparse vegetation.

A gamma survey of the waste rock was conducted with measurements ranging from 0.62 to 4.58 $\mu\text{Sv/hr.}$ (see Site Map 11)

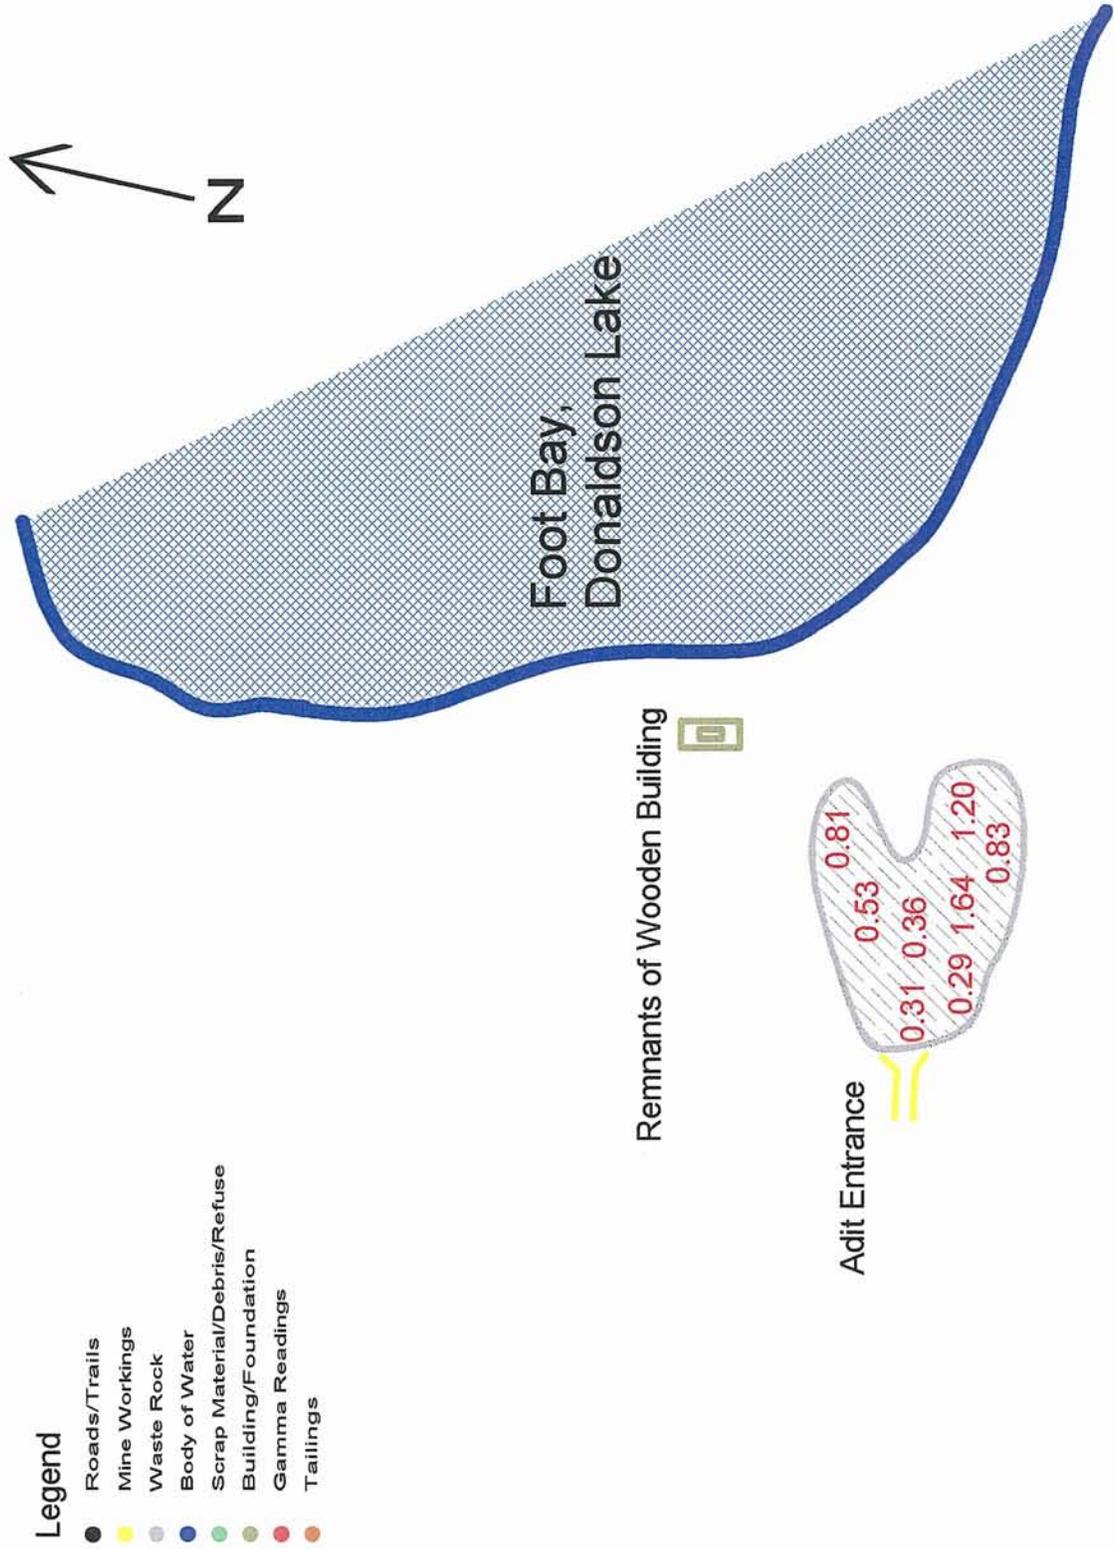
12. National Explorations Ltd. - Keiller Adit

The mine workings consist of a single adit driven into the hillside approximately 15 m from the shore of Donaldson Lake. The entrance is approximately 4 by 4 m and is sealed with a steel grate. The stability and condition of the closure is not adequate as access to the workings is possible for wildlife and humans. There were no support buildings evident in the area.

The site can not be considered a priority for rehabilitation because of the difficult access. However, the adit entrance does pose a hazard to public safety and wildlife as access to the workings is easily made. Although the adit has been restricted, the method used is in poor condition. In addition, evidence of slumping and rock falls is of some concern.

Another option would be to secure the opening with a more secure steel grate - one which cannot be easily removed.

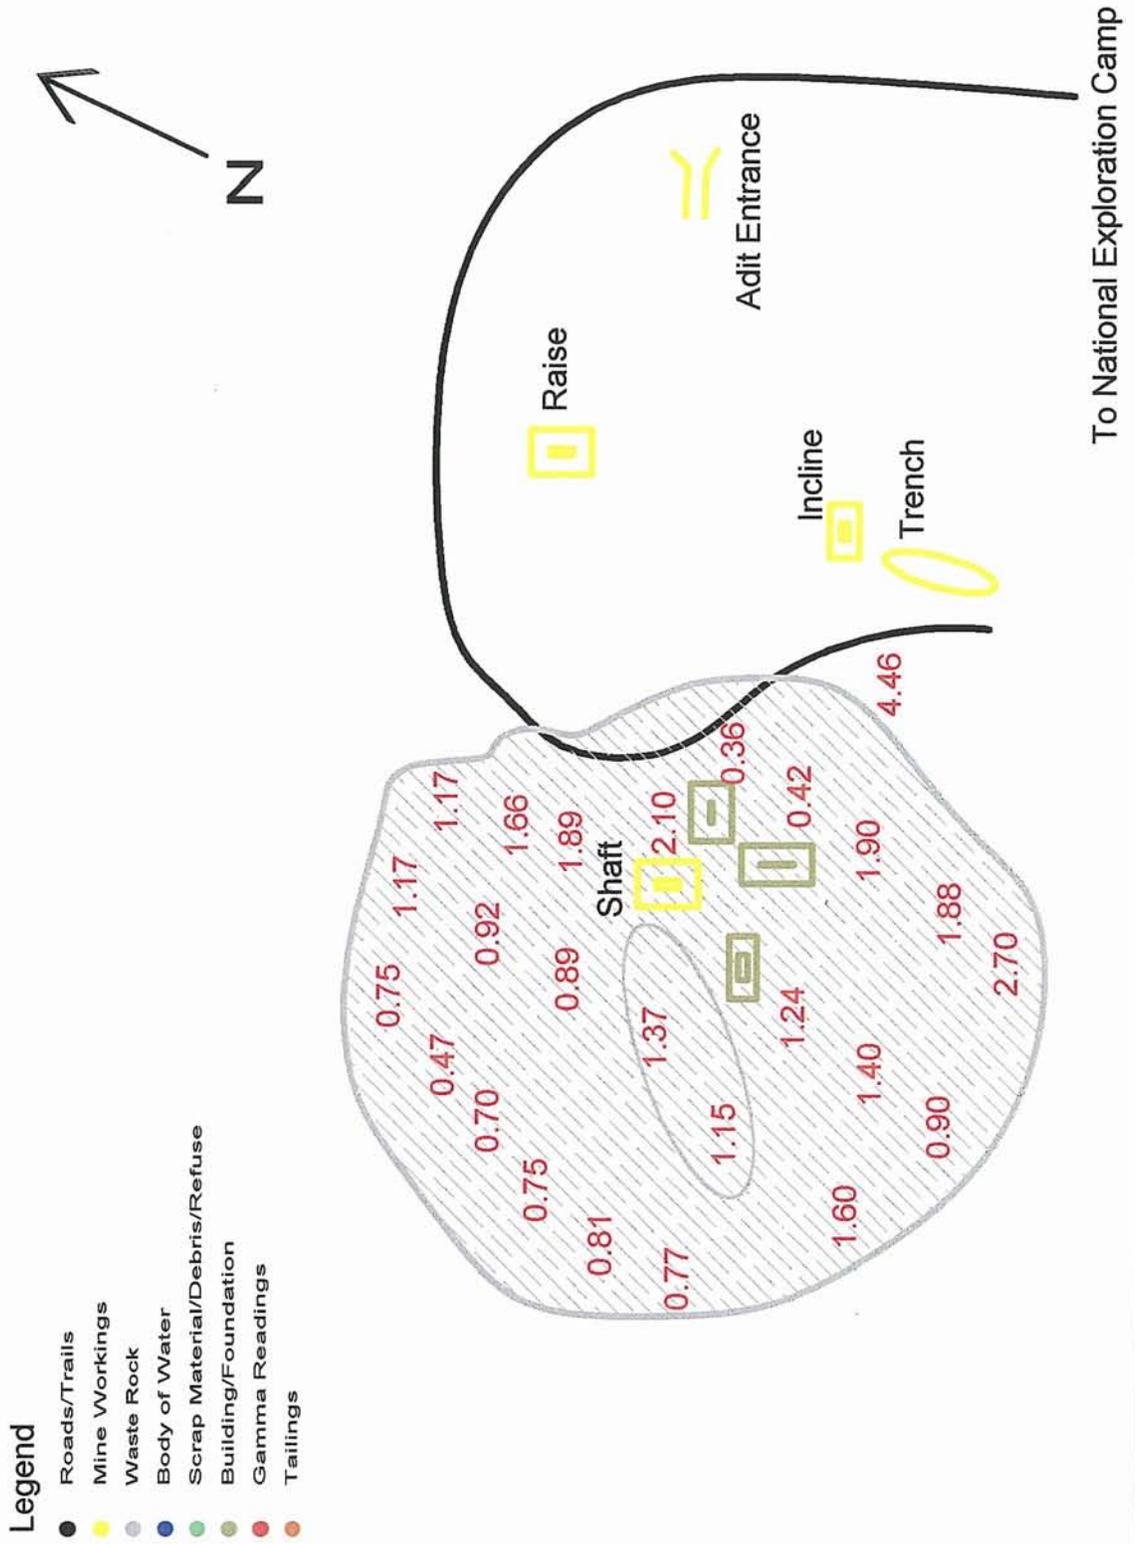
13. National Exploration Ltd. - Pat Claims

The shaft is located near the east end of the mine site. The shaft is approximately 5 by 5 m and is sealed with concrete. The concrete is thin and evidence of rotting is apparent. The cap is deteriorating and is not in good condition. There is several concrete foundations associated with the shaft. There was no liquid discharge at the time of inspection and no evidence of previous flooding.

There is a large amount of waste rock in the area. It has been used for roads and foundations. The majority of the rock is in a pile approximately 10 m high and 50 m in diameter immediately beside the main shaft. It is steep and unstable. All of the waste rock other than the large pile supports a vigorous vegetation cover when compared to other sites in the region.

There is no immediate hazards to the public or environment at this site. However, the stability of the shaft closure method will continue to degrade. The remoteness of the site and the difficulty in accessing it place it low on the list of priorities for rehabilitation.

Generally the site could be improved if heavy equipment were employed to level and contour waste rock and bury both the shaft cover and the debris in the area. A rehabilitation of the shaft cover should be completed before placing waste rock over it.

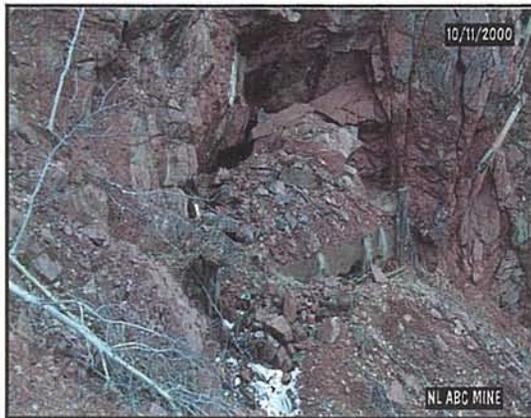
The primary mine site is located near the shore of Melville Lake. Adit #1 is the southerly most adit. This adit is the first opening that is reached when approaching the mine site on the road. It is sealed with waste rock which has opened up revealing a steel piping grate. The grate has collapsed leaving an opening approximately 0.25 by 2 m. There is obvious slumping of the adit entrance making the underground workings accessible. There was no liquid discharges at the time of the inspection and no evidence of previous flooding.

The opening is approximately 1 by 1.5 m. The stability of the rock that was used in an attempt to seal the adit is unstable and is in poor condition.

There is also evidence that there have been several previous attempts to seal that adit entrance. The flooding within the adit appears to eventually wash the rock away leaving the adit entrance open.

Both adits are showing signs of slumping and the general degradation of previous closure attempts and allow for entry into the workings with little or no effort.

Both adits require some rehabilitation however, any work must take into consideration water build up with in the adit. Previous attempts to permanently close adit #2 have failed because the eventual build up of water behind the waste

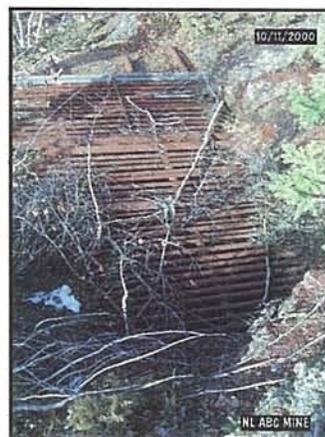
The final opening at Site #41 is the shaft located approximately 20 m immediately above adit #1. The shaft opening is 5.5 by 2.2 m and is sealed with a steel piping grate that is anchored into the bedrock around the opening. The stability and condition of the closure are good and there is no evidence of slumping or liquid discharge. There is a collapsed wooden building near the shaft opening.

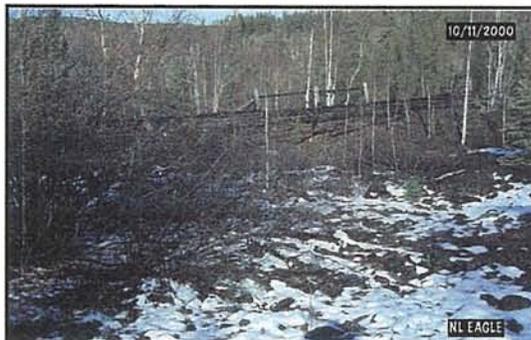
Immediately above the adit entrance there is a storage/loading area. It appears that this area was used for storage, while a hole to the adit below was used for loading. Trucks backed into the adit and they were loaded from above. A wooden retaining wall was used and this is getting very unstable. It is deteriorating to the point that the rock that it is holding up will come down.

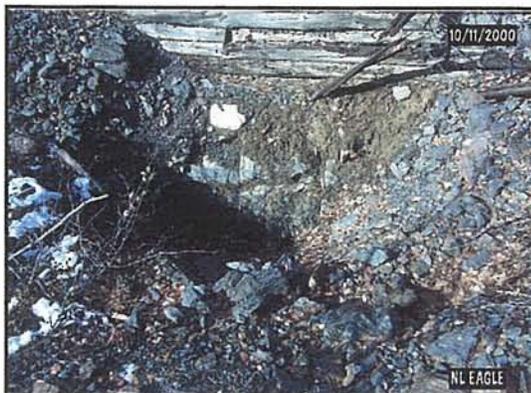
There also was evidence of slumping near the wall where the entrance to the adit was located.

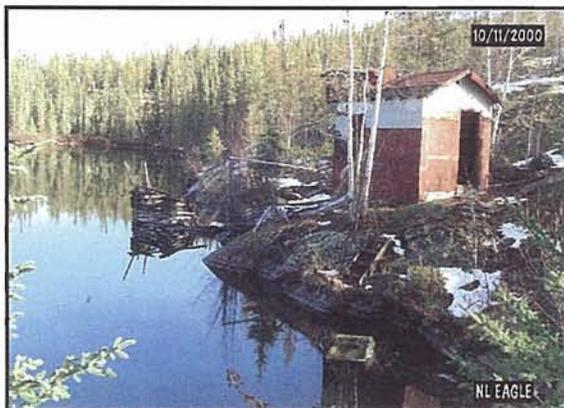
There is a freshwater intake located approximately 500 m northeast of the mine site. There is a support building remaining and debris and remnants of the intake in the water.

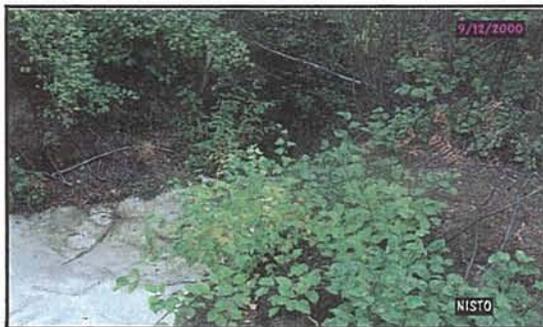
The most easterly of the two adit was sealed with a concrete bulkhead which contains two drains for water.

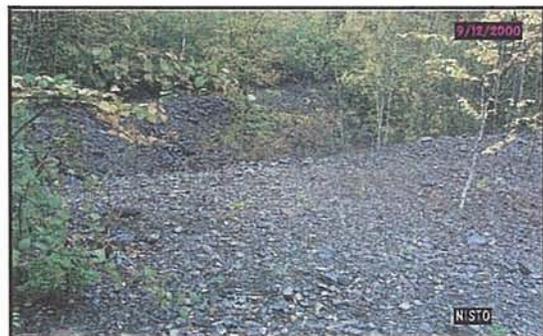
The raise has been sealed with a concrete cap.

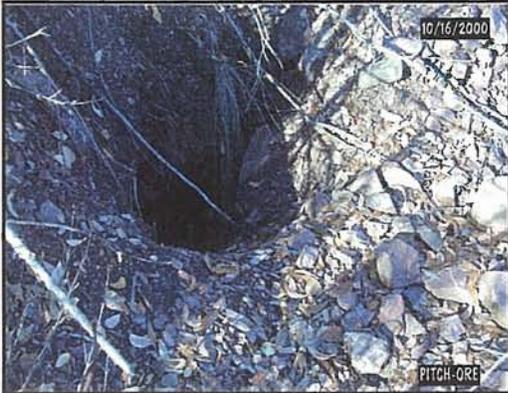
Adit #1 is immediately west of the powerline approximately 5 m from powerline clearing. The entrance is approximately 3 by 2 m in size and is partially sealed with waste rock. The stability is poor and there is obvious slumping leaving a small 0.25 by 0.50 m opening. There are no buildings in the immediate area of the adit entrance. A small amount of liquid was discharging from the entrance that ran on surface for approximately 5 m then disappeared into the waste rock.

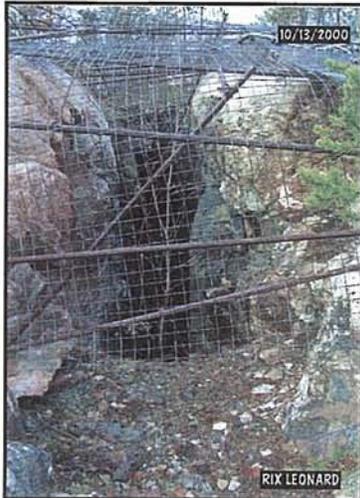
The shaft and trench are approximately 100 m above the adit entrance (N 59° 33.494'; W 108° 40.592'). The shaft opening is approximately 9.6 by 7 m in size and is collared by concrete. The opening consists of two shafts that come together at the surface. The opening is sealed with a drill rod grate and metal screening; all tied to the concrete collar. The grate is in good condition along with the concrete collar. There was no liquid discharge at the time of inspection

and there was no evidence of previous flooding.

The trench which is located immediately to the south of the shaft opening also has a similar type of grate covering it. The trench is approximately 24 m long, 1 m wide, and up to 7 m deep. The grate has deteriorated somewhat and there are openings in several places where access to the workings can be accomplished. The trench did have water in it at the time of inspection, although due to safety concerns it was not sampled during the inspection. There are no explicit signs of slumping in the area of the trench walls.

The Leonard shaft and trench do pose a safety risk. The closure methods are not entirely secure. At the time of inspection the shaft closure was secure, while the trench closure showed signs of deteriorating. The closure methods would not prevent a persistent explorer from accessing the workings.

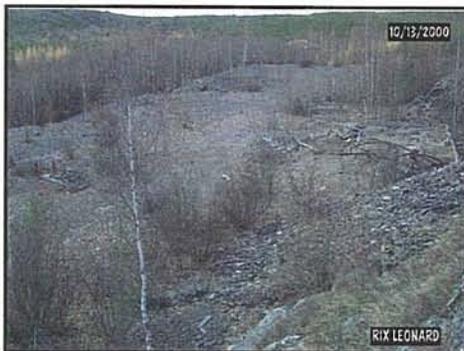
21.6.2 Waste Rock

Waste rock at the Leonard Mine is limited to the vicinity of the adit entrance. An area approximately 100 m by 20 m by 3 m was noted. Due to flooding as a result of the recent beaver activity, water extends to the toe of the waste rock. The area is extremely flat and stable. The area around the mine is extremely well vegetated except for the waste rock that has a few small birch, alders, and willows near the edge.

A gamma survey of the waste rock was conducted with measurements ranging from 0.33 to 1.70 $\mu\text{Sv/hr.}$ (see Site Map 21/22)

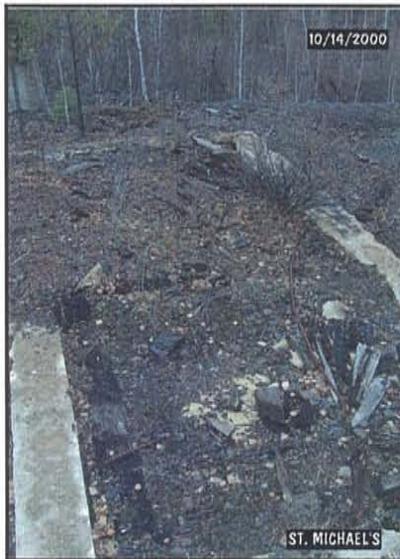
23.6.4 Debris/Rubble

There is a relatively large amount of debris on the site which is concentrated in the vicinity of the shaft. It appears to be the remnants of the headframe and support building. Other scrap material in the area includes remnants of other buildings, tracks, ore carts, barrels, piping, cables, and various scrap metal materials.

The primary issue with this site is the amount of debris near the shaft and the one basement foundation.

If rehabilitation activities were taking place in the area and hydraulic equipment were available, the site could be improved by spending a day burying material and levelling the waste rock.

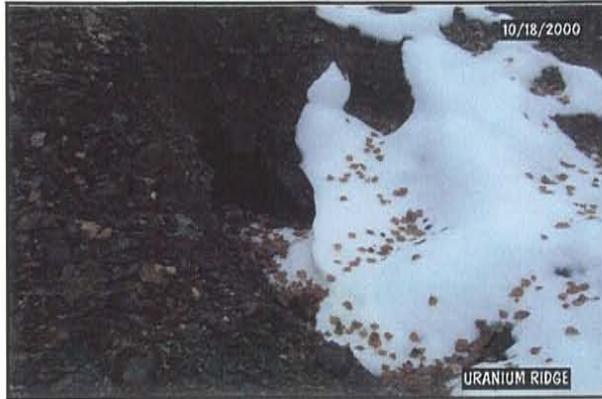
The mine consists of an adit (N 59° 29.359' and W 108° 40.819') near the base of the slope and a raise to ground surface approximately 25 m up the slope from the adit

entrance. The adit, which was blasted and covered with waste rock, is showing signs of slumping and the stability of the closure is poor. At the time of the inspection there was an opening (approximately 0.5 by 0.5 m in size) and evidence that wildlife was occupying the adit. There was no liquid discharge at the time of the inspection, however there was evidence of previous flooding.

The adit shows signs of slumping and the general degradation of previous closure methods allows for relatively easy entry to the workings of the mine, if desired.

The raise should be filled with waste rock or till material which is readily available at the site. In addition, the accumulated debris in front of the adit should be disposed of either in the adit before it is re-sealed or at another appropriate location.

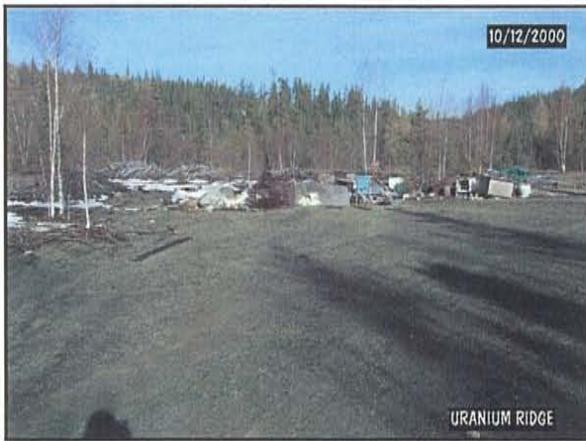
25.6.4 Debris/Rubble

There is a small amount of mine related debris located on the top of the hill above the adit and raise, including some steel debris and the remnants of machinery.

The majority of the debris at the site is located immediately in front of the adit entrance and was deposited after the mine operations ceased. The amount of domestic debris is extensive and ranges from washing machines to chairs and snowmobile helmets.

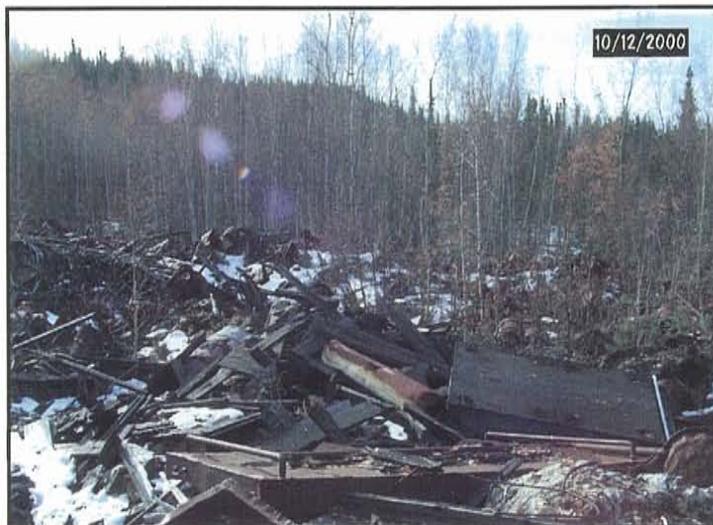
27.6.4 Debris/Rubble

The site appears to be a waste disposal area used during either the operation or the decommissioning of the Lorado mill. The area is approximately 45 m long by 20 m wide. The refuse is piled approximately 1 to 2 m high and consists of various debris and scrap metal; ore barrels, piping, machinery, etc. There are residual fines or chemicals in a number of barrels.

Gamma levels measured within the waste disposal site ranged from background (0.07 - 0.23 $\mu\text{S/hr}$) to 5.56 $\mu\text{S/hr}$.

Careful consideration must be given to the manner in which, and the location at which, this material is disposed of.

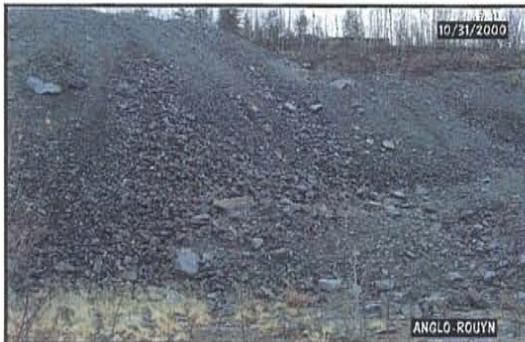
28.6.2 Waste Rock

Waste rock is scattered throughout the area. It has been used for road construction in all areas of the mine site. The primary pile is at the 'C' zone where it is piled approximately 10 m in height. The pit at this zone appears to have been filled using waste rock.

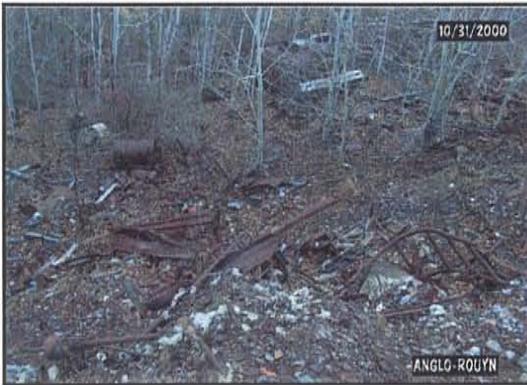
28.6.4 Debris/Rubble

There is an assortment of debris throughout the area. The primary waste disposal area is located at the north end of the tailings area along the slope to the west. The area is approximately 20 by 30 m in size and consists of abandoned vehicles, scrap metal and glass of all types.

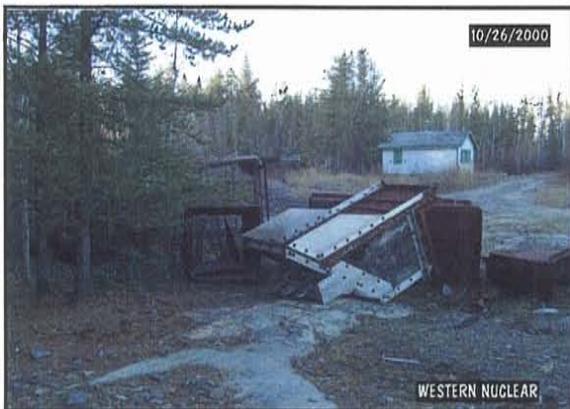
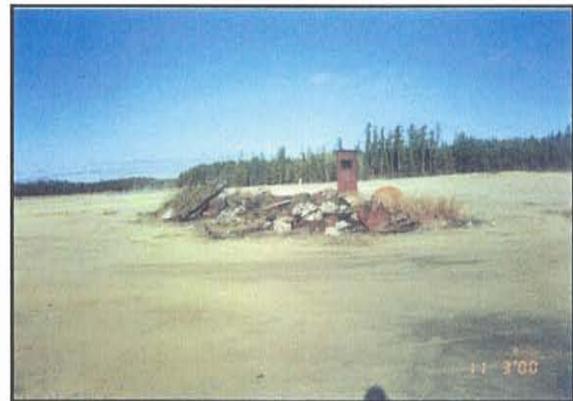
29.6.3 Debris/Rubble

There is very little debris around the mill area. Approximately 200 m northwest of the mill area there is some debris including, mill fines, ore skip, freshwater intake, and various scrap metal.

There are also two substantial debris/rubble piles among the main tailings area.

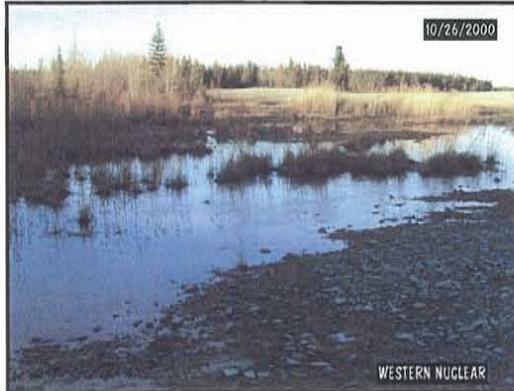
29.6.5 Site Sampling

Water samples were taken from the ponded water immediately west of the mill area, from Hanson Lake immediately east of the mill area, and from the pond north of the primary tailings area.

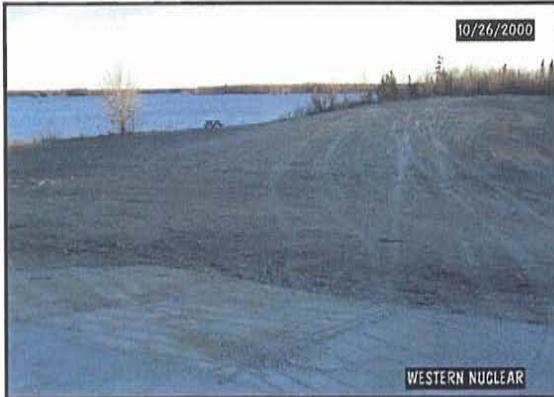
The first area requiring rehabilitation is the tailing management area in general as it has not been decommissioned and is showing significant signs of water and wind erosion with little containment on the southern perimeter.

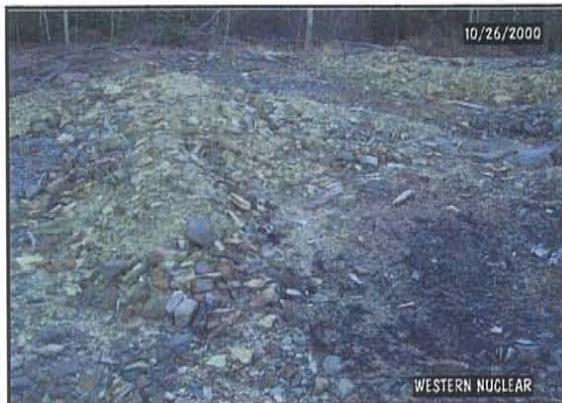
The second area that requires immediate rehabilitation is the area sampled between the former mill site and the shore of Hanson Lake, which as the analytical results show has been contaminated at some point in the past.

With regards to the last two, it is recommended that both areas be excavated and the material placed within the primary tailings management area.
