**AN ASSESSMENT OF
ABANDONED MINES IN
NORTHERN SASKATCHEWAN
(YEAR 2)**

**GULCH MINE ADIT-URANIUM CITY AREA
SEPTEMBER 29, 2001**

An Assessment of Abandoned Mines in
Northern Saskatchewan

Prepared by: Clifton Associates Ltd.
on behalf of
P.A.N.S. Joint Venture

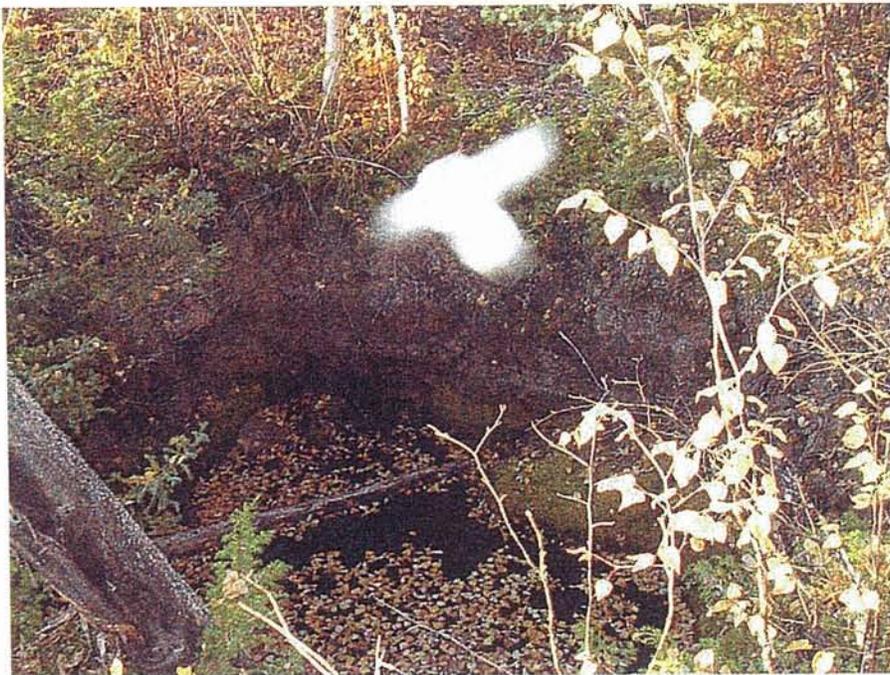
Photo 6.2-3 Caba Shaft Opening
September 26, 2001

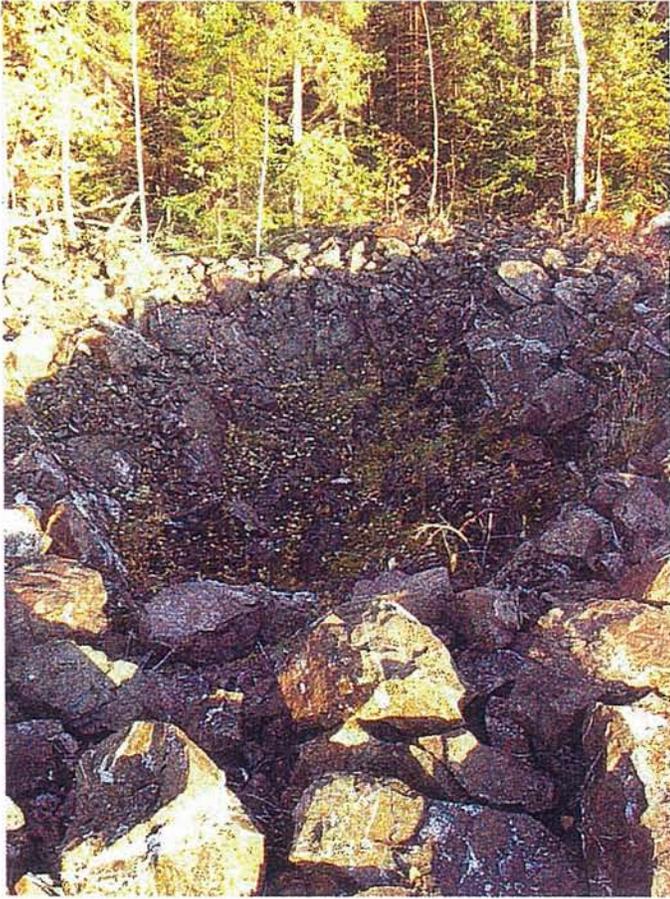
Photo 6.2-4 Caba Trench
September 26, 2001

Waste rock adjacent to the trenches should be pushed back into the trenches and graded.

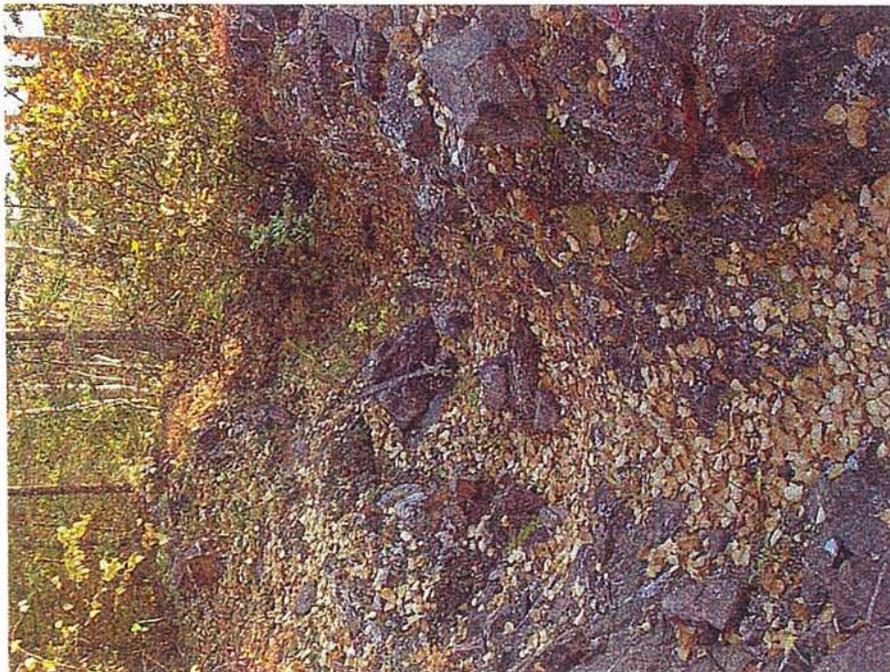
Photo 6.2-5 Caba Trench
September 26, 2001

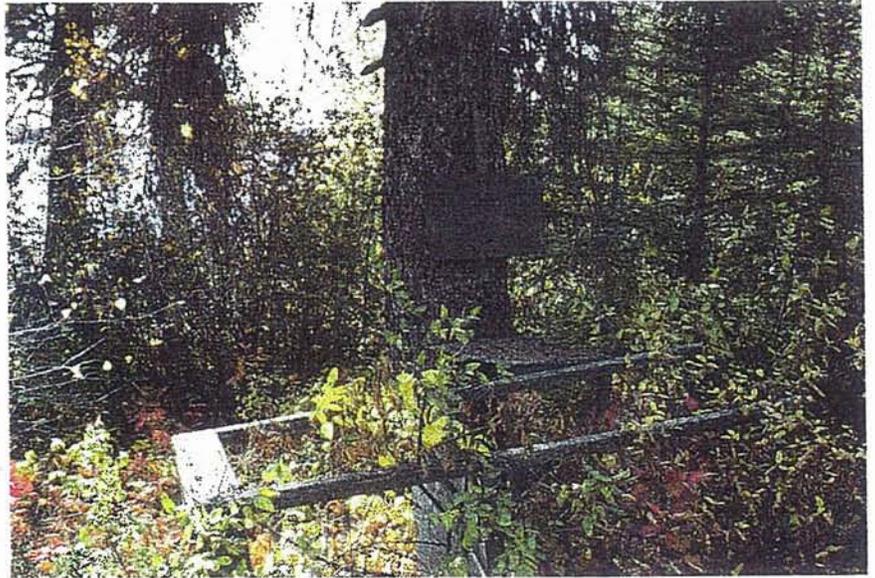
Photo 6.4-2 Dilapidated Cabins Frame
September 27, 2001

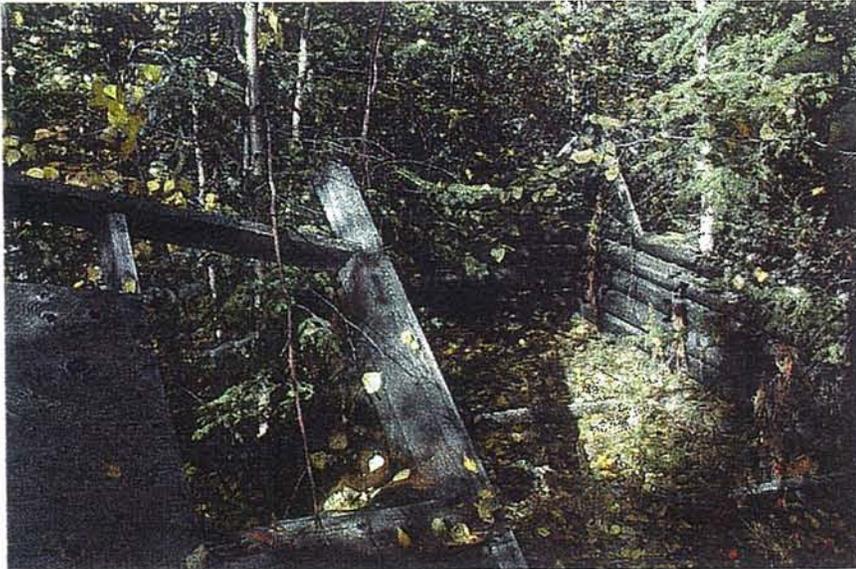
Photo 6.4-3 Dilapidated Cabin and
Debris
September 27, 2001

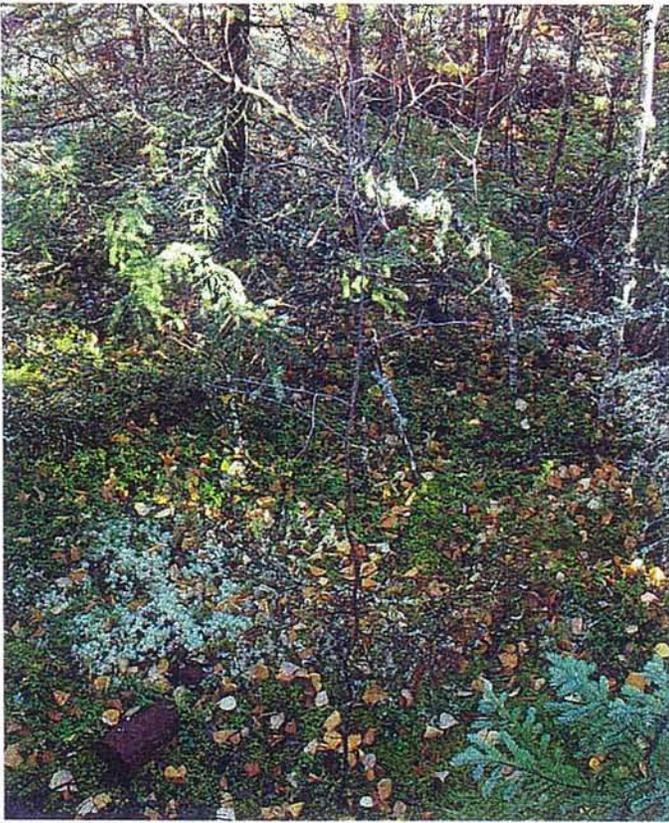
Photo 6.4-4 Trench Near Cabins on South Side
September 27, 2001

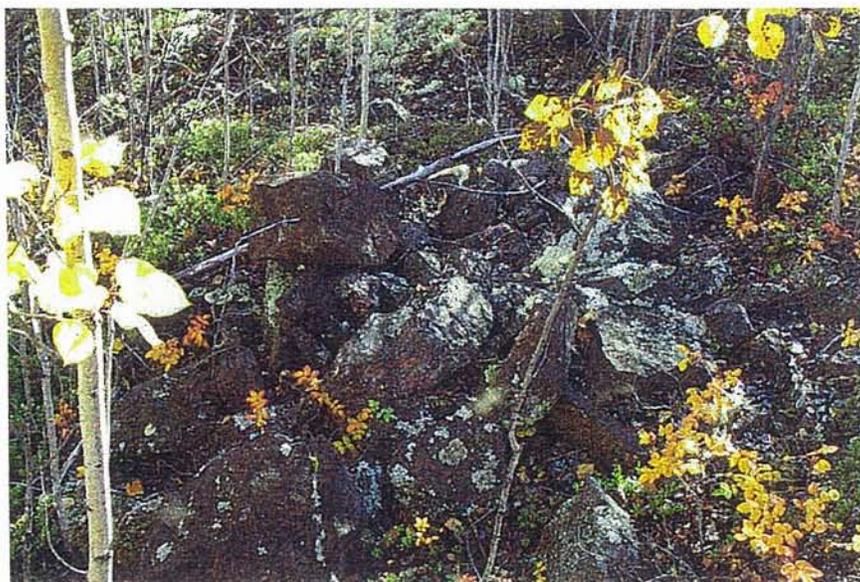
Photo 6.6-3 Trench Waste Rock
September 28, 2001

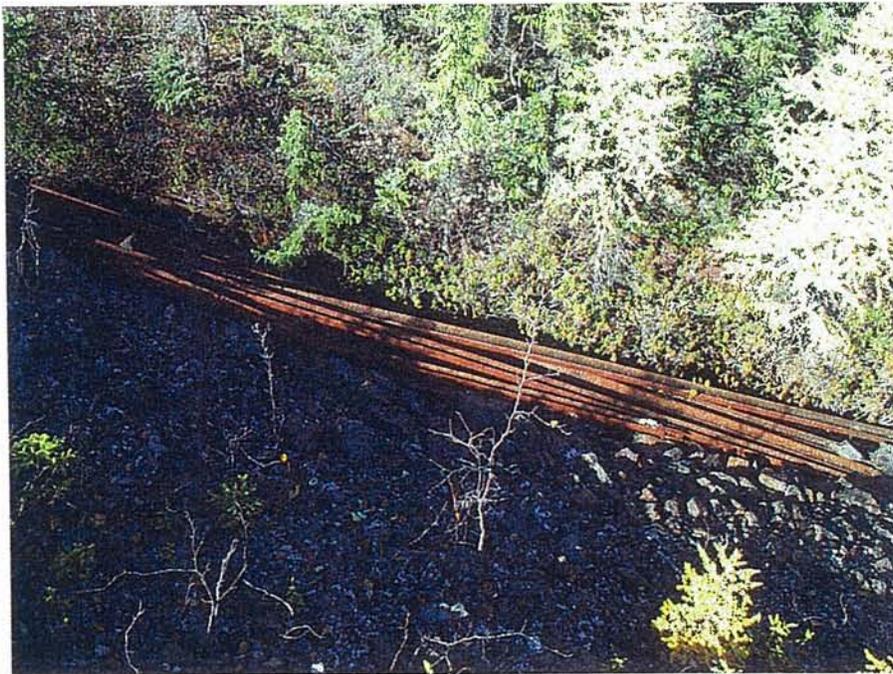
Photo 6.6-6 Debris-Homer Yellowknife
September 28, 2001

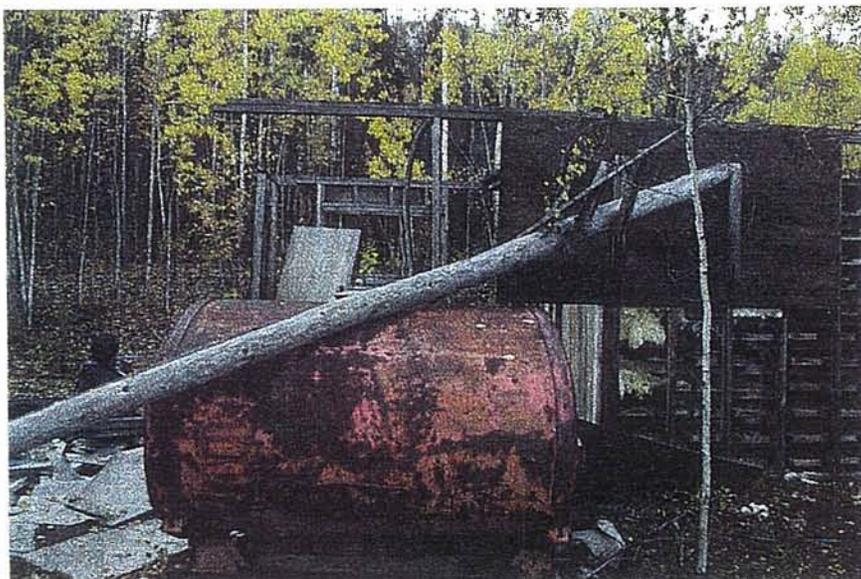
At the shoreline, there is a large fuel storage tank. Approximate dimensions are 6 m high by 8 m diameter. Approximate volume is therefore about 300 m³ or 300,000 l (66,000 imperial gallons). A steel fill line extends out from the base of the tank towards the shoreline. The line does not extend all the way to the shoreline. There are no signs of leaking fuel from the tank or the line. The tank did not appear to contain significant amounts of fuel (based on knocking on the side of the tank and listening for differences in sound).

Photo 6.7-4 Large Fuel Tank on
Shoreline
September 28, 2001

The site requires extensive follow-up work. Work should focus on permanently blasting the adit closed, removing the large fuel tank, genset, and transformers. Shacks at the camp and mine sites could be burned along with a general housecleaning by either removing debris from the site or disposing of it at the site. Steel drill stem at the mine site could be removed along with the genset. The former exploration trail could be used to drive a skidder to the site and pull debris out. The debris could be piled up in the summer and pulled out by a skidder over the lake in the winter to Uranium City for disposal or disposed of in the adit before it is closed.

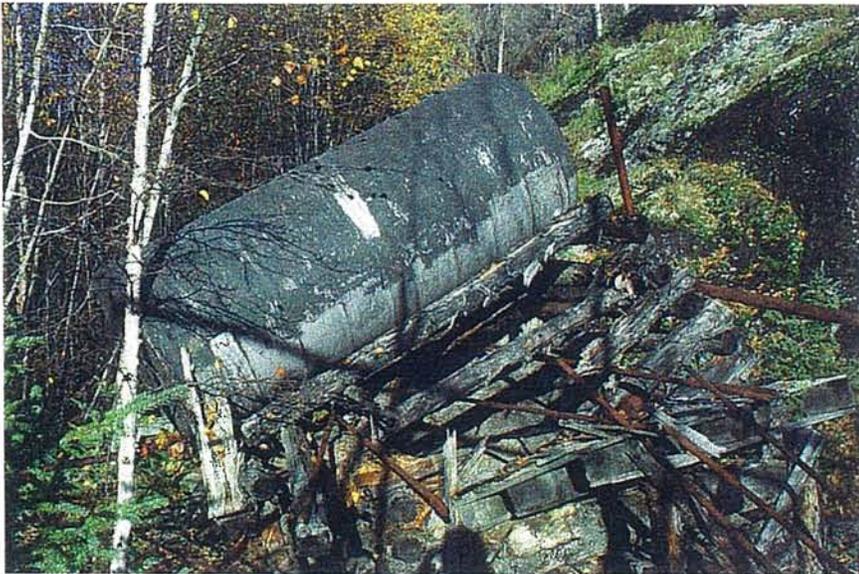
Photo 6.7-8 Debris Outside Adit
September 28, 2001

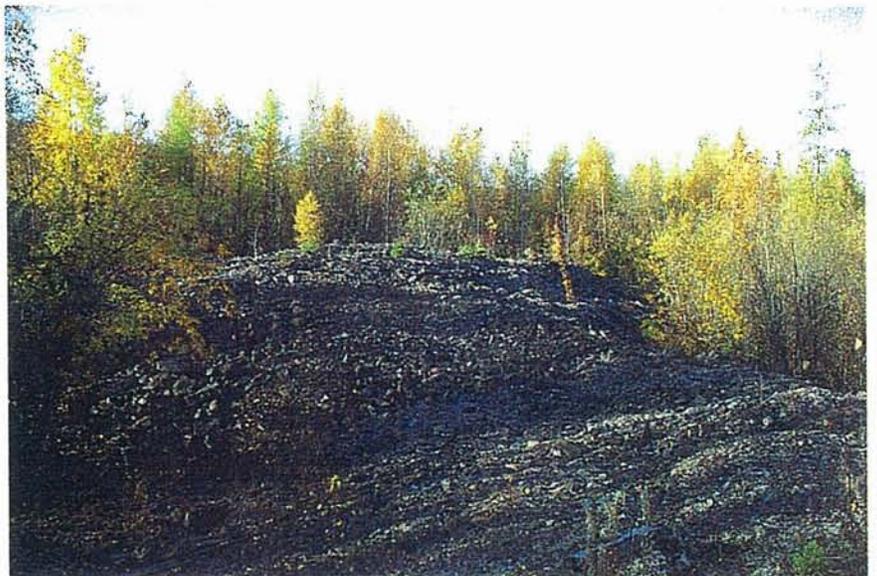
The piles appear to be stable and do not present an environmental or public safety hazard.

Photo 6.7-9 Main Waste Rock Pile
September 28, 2001

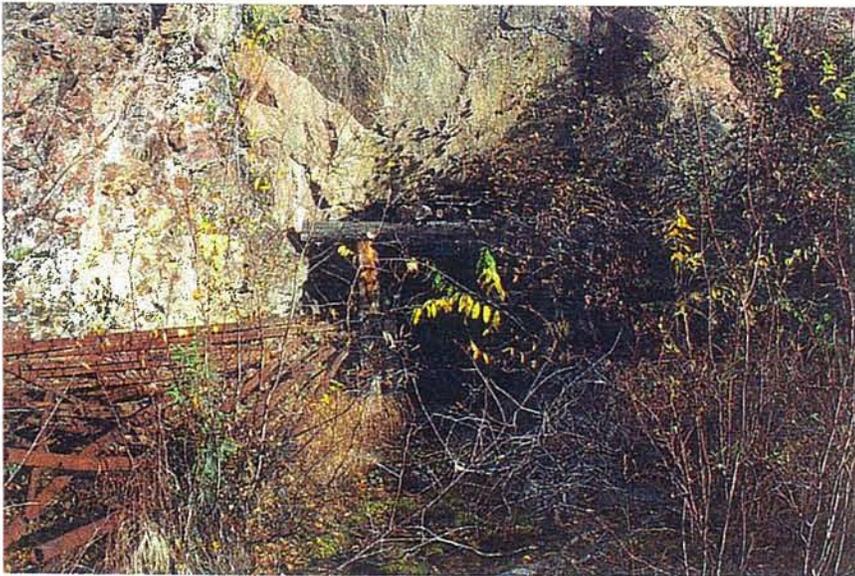
Photo 6.8-2 Baska Adit Opening
September 29, 2001

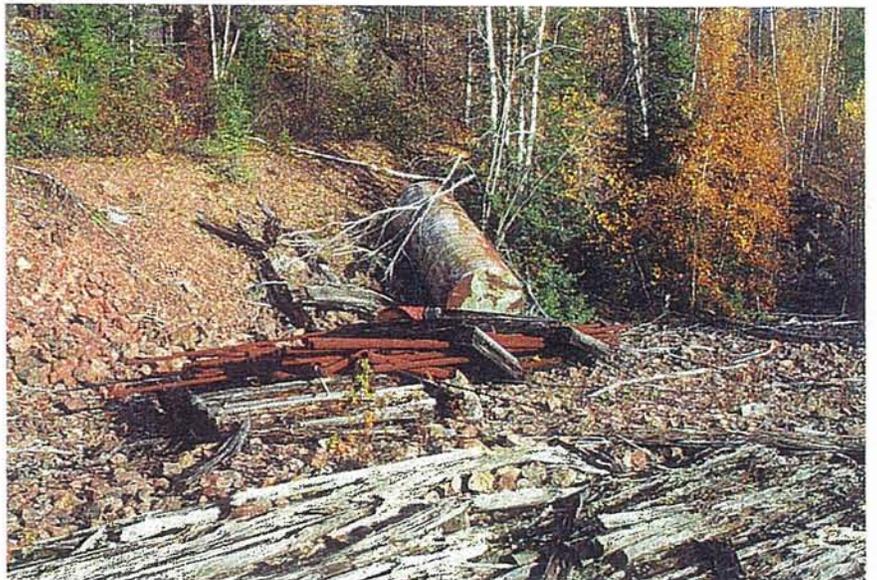
Photo 6.8-3 Debris Near Baska Adit
September 29, 2001

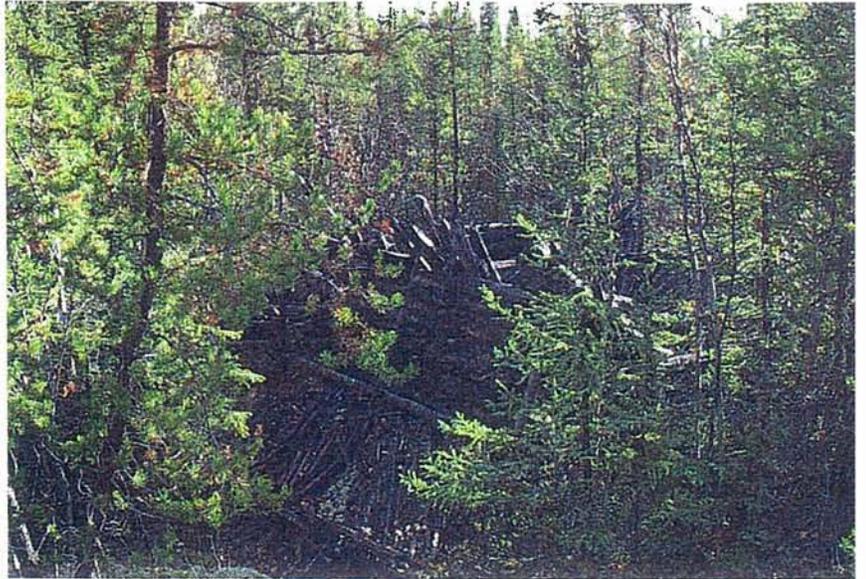
Photo 6.8-4 Baska Core Storage Area
September 29, 2001

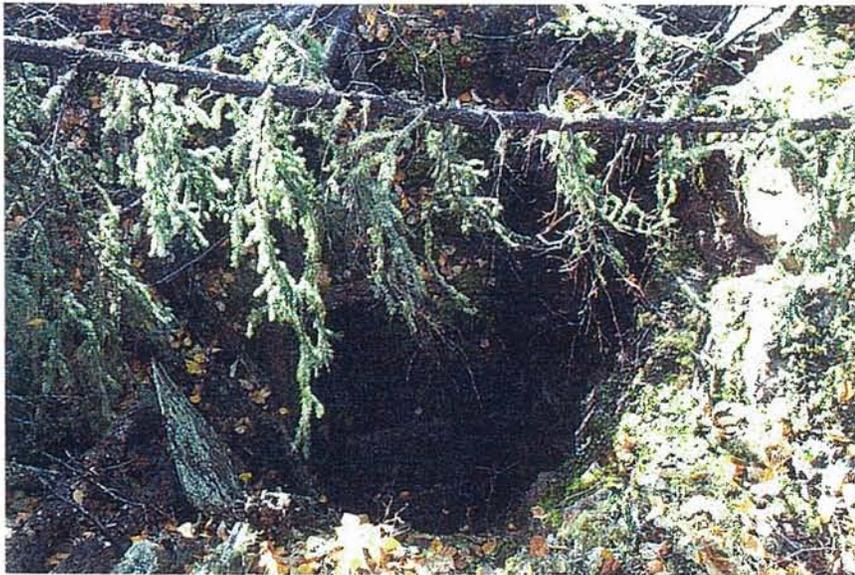
Photo 6.8-5 Baska Raise Opening
September 29, 2001

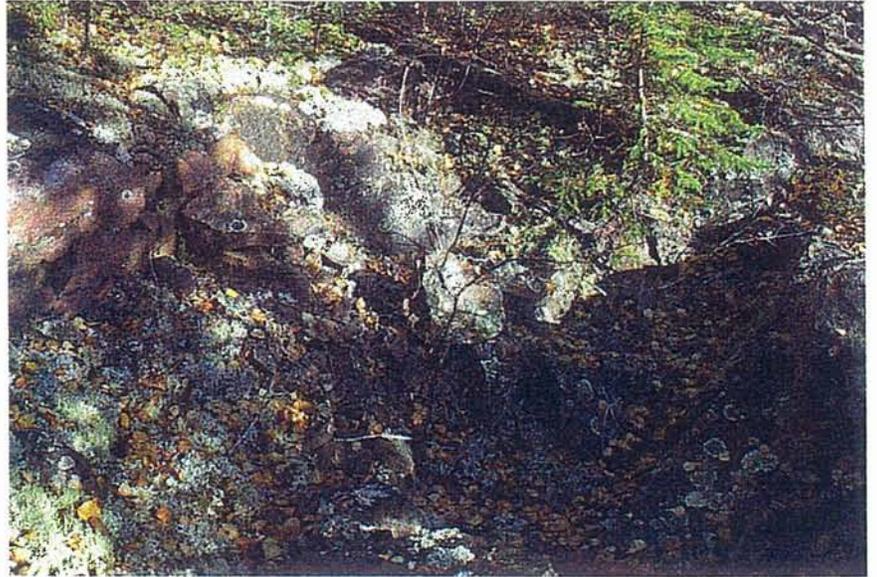
Photo 6.8-7 Small Trench Upslope and
North of Adit
September 29, 2001

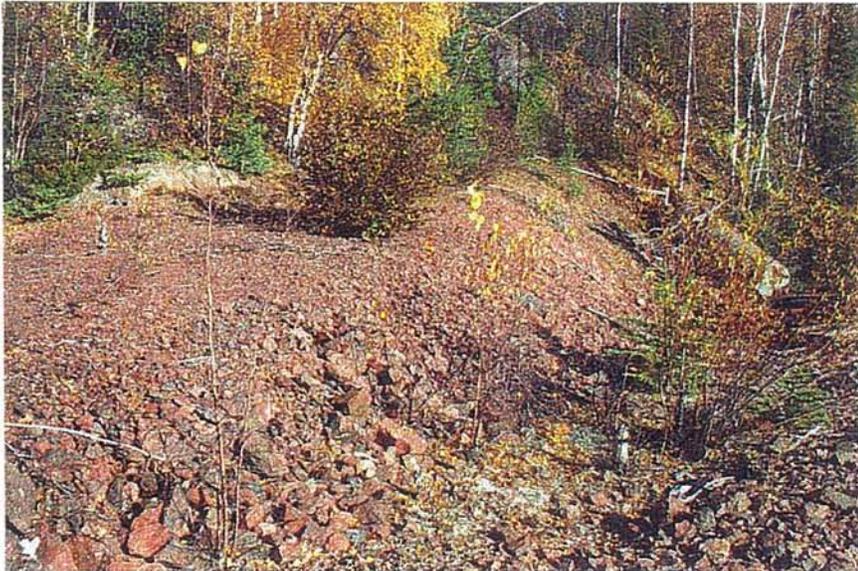
Photo 6.8-8 Waste Rock Ramp
September 29, 2001

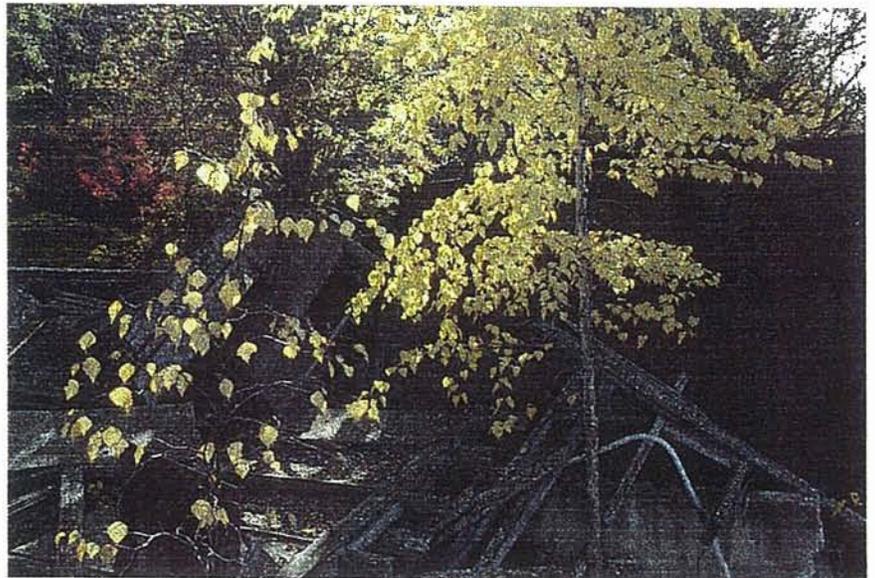
Phot 6.10-3 Dilapidated Wooden Building
September 29, 2001

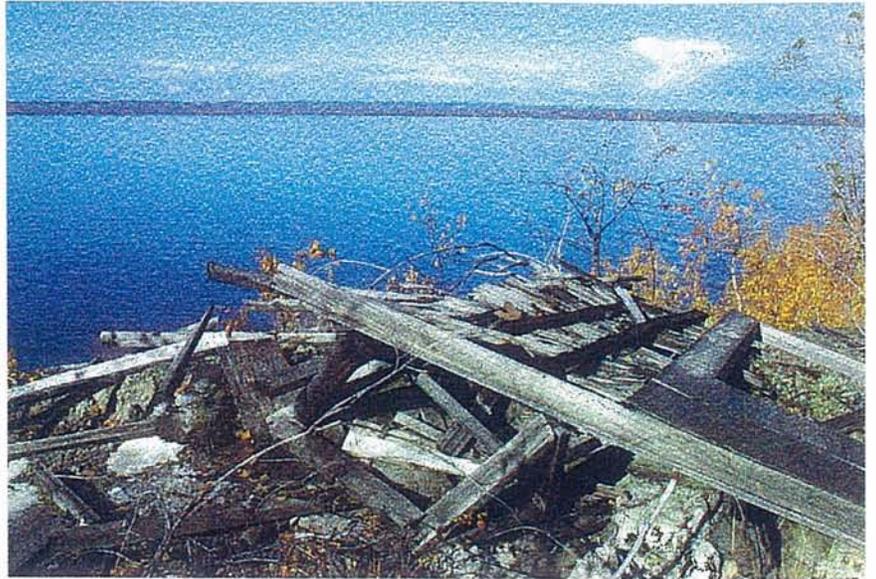
Photo 6.10-4 Wooden Debris near
Shoreline
September 29, 2001

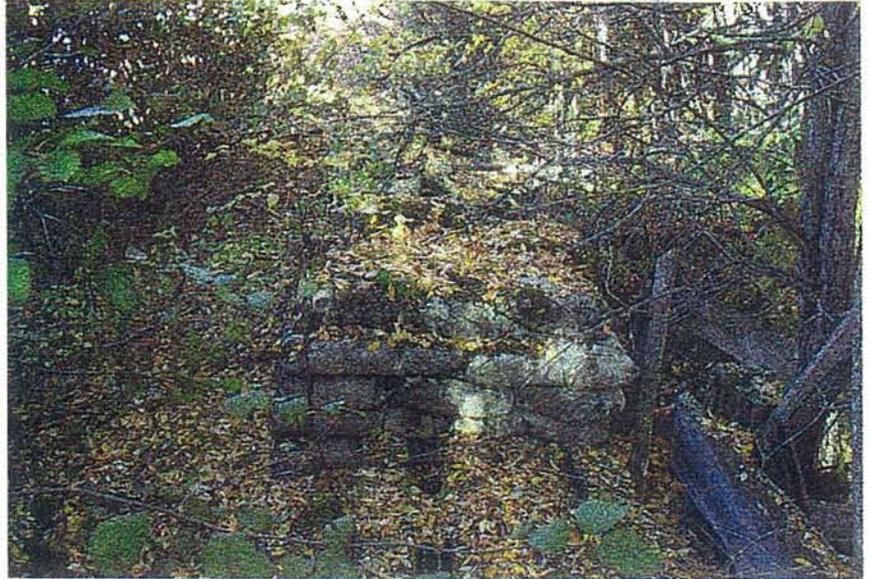
Photo 6.10-7 Bags of Cement
September 29, 2001

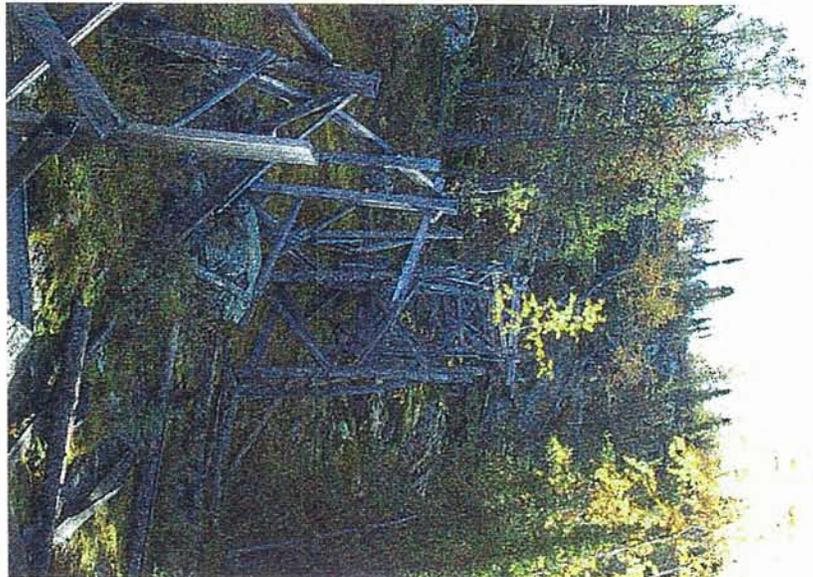
Photo 6.10-9 Wooden Trestle Leading
Upslope From Adit
September 29, 2001

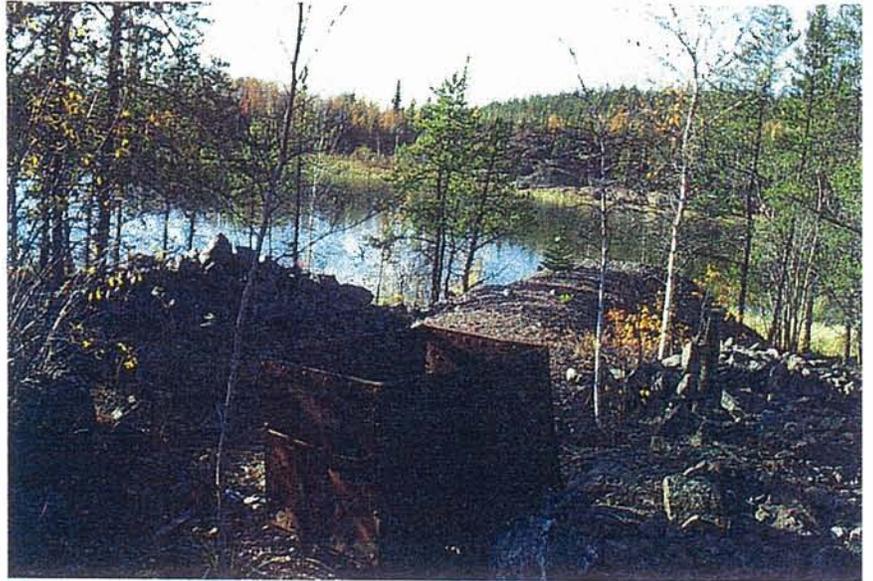
Photo 6.11-1 Debris and Waste Rock
September 29, 2001

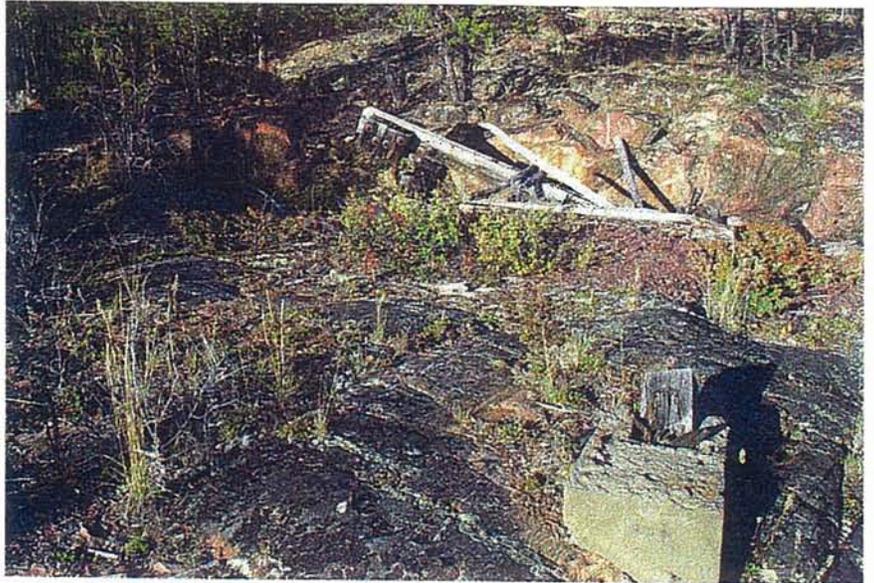
Photo 6.11-4 Small Amount of Waste
Rock and Concrete Headframe Footing
September 29, 2001

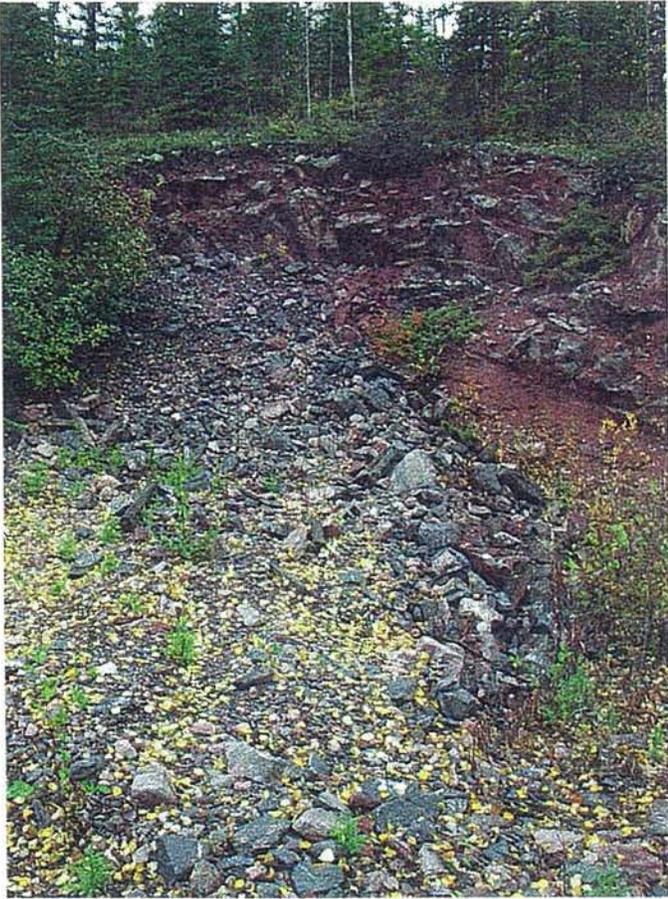
Photo 6.12-1 Harrison Adit-Sealed With Waste Rock
September 30, 2001

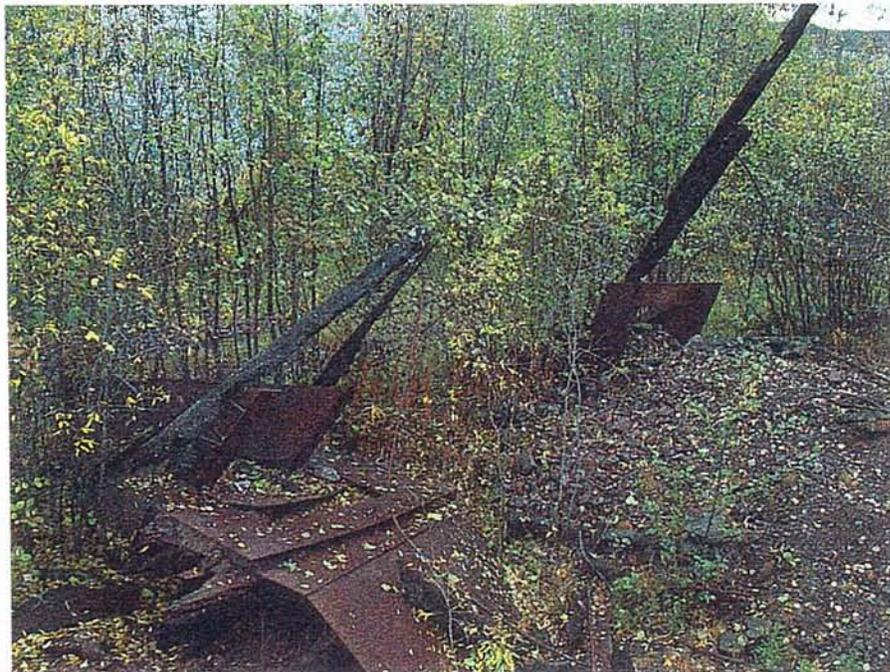
Photo 6.12-3 Partially Buried Debris
September 30, 2001

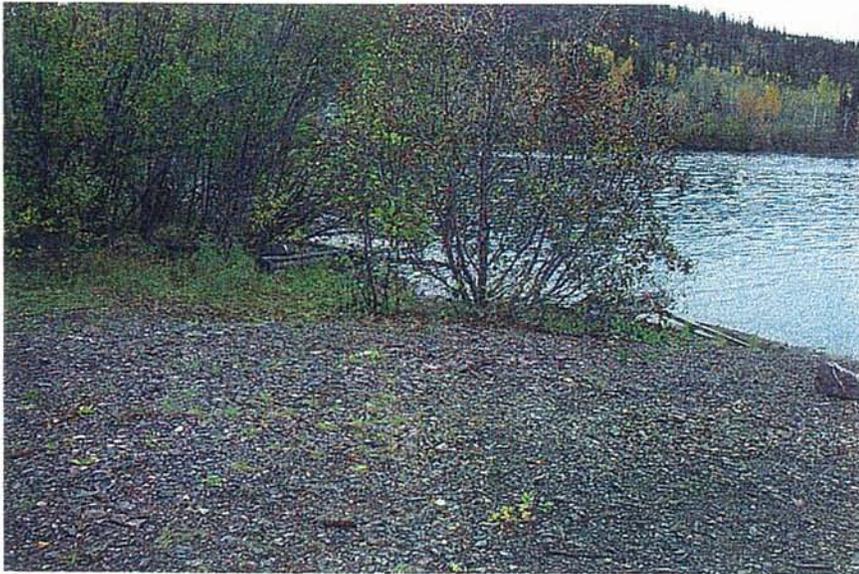
Photo 6.12-5 Boat Ramp Near Site With
Waste Rock Used For Grading
September 30, 2001

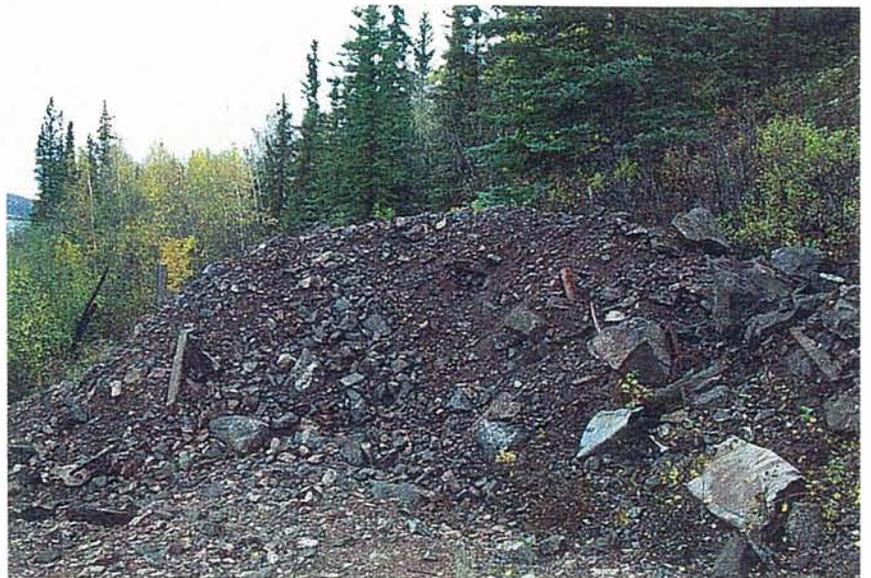
Photo 6.12-6 Main Waste Rock Pile
September 30, 2001

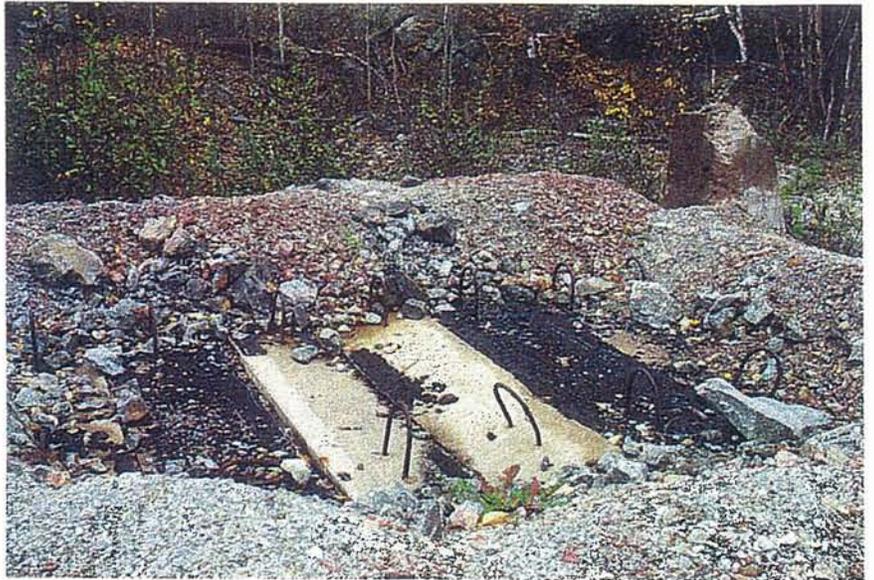
Shaft No.1 (Zone 4) is located on the west side of the property at 6594014 m N and 645295 m E. The shaft had a wood timber headframe over it, but the headframe was removed and intentionally burned down in 1991. Scrap material was pushed down the shaft and the opening was covered with a concrete pad in 1991. The concrete pad is in excellent condition and there is no sign of subsidence or slumping.

Photo 6.13-1 Consolidated Nicholson
Shaft No. 1 (Sealed)
October 01, 2001

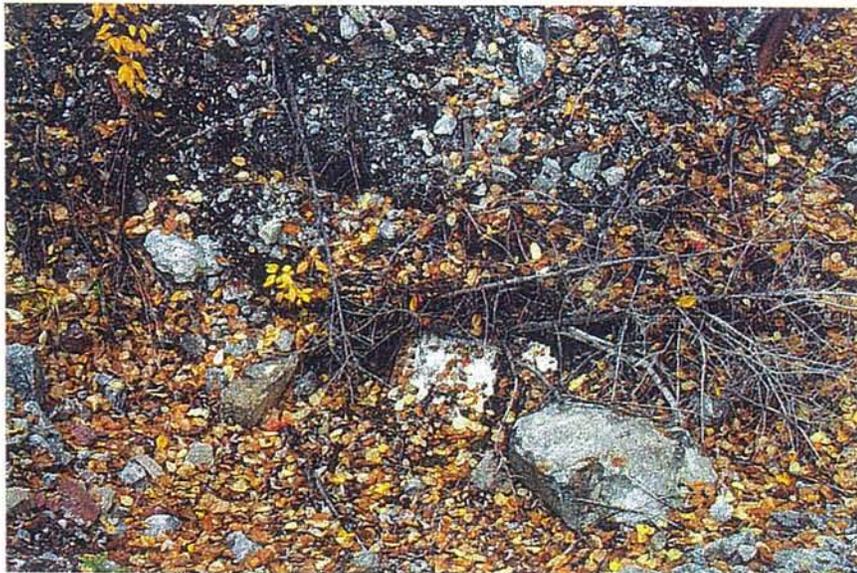
Photo 6.13-2 Consolidated Nicholson
Shaft No. 2 (Sealed)
October 01, 2001

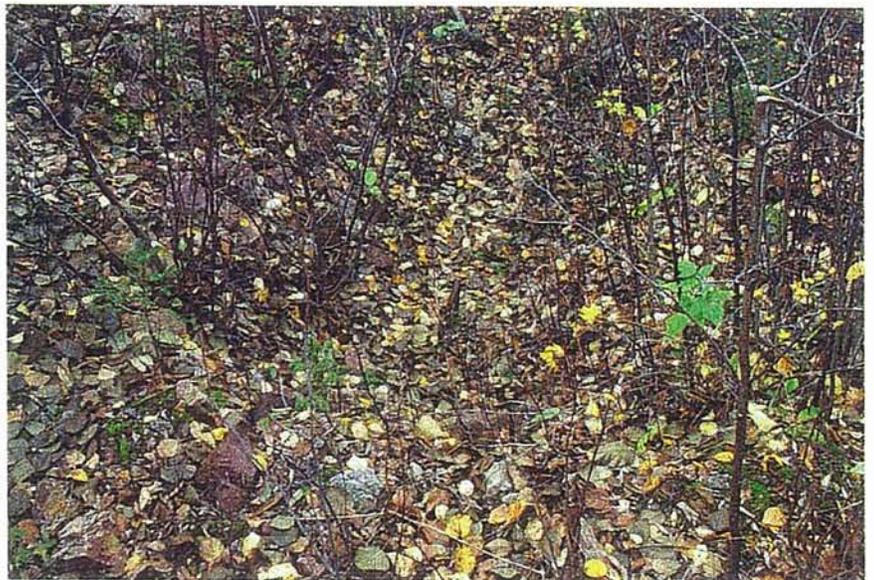
Shaft No. 3 is located on the east side of the property at 6593647 m N and 646239 m E, about 95 m south and 760 m east of shaft No. 1. This shaft is also capped with a concrete pad. The cap is in excellent condition with no signs of slumping or subsidence. The cap is covered with dead vegetation (leaves, etc.) and is difficult to locate.

Photo 6.13-3 Consolidated Nicholson
Shaft No. 3 (Sealed)
Note Metal Handle on Concrete Cap in
Middle of Photo
October 01, 2001

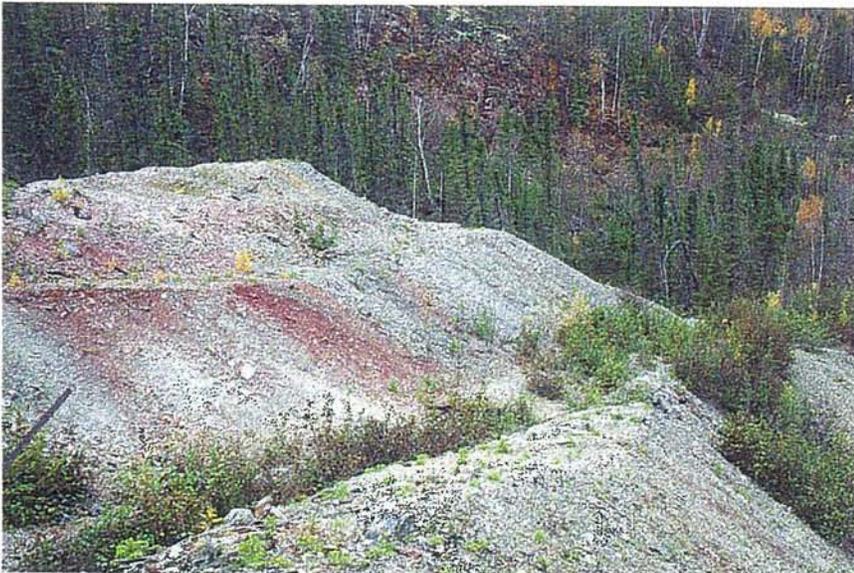
**Photo 6.13-5 Consolidated Nicholson
Main Waste Rock Pile Near Shaft No. 1
October 01, 2001**

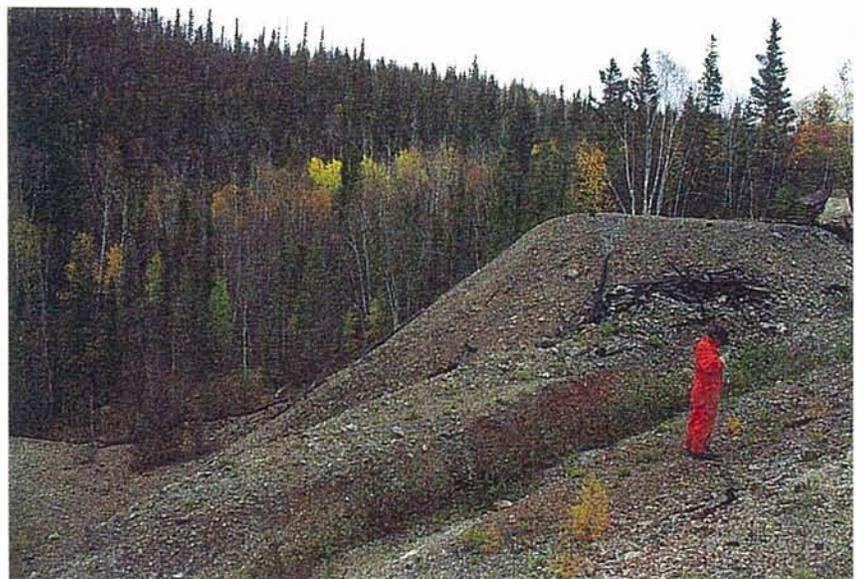
**Photo 6.13-6 Consolidated Nicholson
Main Waste Rock Pile Near Shaft No. 1
October 01, 2001**

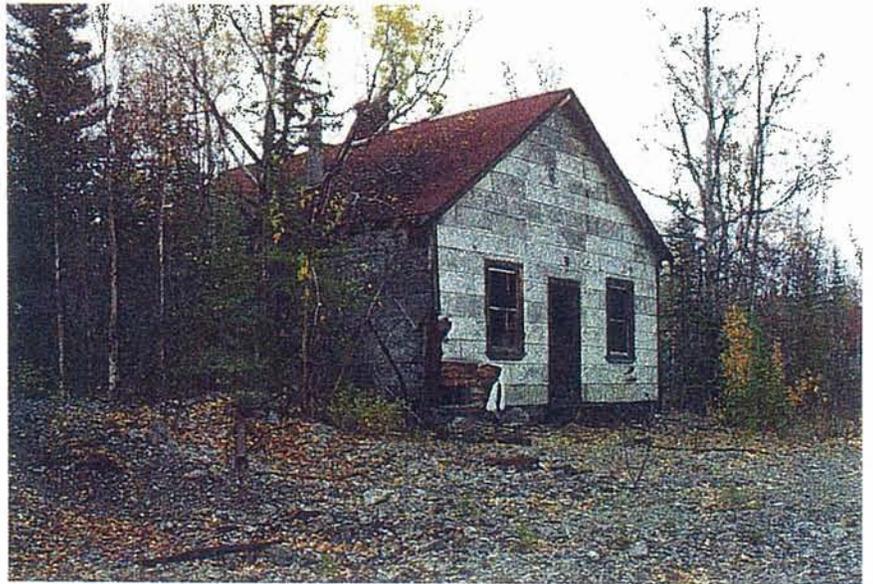
Photo 6.13-7 Consolidated Nicholson
Machine Shop
October 01, 2001

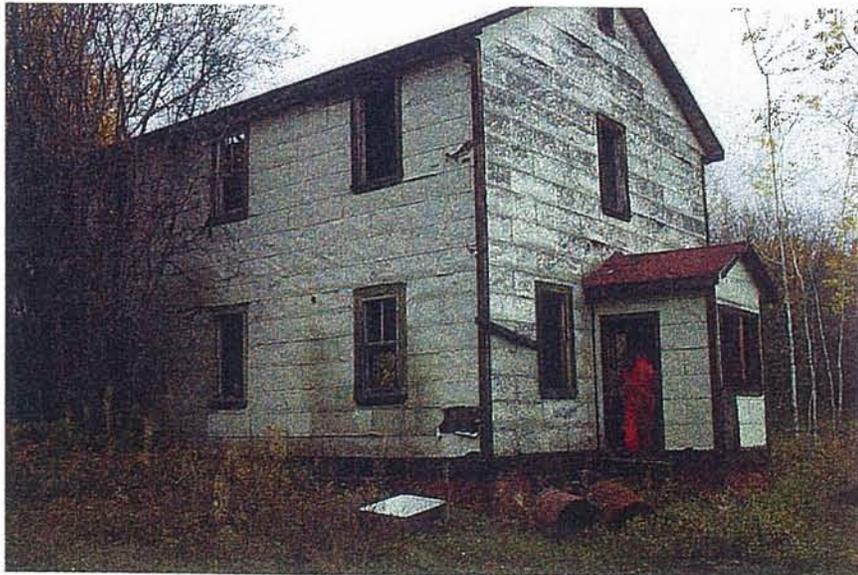
Photo 6.13-11 Consolidated Nicholson
Bunkhouse
October 01, 2001

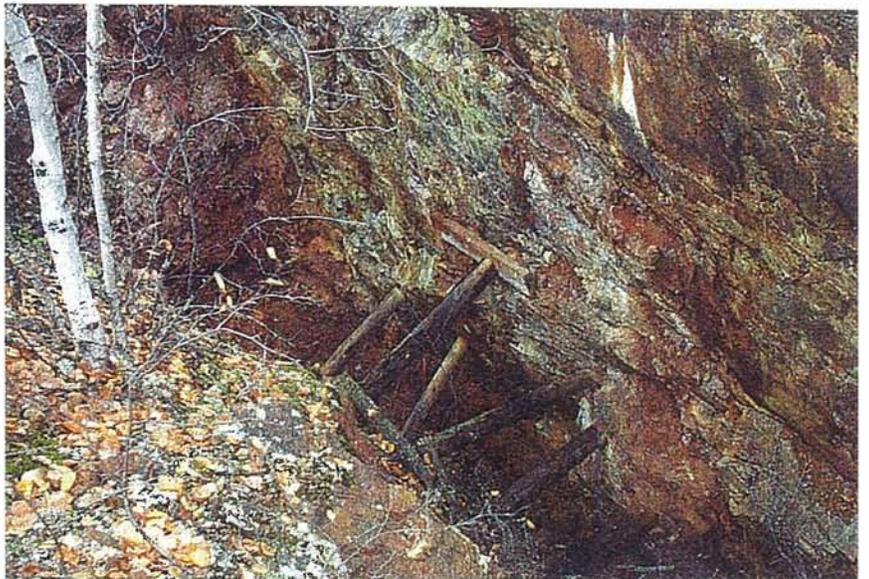
Photo 6.13-12 Consolidated Nicholson
Trench Leading to Adit
October 01, 2001

The entrance at the end of the trench should be filled with waste rock and portions of the trench filled to reduce the steep slopes.

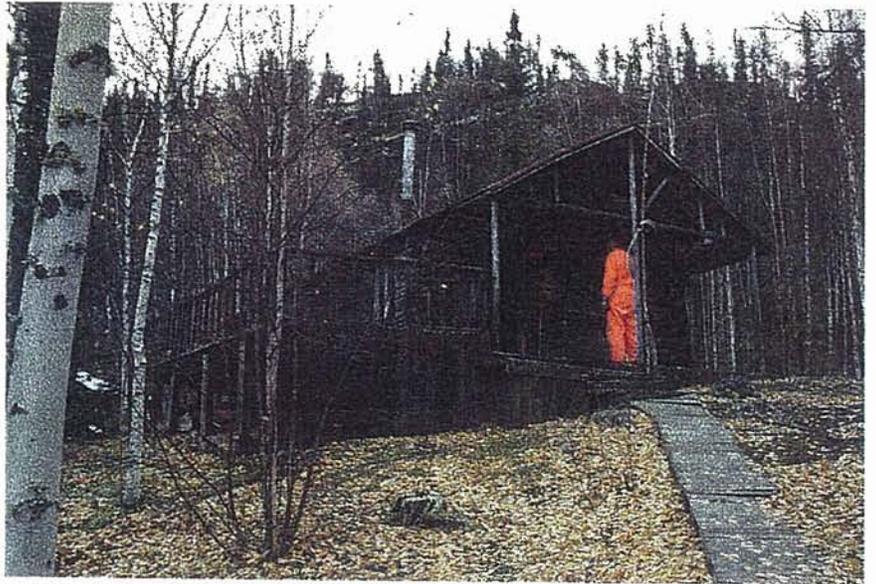
Photo 6.14-4 Private Cabin at
Beaverlodge Site
October 02, 2001

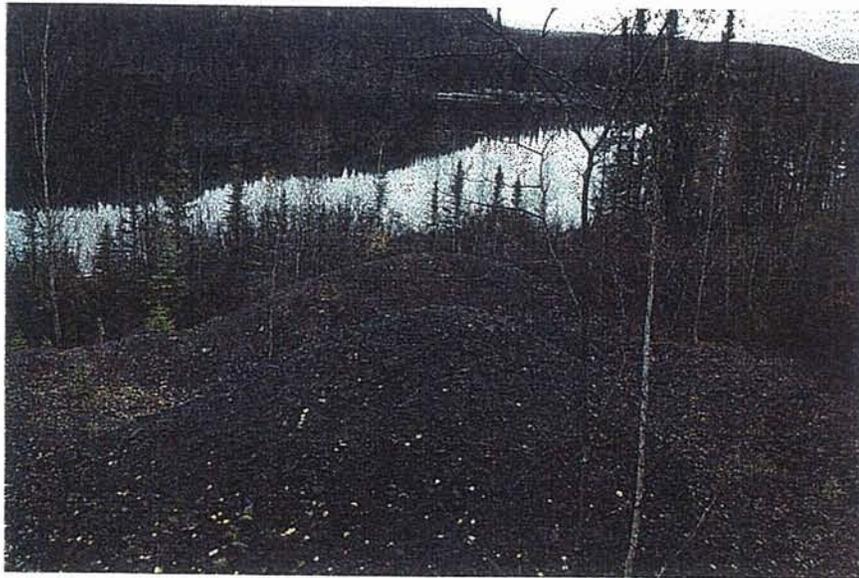
Photo 6.14-5 Main Waste Rock Pile
Extending Our From Adit
October 02, 2001

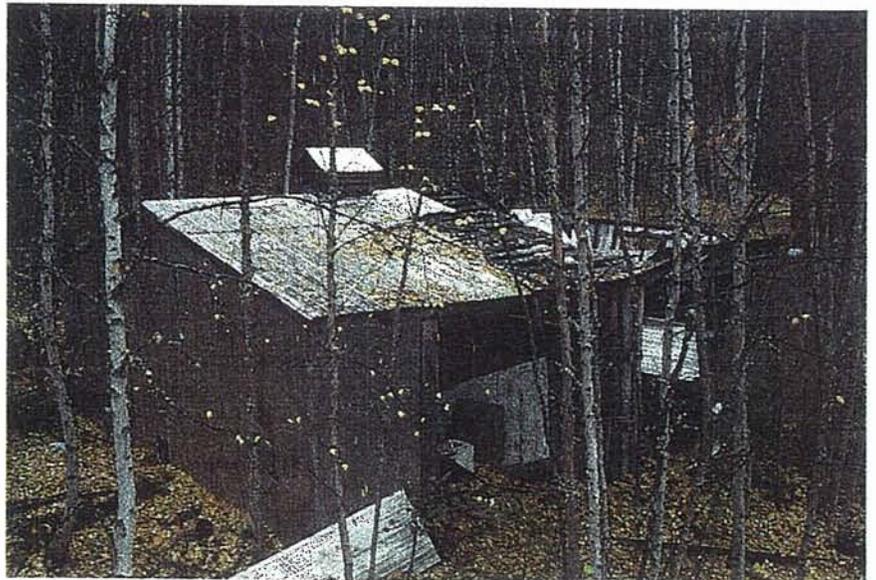
Photo 6.14-6 Dilapidated Mine Building
Near Adit
October 02, 2001

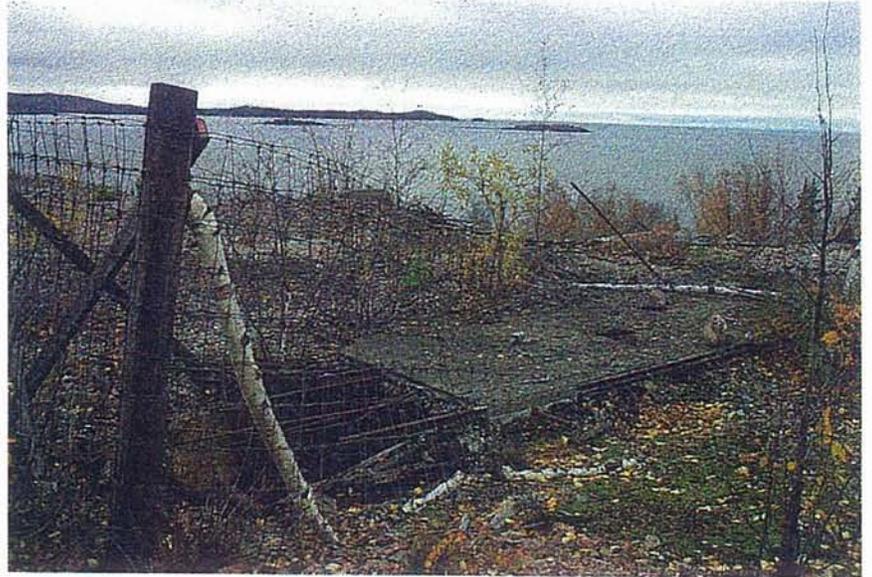
Photo 6.15-1 Athona Shaft
October 01, 2001

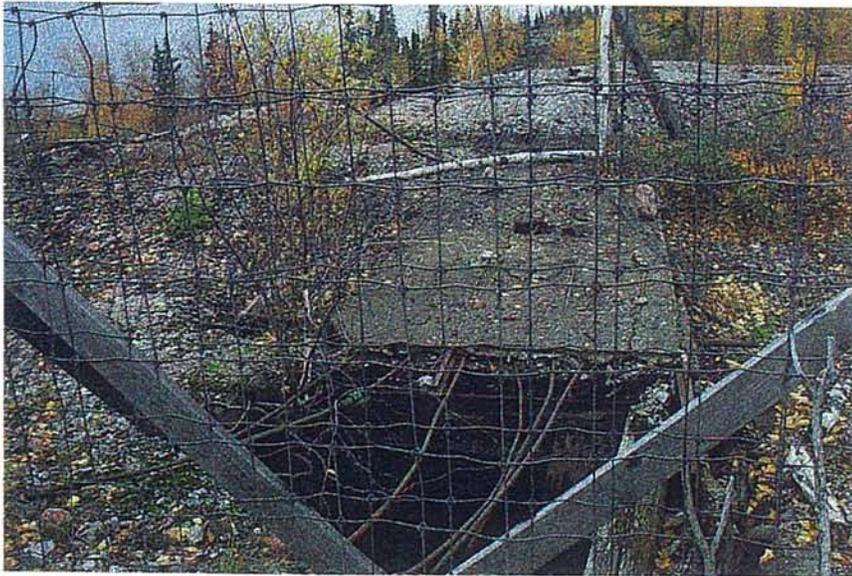
Photo 6.15-2 Athona Shaft
October 01, 2001

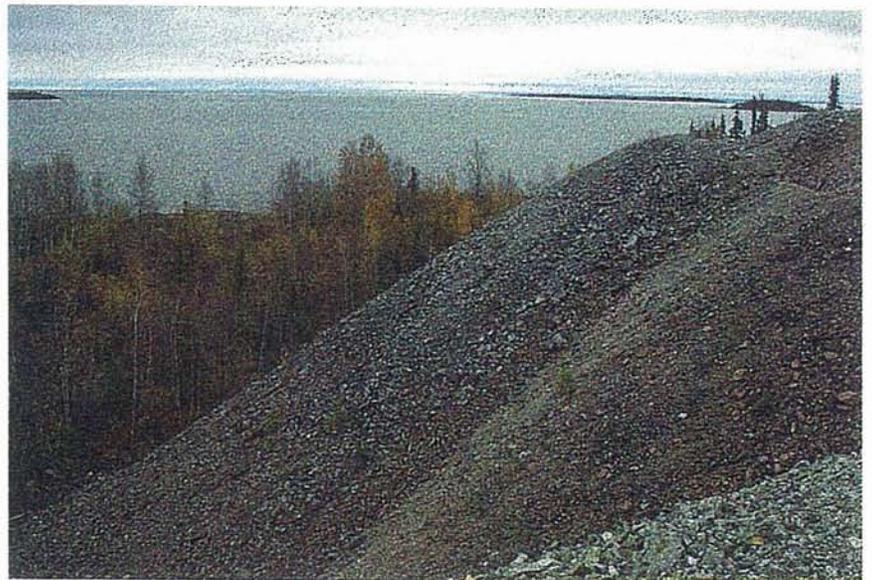
Photo 6.15-4 Athona Waste Rock Pile
October 01, 2001

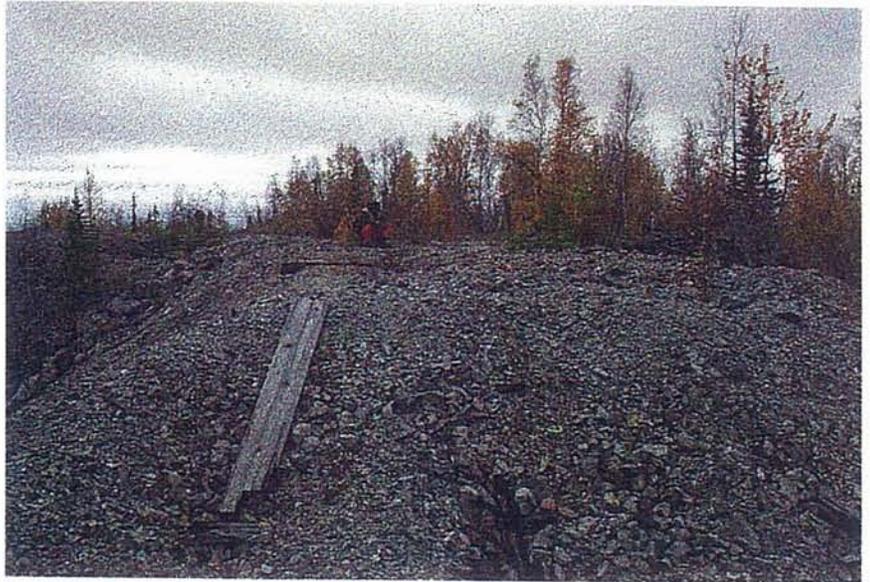
Photo 6.15-5 Trenches North of Athona
Shaft
October 01, 2001
