**AN ASSESSMENT OF
ABANDONED MINES IN
NORTHERN SASKATCHEWAN
(YEAR 2)**

**GULCH MINE ADIT-URANIUM CITY AREA
SEPTEMBER 29, 2001**

An Assessment of Abandoned Mines in
Northern Saskatchewan

Prepared by: Clifton Associates Ltd.
on behalf of
P.A.N.S. Joint Venture

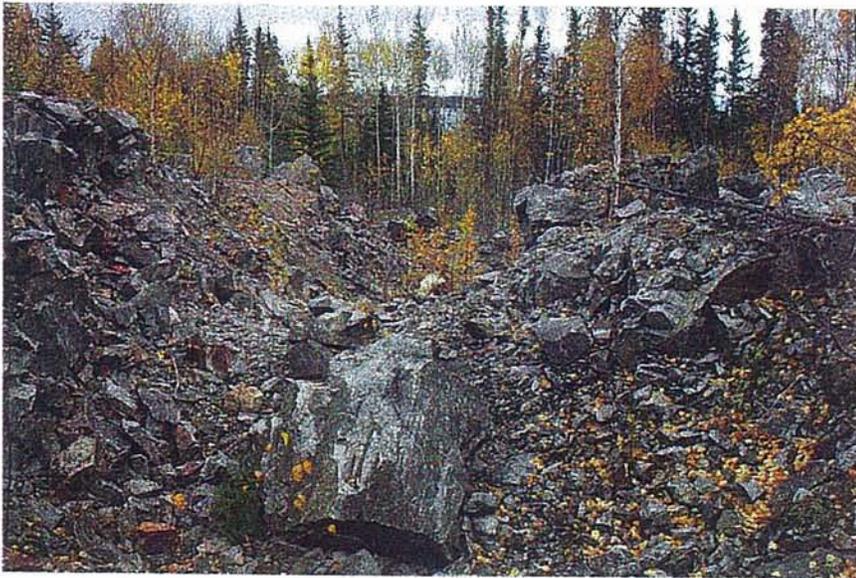
Photo 6.15-6 Waste Rock/Ore Near
Goldfields Bay
October 01, 2001

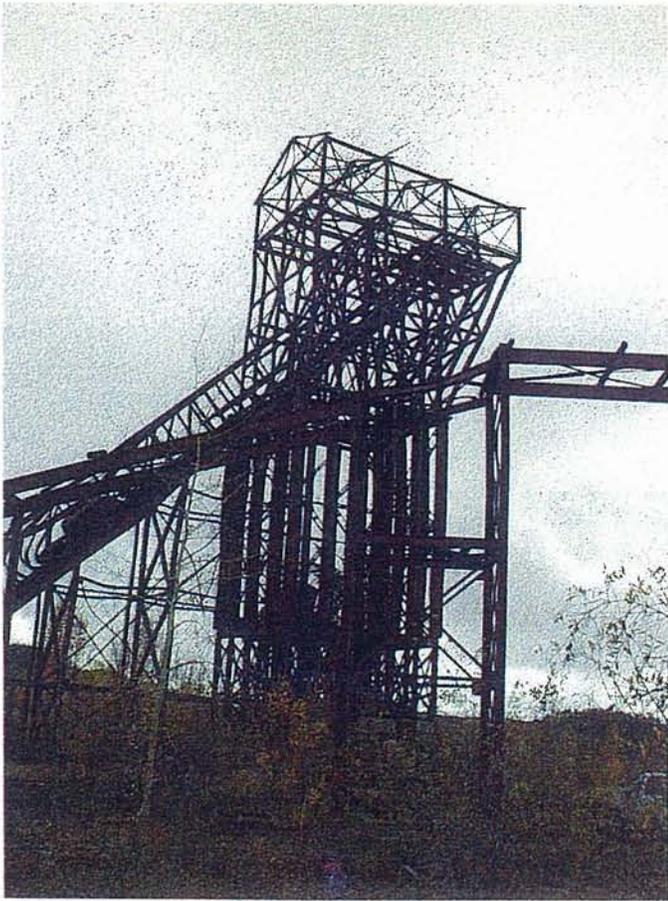
Photo 6.16-1 Box Mine Headframe
October 01, 2001

The headframe and mill remains should be dismantled and the shaft opening and any other opening permanently sealed. Given the condition and accessibility of the headframe, it poses a severe public safety hazard.

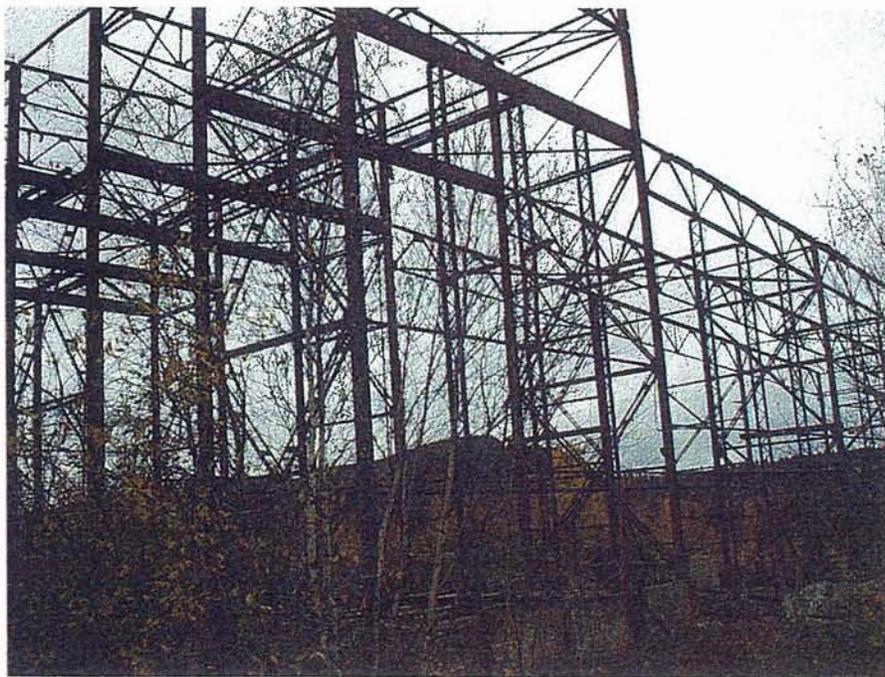
Photo 6.16-3 Box Mine Mill Building Frame
October 01, 2001

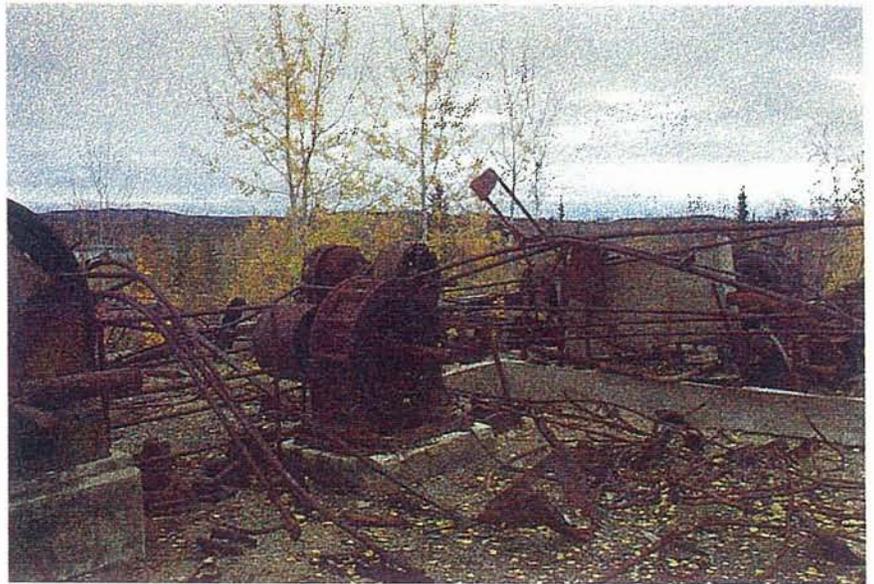
The Box site contains numerous public safety hazards and is easily accessible. Therefore three points were attributed to the "additional public safety risks" category. In addition, one point was attributed to the "additional environmental risks" category due to the presence of unconfined tailings.

Photo 6.16-5 Box Mine Tailings and
Headframe
October 01, 2001

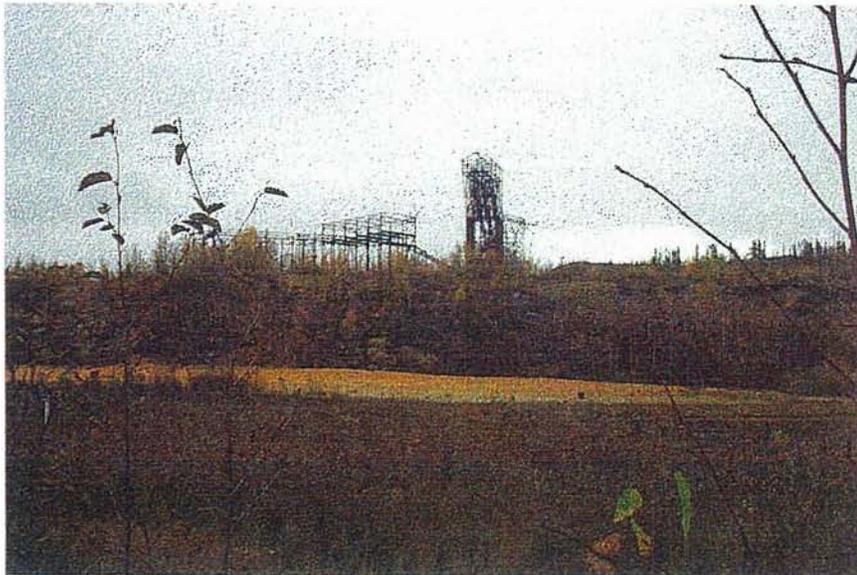
Photo 6.16-6 Box Mine Tailings Area
October 01, 2001

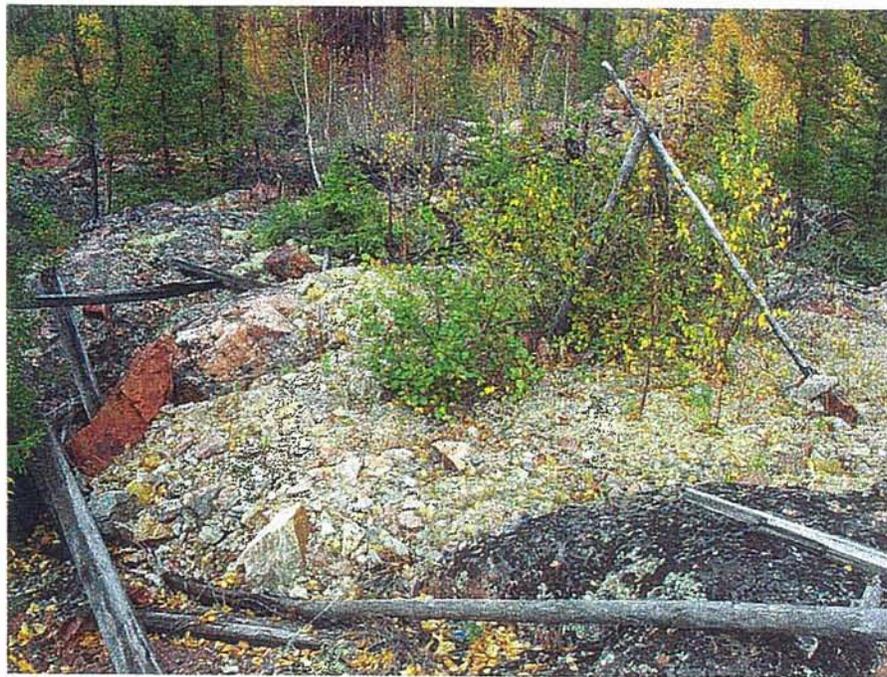
Photo 6.16-9 Covered Raise
October 01, 2001

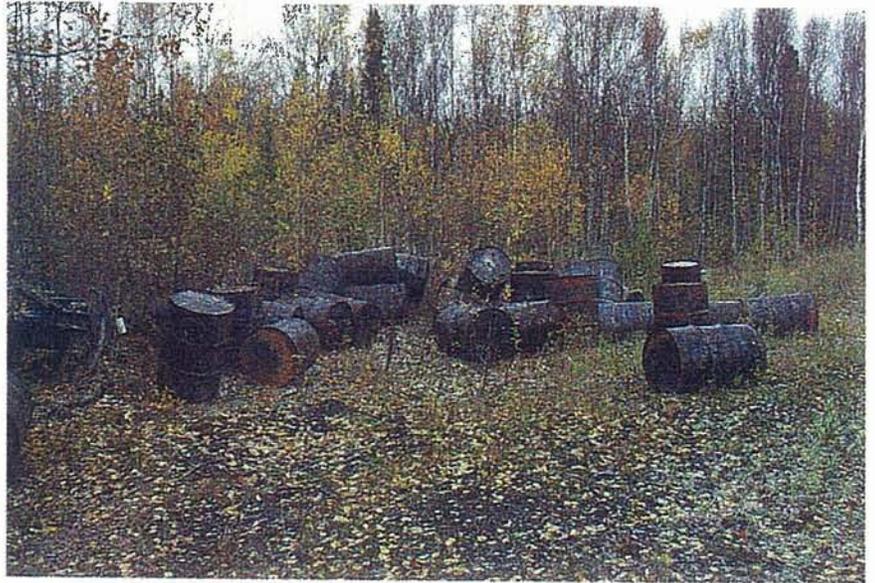
Near the exploration camp are two core storage facilities. Both are in a deteriorating condition. Several core racks have tipped and core is spread on the ground. The larger of the two core storage areas is about 70 m southwest of the camp area, and the second is close by the camp.

Photo 6.16-11 Delapidated Core Storage
Near Current Exploration Camp
October 01, 2001

Remaining work should focus on removal of asbestos panels from the old bunkhouses and secure disposal down the shaft, burning wooden buildings, disposal of concrete down the shaft, and removal of all other debris; including spilled core, barrels and scrap metal.

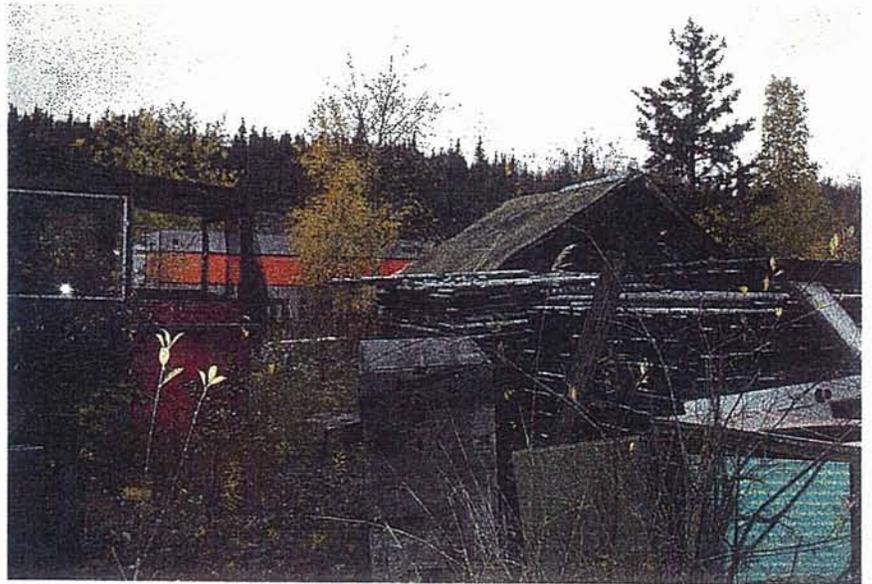
Photo 6.16-14 Abandoned Generator
Building
October 01, 2001

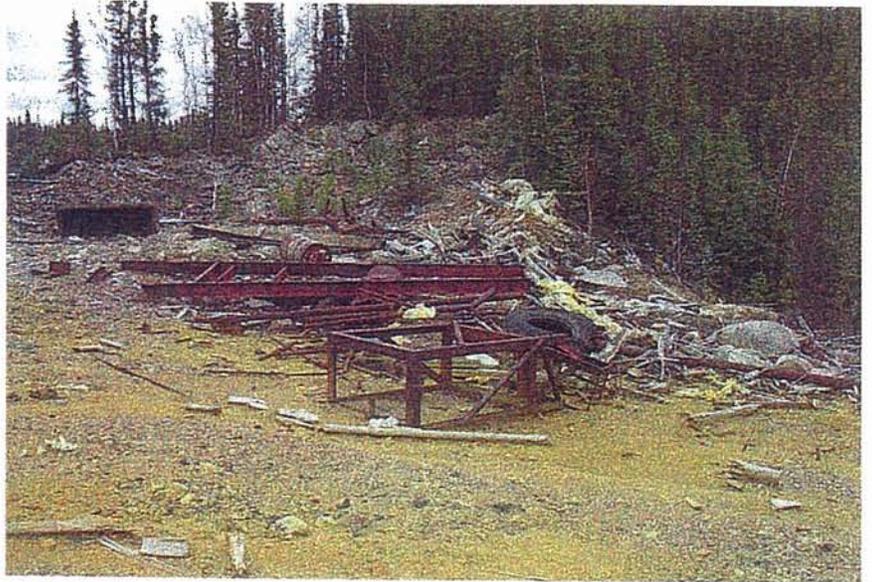
East of the pit is the remnants of the mill. The mill was constructed of jackpine logs and is still standing, although in a deteriorating condition. There is a metal ore feed structure at the base. A waste rock ramp leads up to the mill.

Photo 6.18-5 View of Mill From
Concentrate Area
October 17, 2001

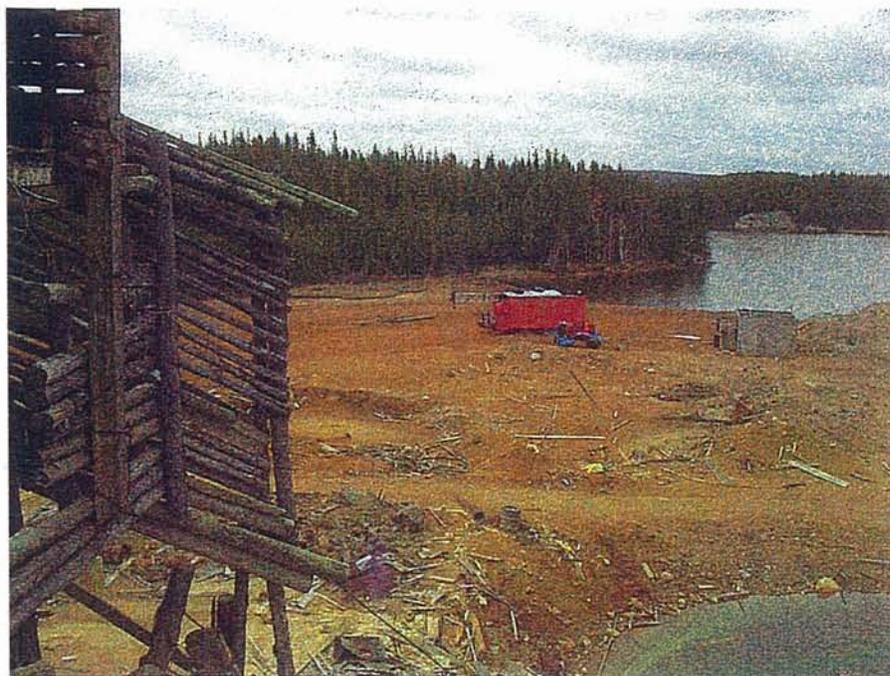
Photo 6.18-12 View of Tailings Area From Top of Loading Ramp
October 17, 2001

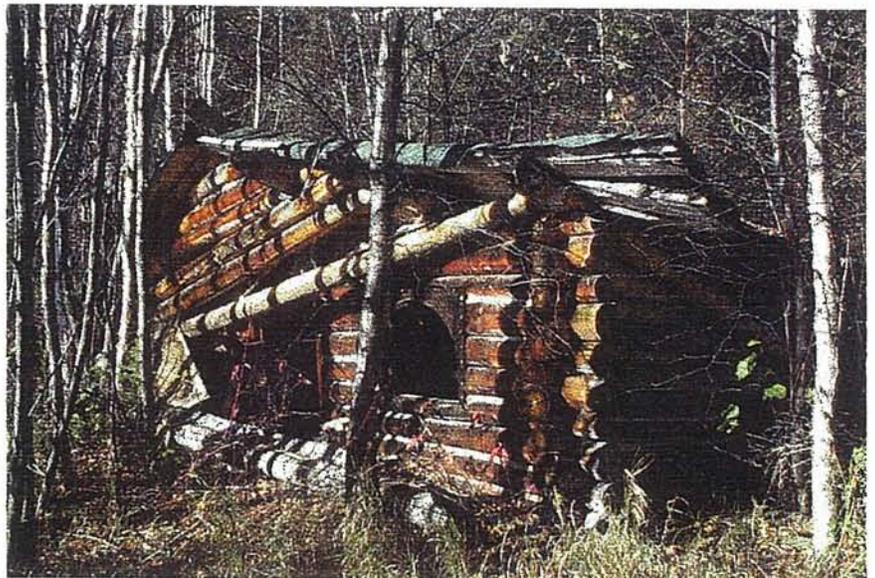
**Photo 6.19-3 Dilapidated Cabin at South
End of Property
October 18, 2001**

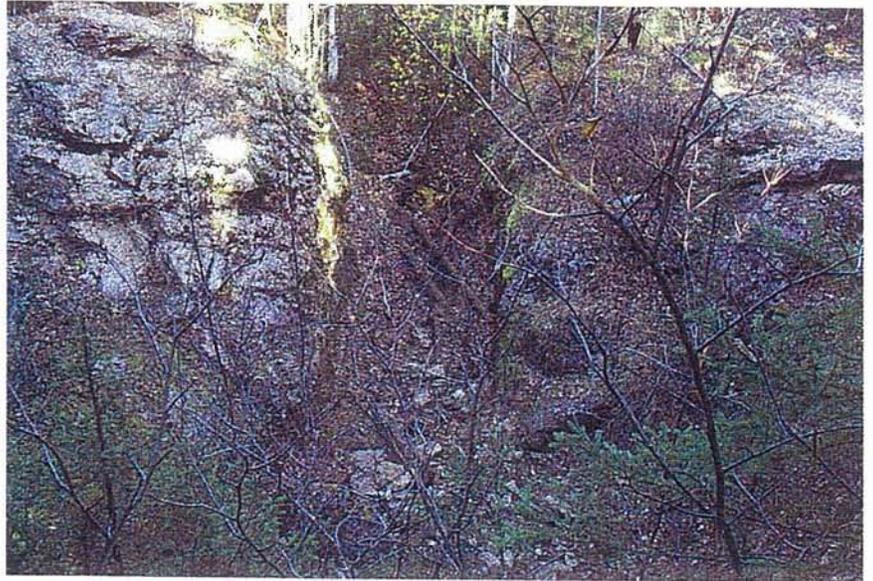
Photo 6.20-2 La Ronge Open Pit
October 18, 2001

Remedial work should focus on placing debris in the open pit and covering with waste rock if sufficient volumes of material are available.

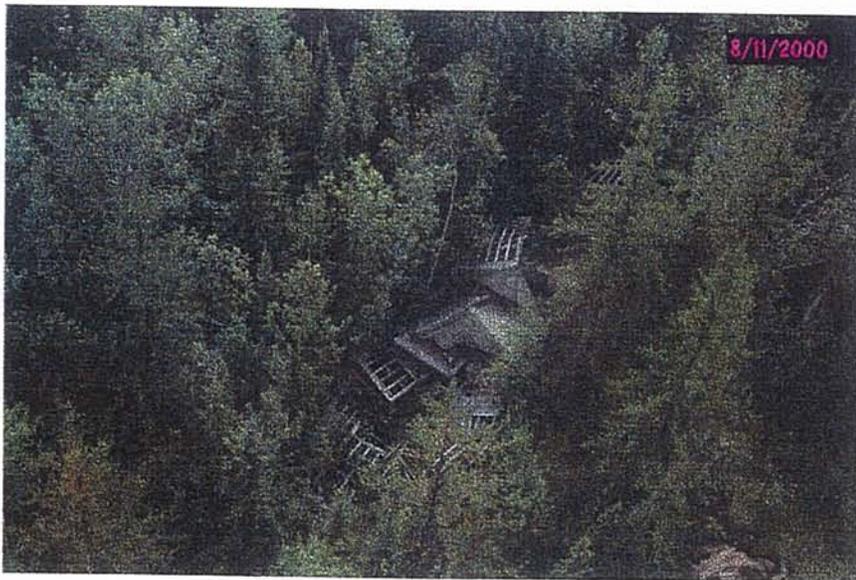
Photo 6.20-9 Aerial View of Site
(From SERM-August 11, 2000)

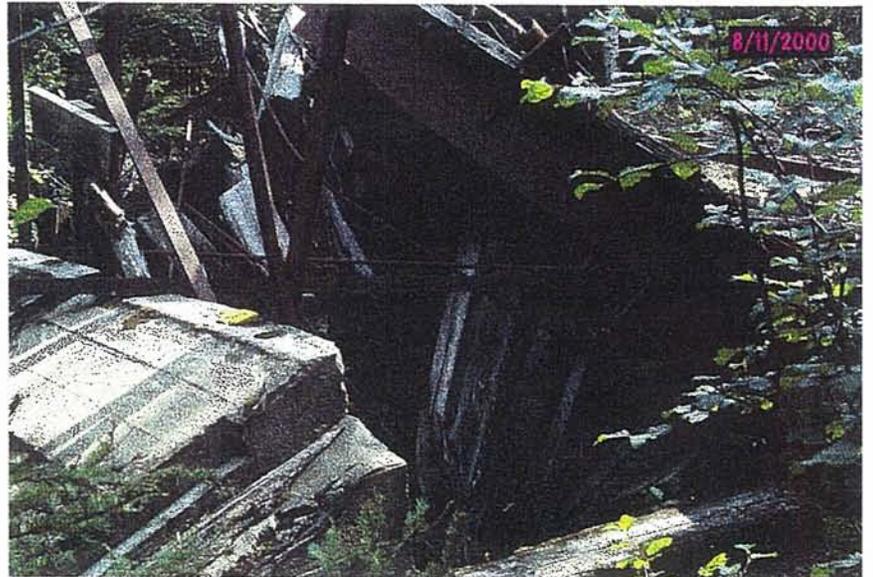
Although the shaft does not presently pose a public safety risk, the entrance may become open again in the future. In order to seal the shaft, it will be necessary to burn the wood debris or remove it.

Photo 6.21-3 Pitching Lake Shaft
(From SERM-August 11, 2000)

The shaft should be sealed with a concrete cap or filled in with debris and rock.
