APPENDIX C – PlanGrid Task Report

PlanGrid Task Report - Aug 19, 2020

Prepared by James Holtom

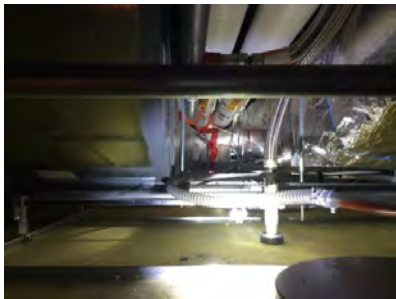
20200218_094854_photo

Red tape used for fire seal,
appropriate material?

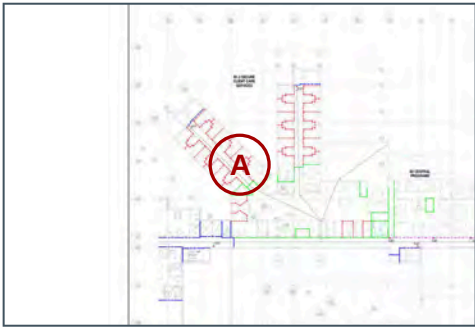
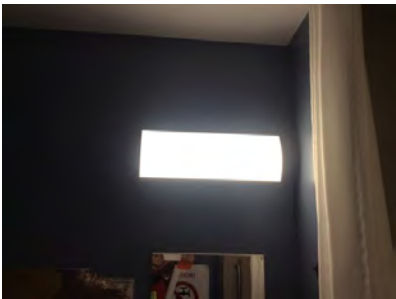
20200218_095617_photo
James Holtom
Feb 18, 2020 9:56 AM

Description
Ligature potential

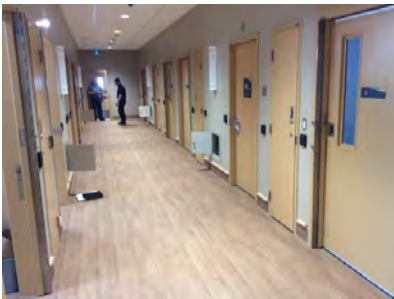
20200218_095912_photo

Wall protection meet spec?

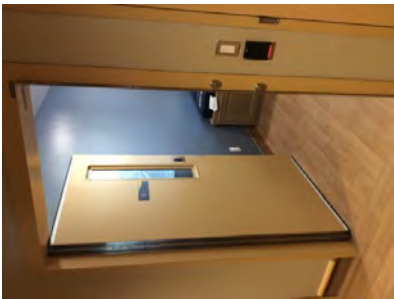
20200218_100239_photo

No fire rating evident to door or
kon-bon door

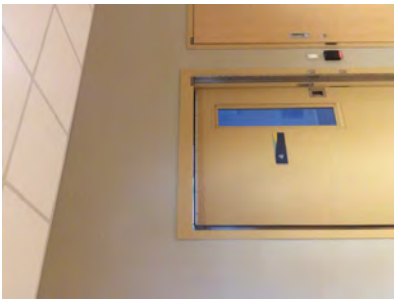
20200218_100348_photo

Reason for brush seal, no acoustic properties gained

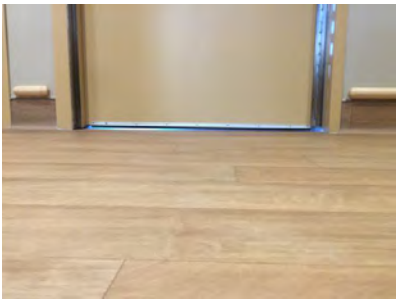
20200218_100735_photo
James Holtom
Feb 18, 2020 10:07 AM

Description
No smoke separation

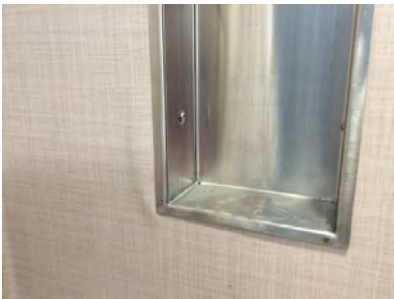
20200218_101100_photo

Wall protection bubbling off, leak to the soap holder

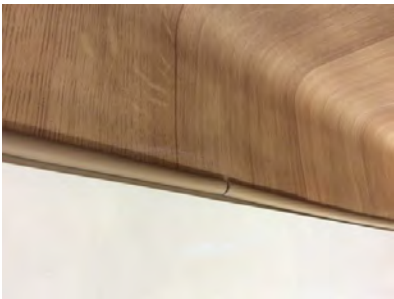
20200218_122255_photo

Wall protection not sealed to base

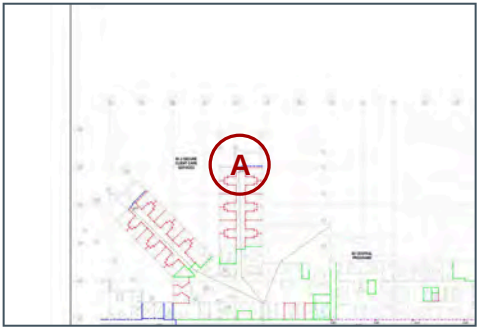
20200218_102101_photo
James Holtom
Feb 18, 2020 10:21 AM

Description
Gap to door

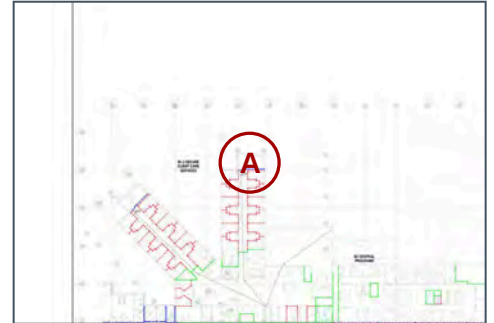
20200218_102231_photo

Gap to stringer

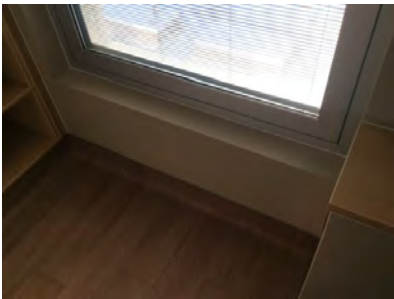
20200218_102749_photo

No window sill, check project requirements

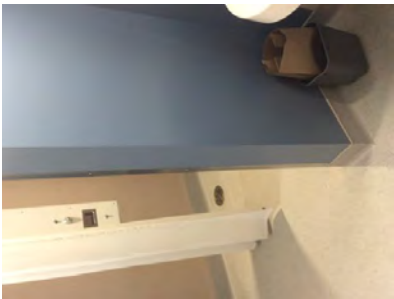
Sharp corner, should they be rounded?

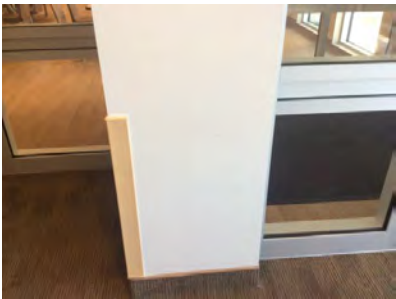
Description
Appropriate wall protection?

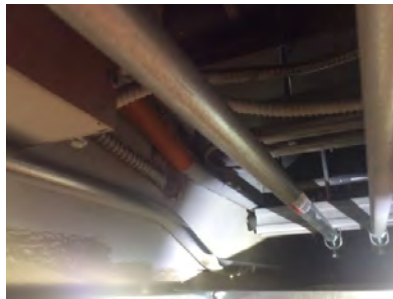
Fire rating penetrations may not all be fire caulked to meet smoke separation requirements

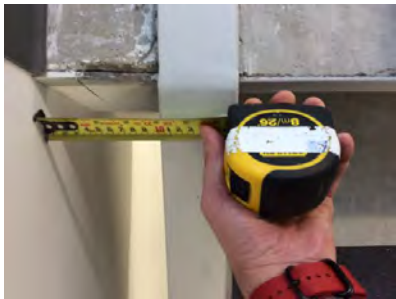
Gap between stringer and wall greater than 100mm

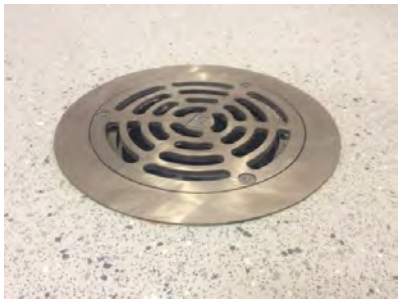
Description
Lip to floor drain, should be flush

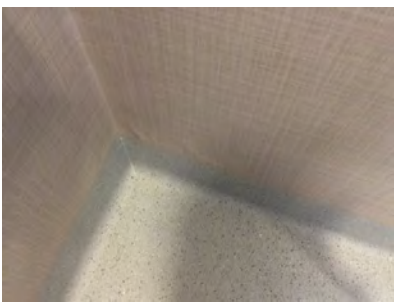
May be evidence of moisture behind

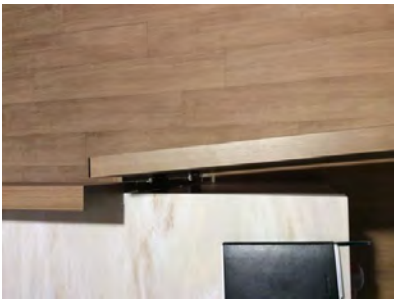
At main desk - bumpers should be provided for gates. Veneer delaminating.

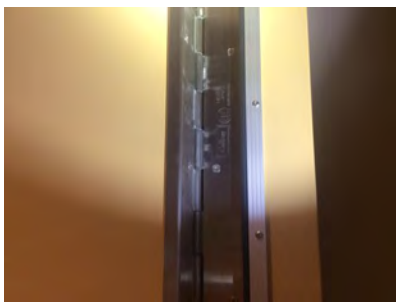
Frame is rated door rating not evident

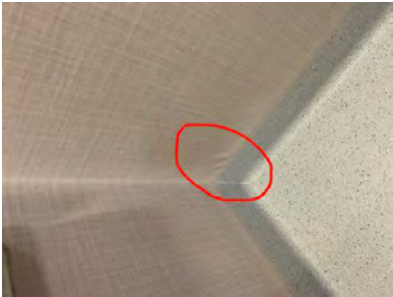
Location
E2-456

Description
Wall covering peeling off.
E2-456

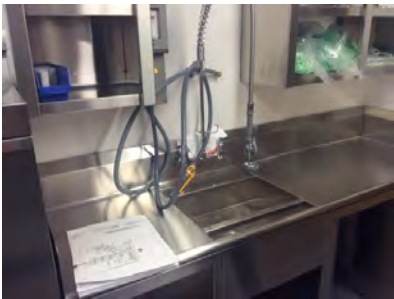
20200218_132817_photo

Single compartment sink suitable?

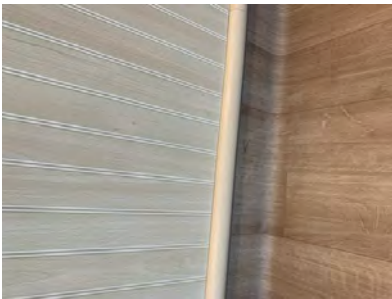
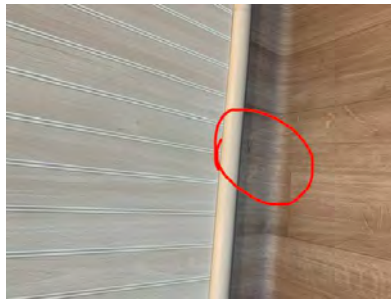
20200218_132821_photo

Construction marks left.

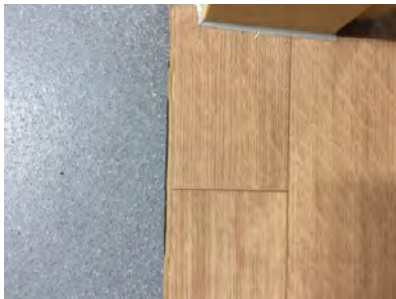
20200218_133351_photo

Gap between safety flooring and
lvt at transition

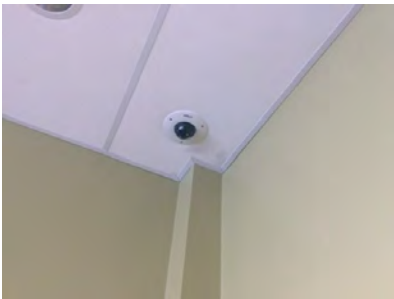
20200218_133748_photo

Tile appears to have been painted

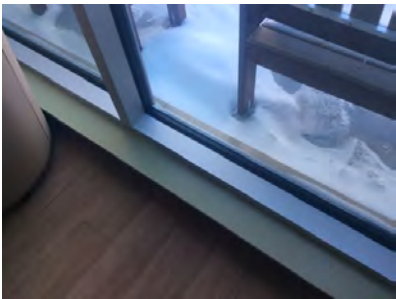
Description
Sills required?

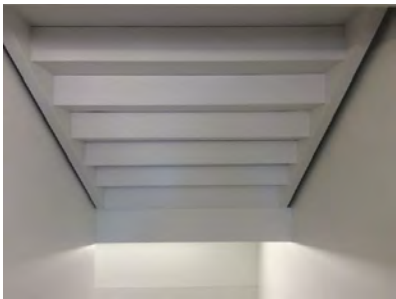
Description
Limited sprinkler coverage, one head noted near door in picture but none on the half landing or under the stairs

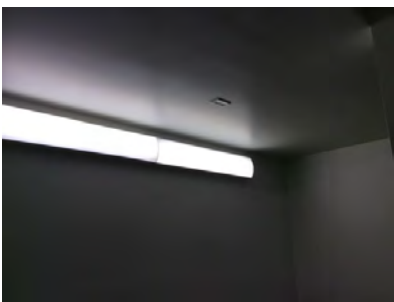
20200218_134533_photo

Lack of sprinklers throughout stairwell. Only 2.

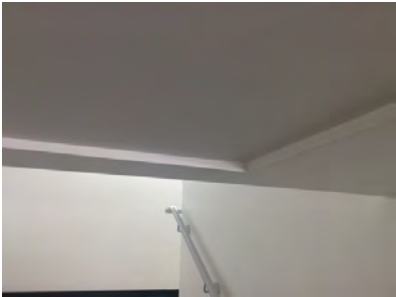
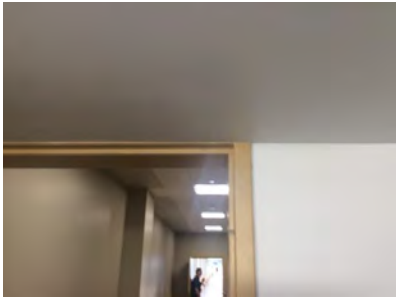
Description
Door frame drywall thickness

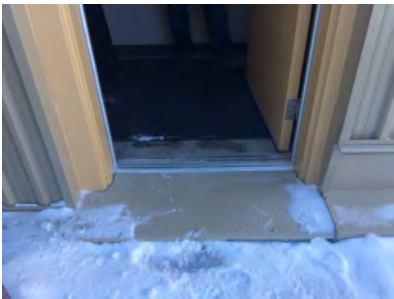
20200218_135606_photo

Low door threshold, recommend
8" min

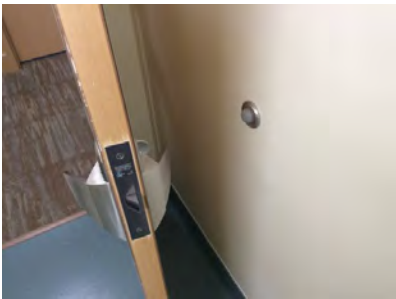
Description
Inappropriate door stop

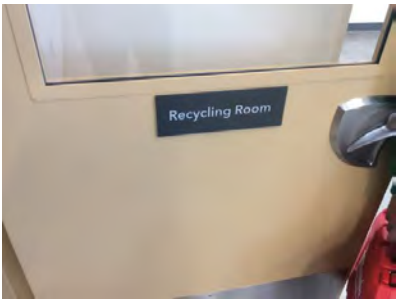
Description
No floor drain if used as a recycling room

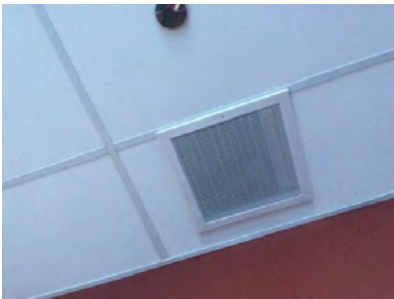
20200218_140827_photo

Excessive hvac noise

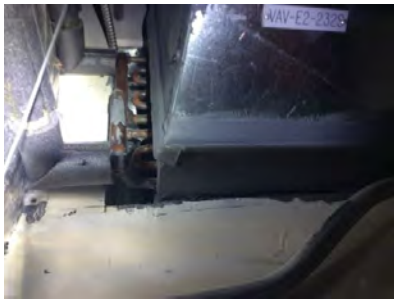
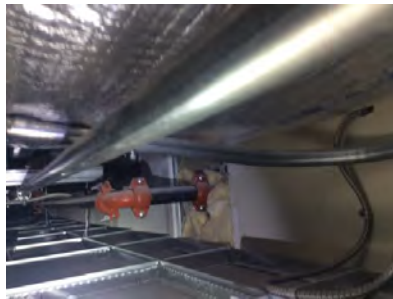
Drywall section missing, reheat coil recessed into the wall

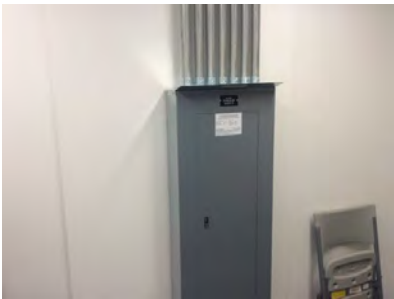
20200218_141442_photo

Confirm intumescent paint to plywood

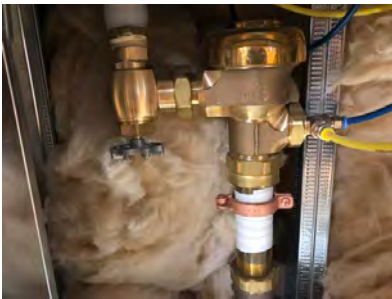
20200218_131558_photo

Insulation touching valve again.
Outside E2-443.

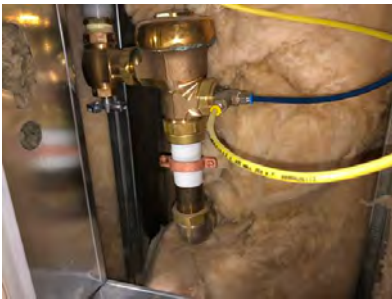
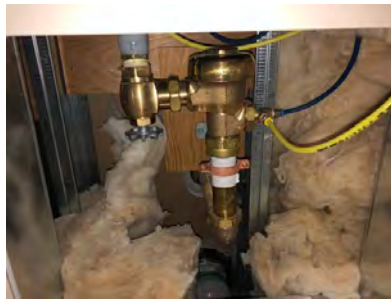
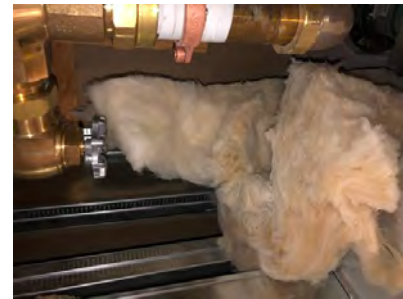
Inconsistent insulation installation. Missing or just left at bottom. Some you hung the pup and valves. Outside room E2-440.

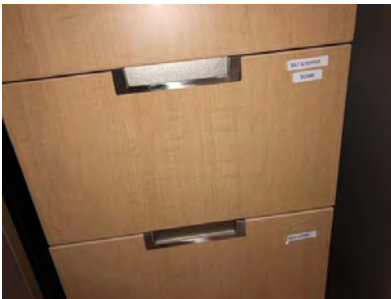
20200218_133045_photo

E2-413B - middle drawer very difficult to open.

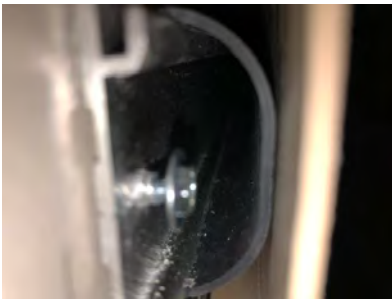
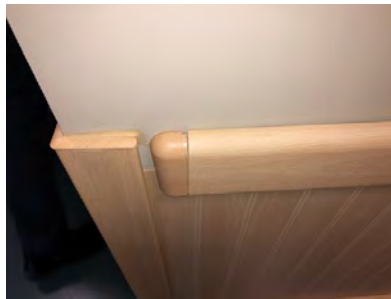
Bumper rails are loose in hallway. Might be missing connection bolts, some are loose. Outside E2-252.

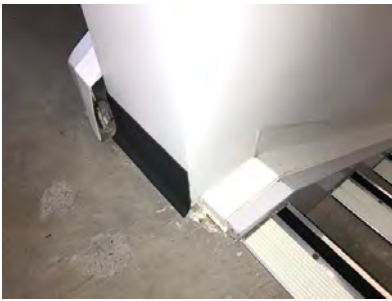
20200218_143310_photo

plastic stringer cover which is questionable to meet durability requirements of a hospital. Large gap at base. These covers don't exist in all hallways.

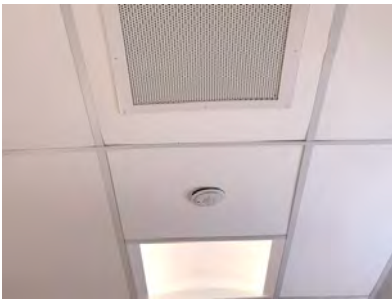
20200218_143631_photo

Sensor is loose. Ceiling tile is loose.

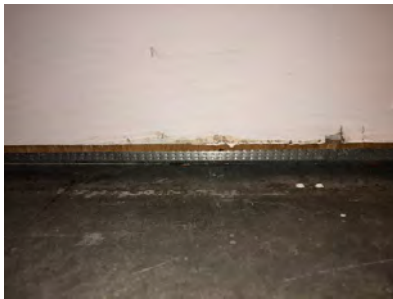
20200218_143836_photo

E2-002. Large gap below drywall. How is fire rating maintained?

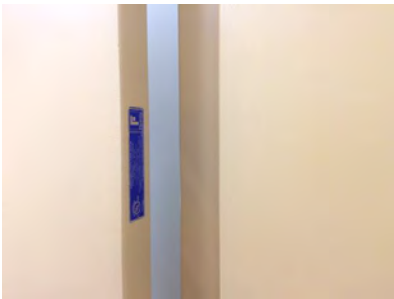
20200218_144408_photo

No fire rating to the frame

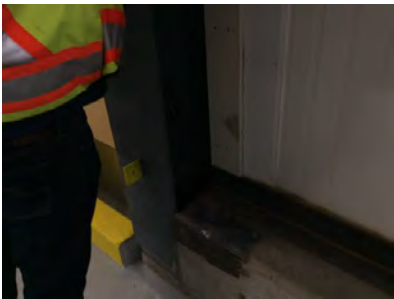
20200218_144520_photo

Noticeable air leakage

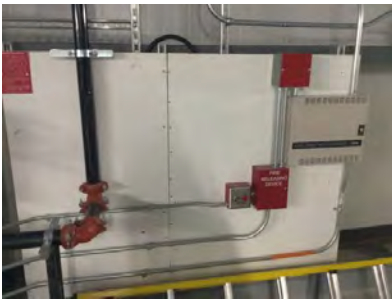
20200218_144903_photo

Electrical to confirm if this plywood is required to be fire rated?

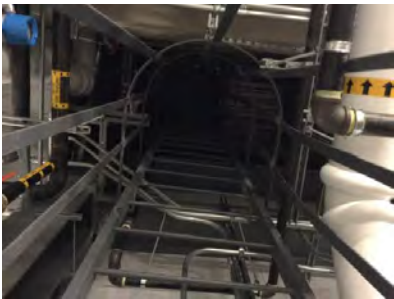
20200218_145027_photo

No apparent fall restraint/
protection to roof access ladder

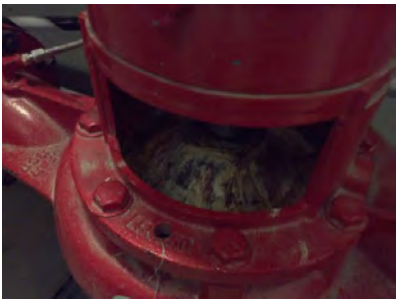
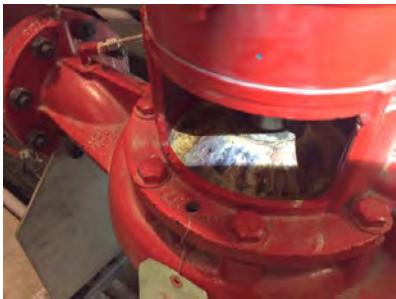
Description
Corrosion to pump p5 May be an issue

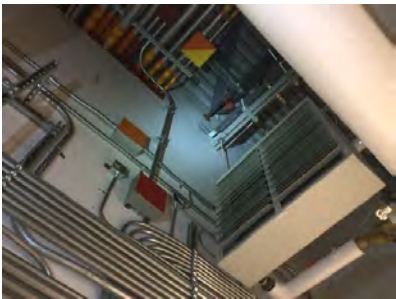
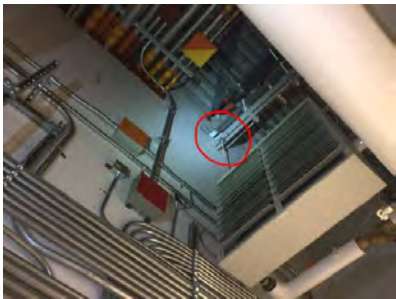
Description
Not firestopped

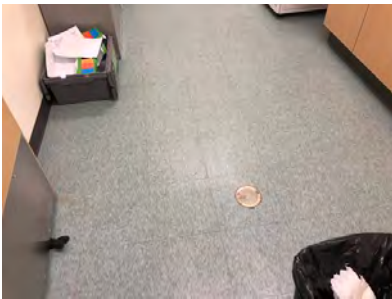
C2-253 VCT appears to not be sealed.

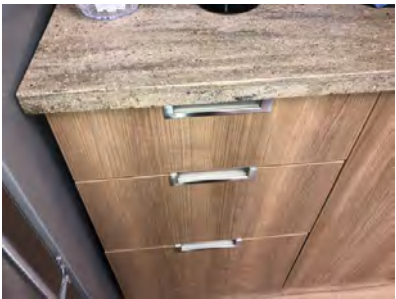
Description
Top drawer hard to open.

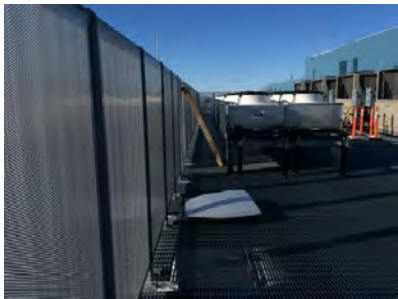
Description
Confirm materials, make sure no
dissimilar metals are used

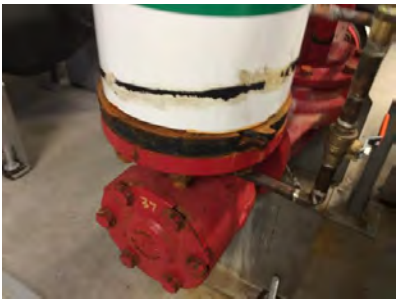
Description
Corrosion for mech to review

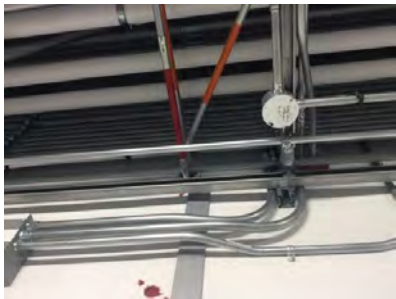
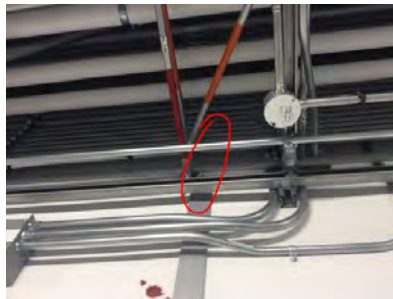
Crack in wall to u/s of deck, expansion/construction joint should be used here. This wall is a fire separation

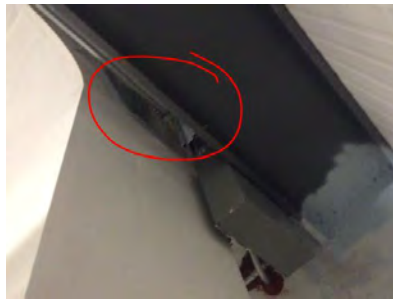
Mech to review, canvas wrap missing to duct

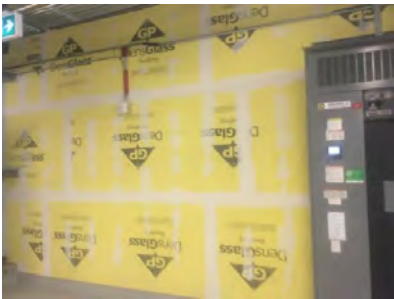
Unpainted wall

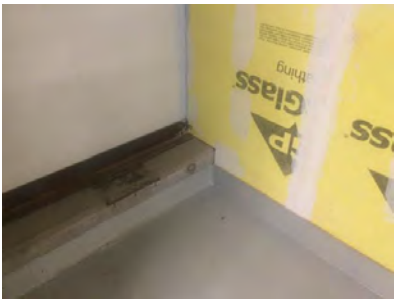
Fire sealant missing

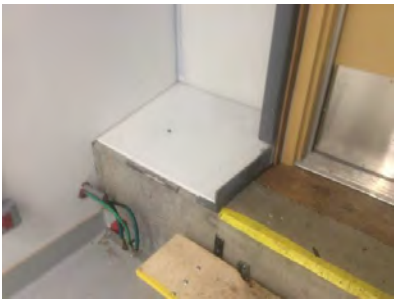
Fire separation to be investigated at this location

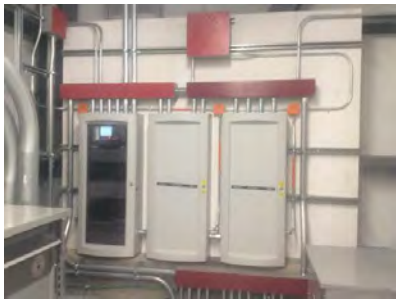
Electrical to confirm if rated wood is required

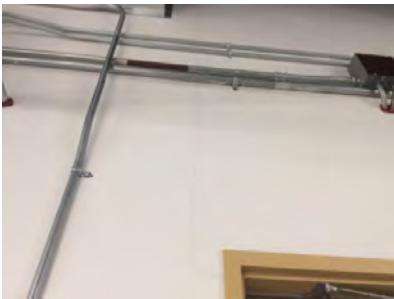
Crack to drywall, expansion joint required

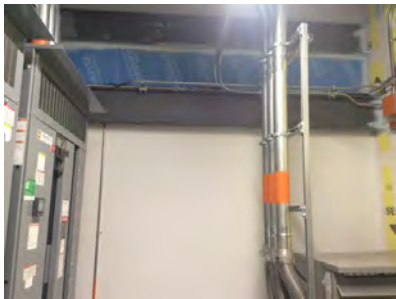
Confirm rating to this wall,
membrane visible above beam

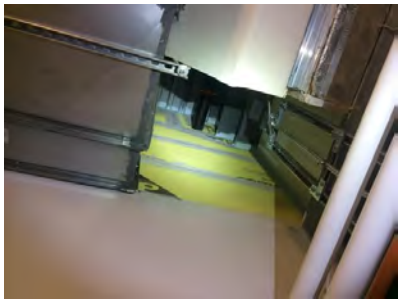
Description
Strange condition

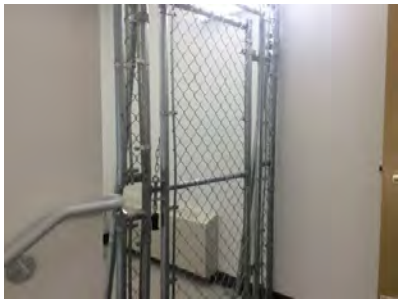
Confirm continuity of fire separation

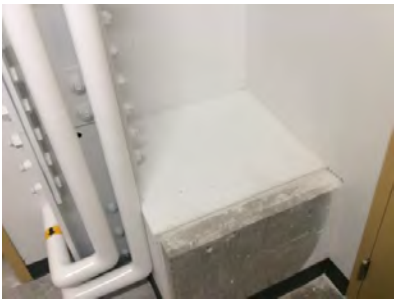
Paint and construction materials
stored in mech penthouse

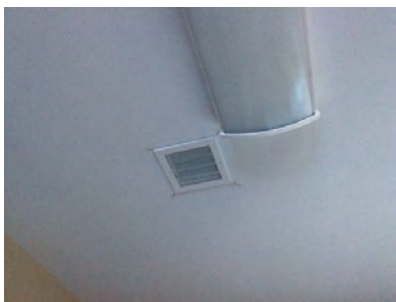
CRUs - Staining to ceiling, mech to review. Location not suitable for users.

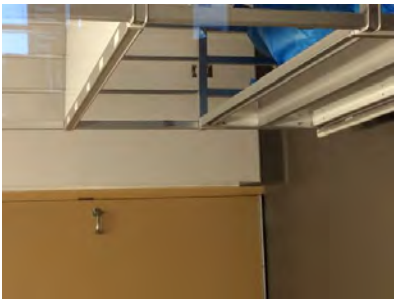
Corner guard on this corner
would be beneficial

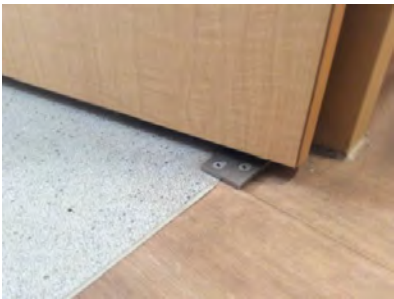
CRUs - Surface floor mounted hinge bracket could be an issue for infection prevention & control

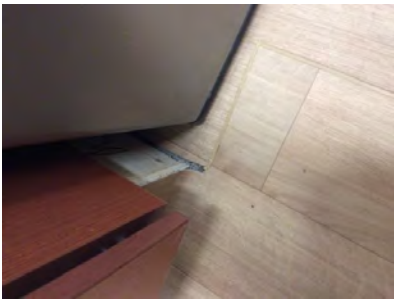
Section of base and unfinished

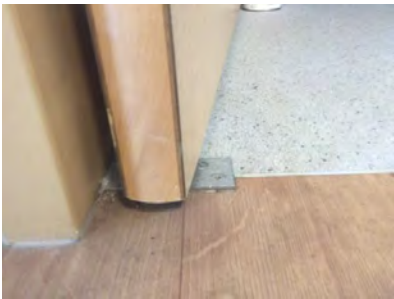
Cru -2 floor mounted bracket
with potential infection
prevention issue

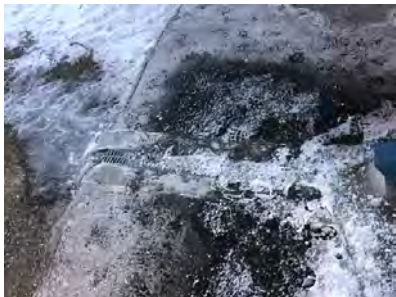
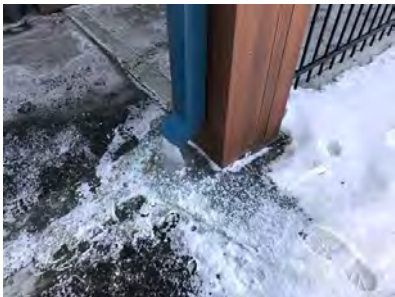
Description
Rain water leader pours onto walkway. Drain system overflowing and creating ice.

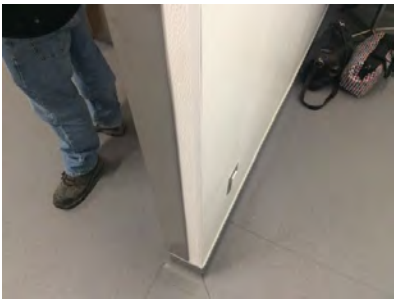
20200218_180609_photo

Corner guards required

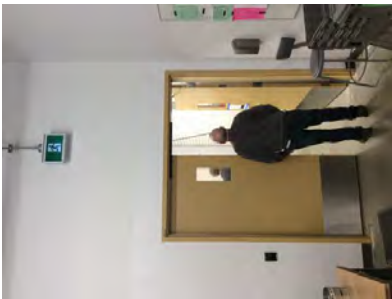
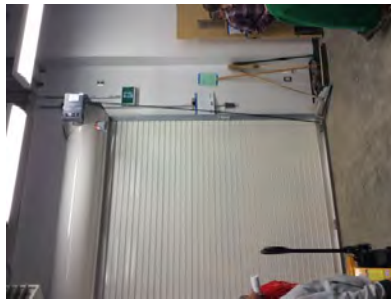
Not an exit. Should not have an exit sign. Unless the tied bag of hardware comes down. Second means of egress isn't clear from here or the woodworking area.

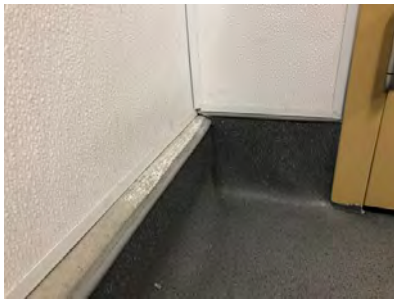
20200218_181250_photo

By door to C0-125B. Gap at corner base in wash down area. Concrete lip at wall that is flat, water might pool.

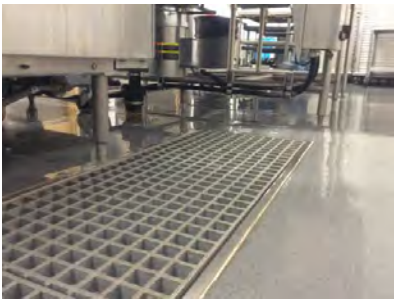
20200218_181425_photo

Possible slope issue with floor

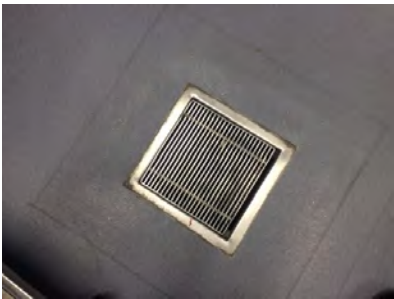
20200218_181521_photo

Floor grill doesn't fit recess

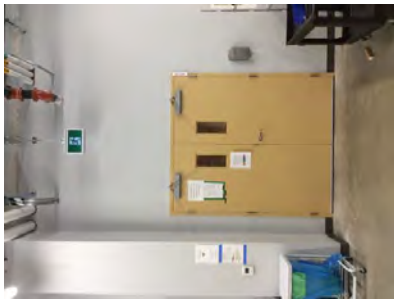
20200218_181530_photo

Doors appear to go in the wrong direction unless this room is assumed to have less than 50 people in it

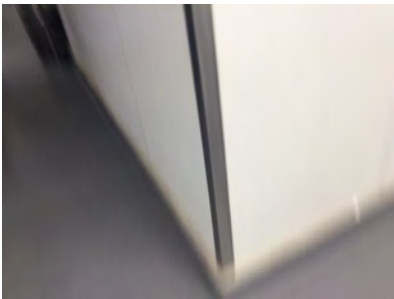
20200218_181630_photo

Pointless condition collects moisture & dirt

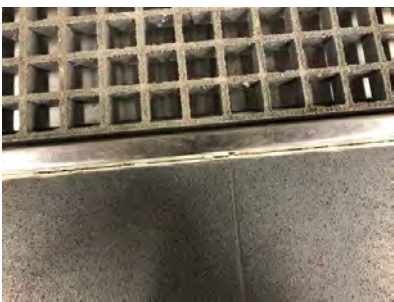
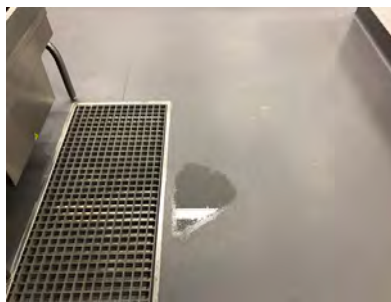
20200218_181820_photo

Pounding near grate. Uneven slope. Caulking is cracked.

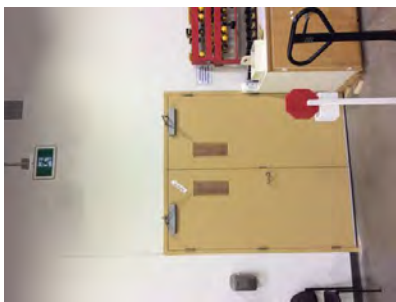
20200218_181733_photo

Similar note. Exiting needs to be looked at throughout this area

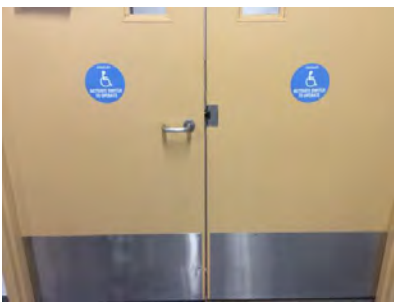
20200218_182145_photo

Gap in double doors

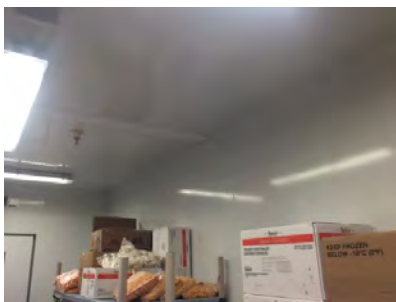
20200218_182357_photo

Discolouration in seam to ceiling
of freezer #2

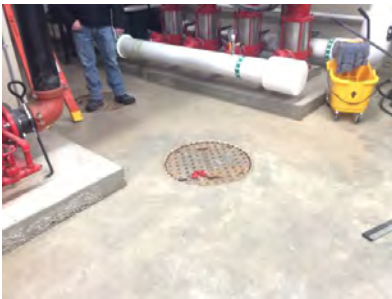
20200218_183002_photo

Suspected sewer gas aroma,
trip hazard to my cover

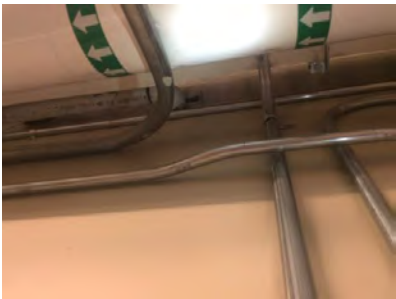
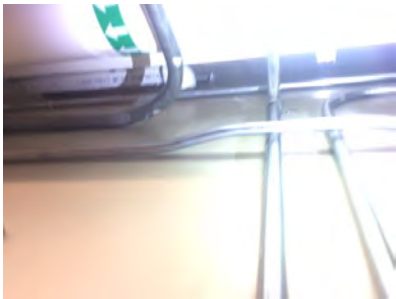
Description
Fire caulking required

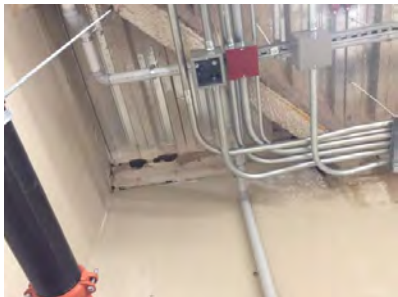
20200219_080148_photo
James Holtom
Feb 19, 2020 8:01 AM

Description
Unidentified material leaking at high level

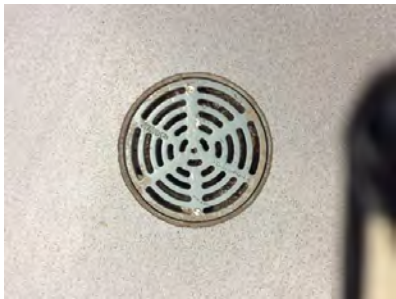
20200219_080807_photo

Floor drain covers corroding quickly

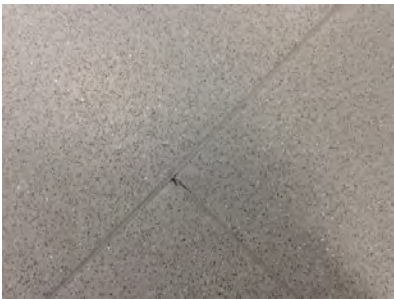
20200219_080812_photo

Failure of floor weld

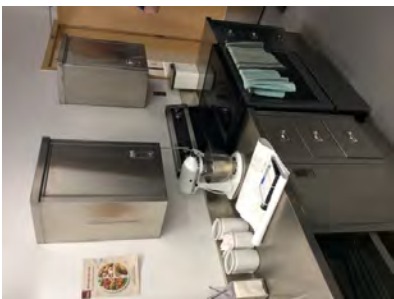
20200219_081007_photo

No exhaust hood, fairly well equipped kitchen in which I think there are some cooking activities which would generate grease laden vapours.

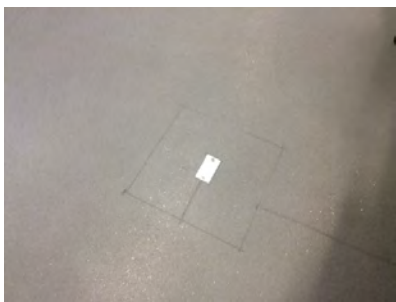
20200219_082909_photo

Floor plate infection control issue

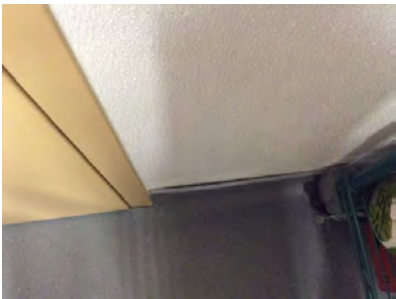
20200219_083401_photo
James Holtom
Feb 19, 2020 8:34 AM

Description
Flooring failure

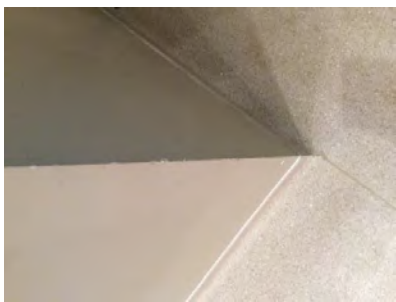
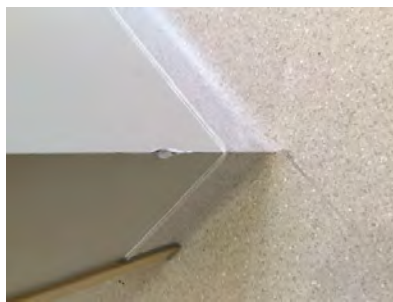
20200219_083532_photo

No corner guards in the main reception area. Corners well abused.

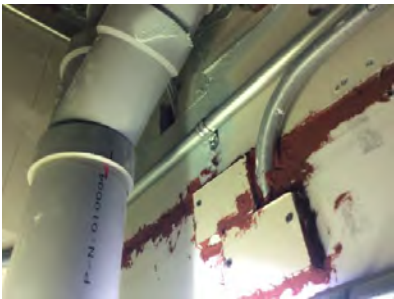
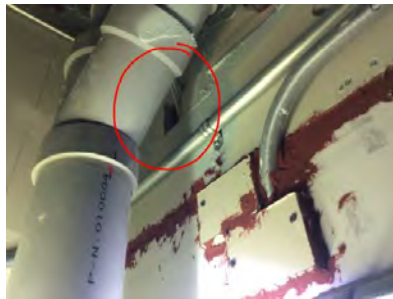
Missing fire sealant above door

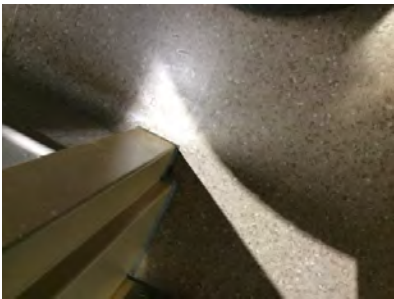
Missing caulk at door frame

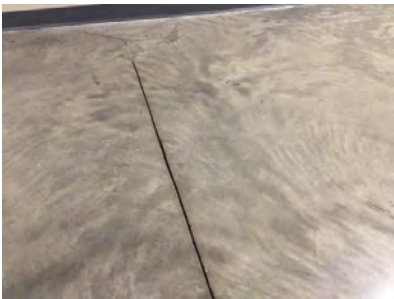
Saw cuts not sealed to the basement

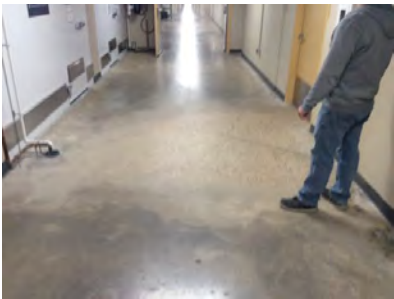
Floor grinding may be due to heave, structural to review

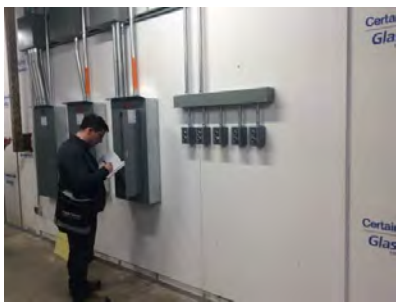
Confirm fire rating requirement
to plywood behind panels

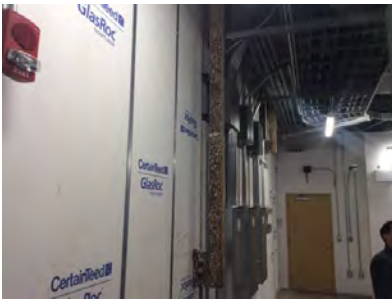
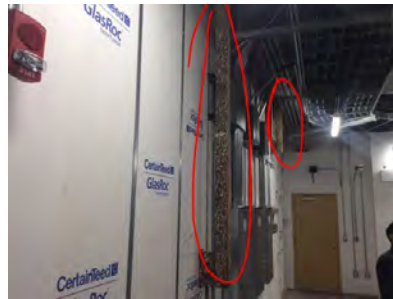
Structure requires a fire rating

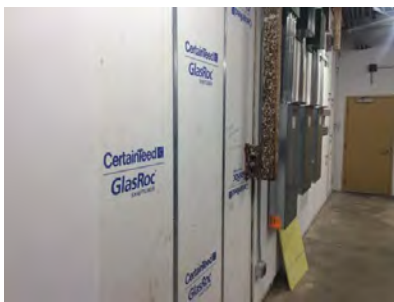
Shaft liner appropriate per contract requirements?

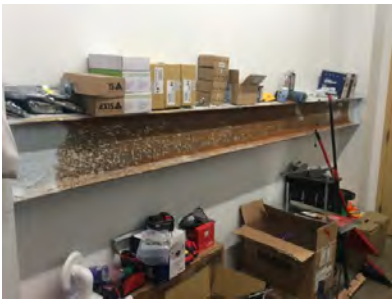
Fire rating to structure required

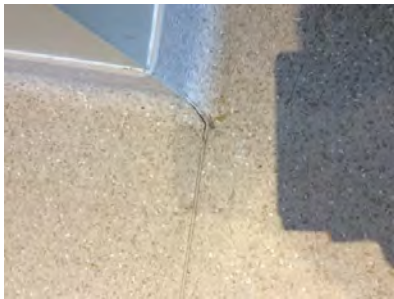
Flooring seam failed at cover corner.

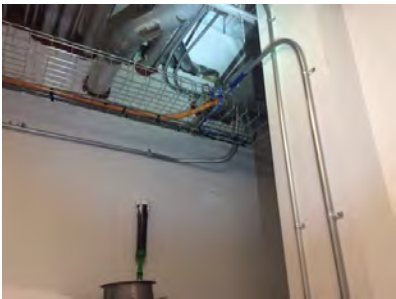
Description
Fire seal required

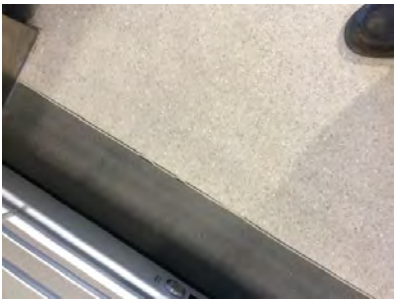
20200219_090102_photo

Transition seam fail..

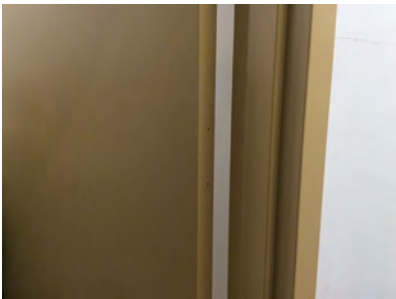
20200219_090232_photo
James Holtom
Feb 19, 2020 9:02 AM

Description
Door rating tag missing

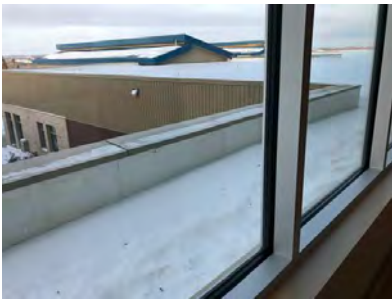
20200219_090209_photo

Roof access limited by narrow walkway. Parapet height not high enough.

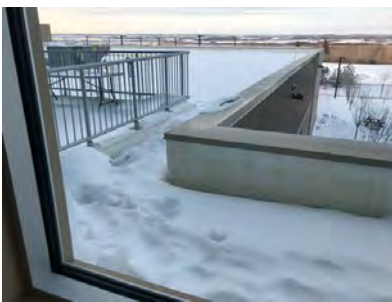
20200219_090314_photo

Roof access severely limited.
Parapet is not high enough to be
a barrier.

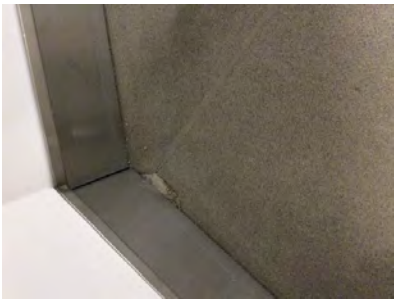
20200219_090601_photo

Flooring missing near counter

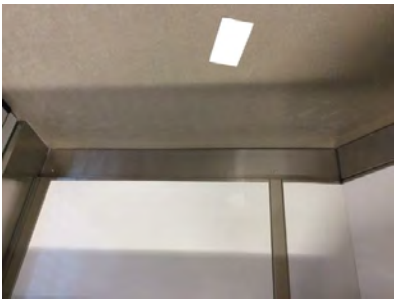
20200219_090712_photo

None of the stainless steel is caulked to floor but it is caulked to walls.

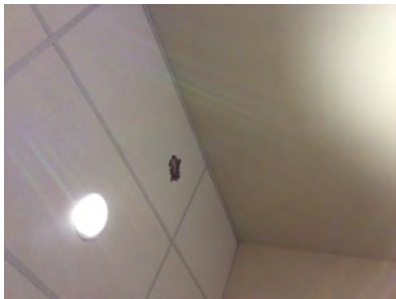
20200219_091047_photo

New leak in ceiling

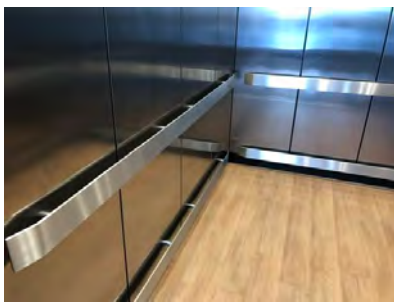
IMG_0954

No anti ligature hand rails in elevators.

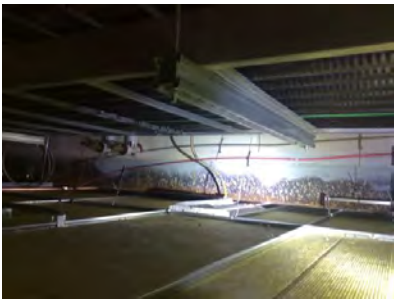
20200219_091451_photo

Rating required to structure if failure will cause the floor above to fail. Structure to confirm

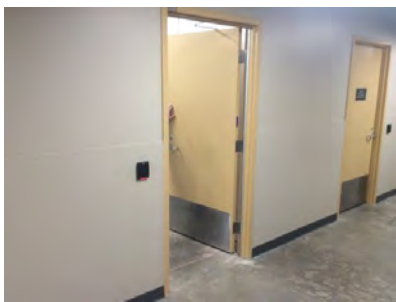
20200219_095719_photo

Door here not on plans

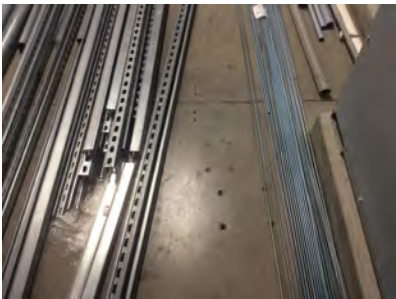
20200219_100042_photo
James Holtom
Feb 19, 2020 10:00 AM

Description
Floor penetrations not sealed

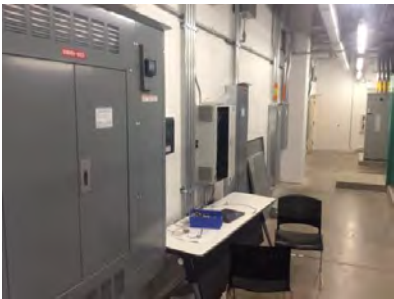
20200219_100400_photo

Confirm if fire treated plywood is required behind panels

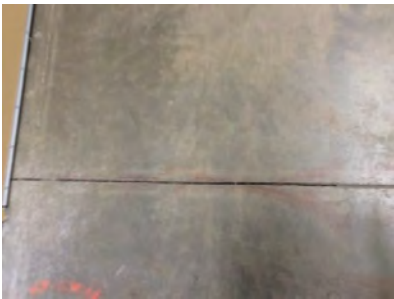
20200219_100603_photo

Saw cuts not filled, confirm spec requirements.

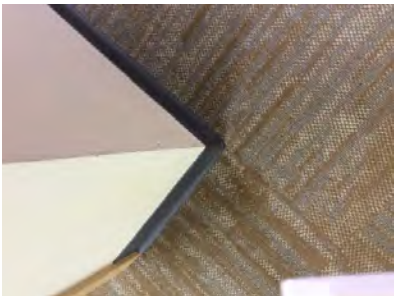
20200219_100142_photo

No corner guards have been included in admin suite and main corridors are seeing some wear

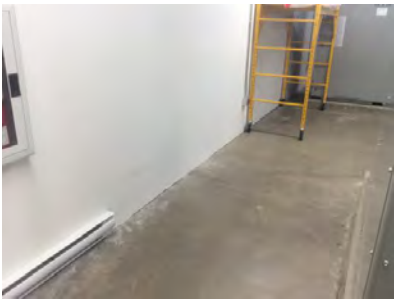
20200219_100830_photo

Confirm if rubber base was required to all basement areas

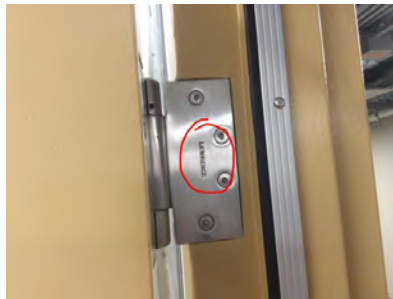
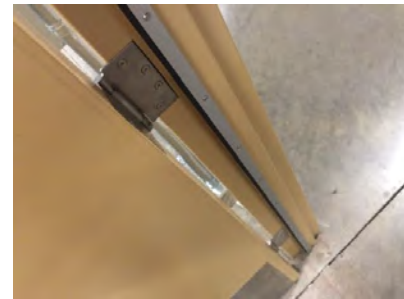
Confirm door hinge manufacturer is approved on submittal, middle hinge has no name tag noted, others are 'Lawrence'

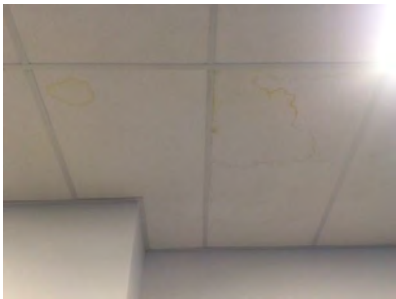
Description
Evidence of leak, to be investigated my mechanical

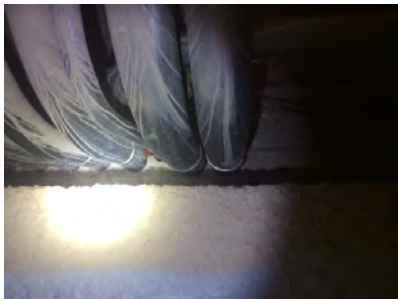
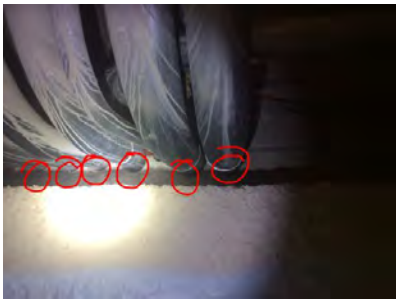
Description
Incomplete fire seals

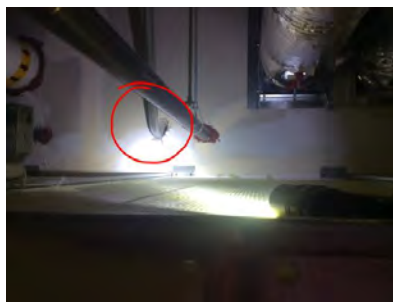
Missing fire sealant

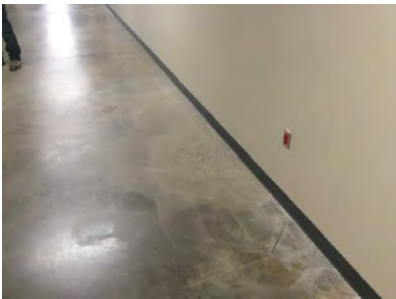
Description
Evidence of heave to floor

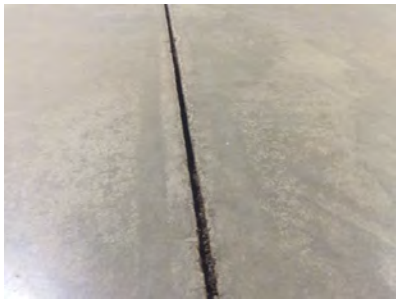
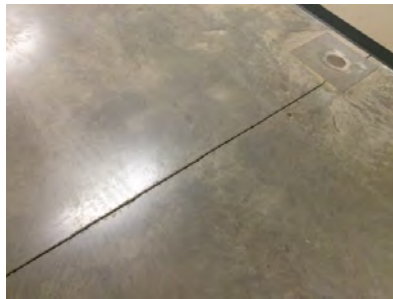
Construction joint not sealed

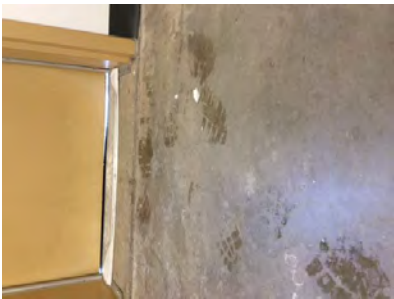
Door sweep not touching.
Operator noted mice are being
caught in vestibule

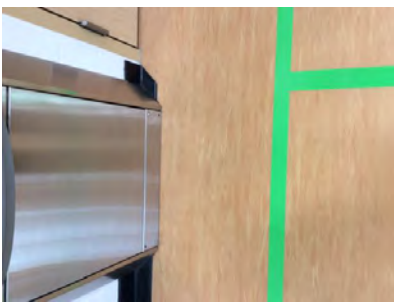
Missing fasteners at water fountains

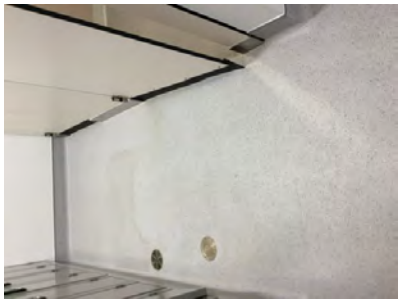
Location
C1-039

Description
Water pounding outside of showers, not making it to the drain.

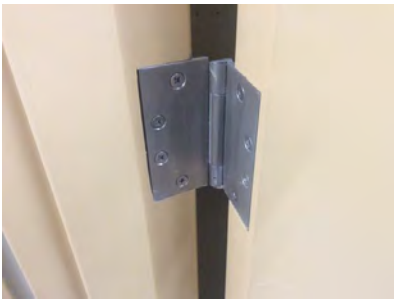
No name plate to hinge, no security type screw heads used

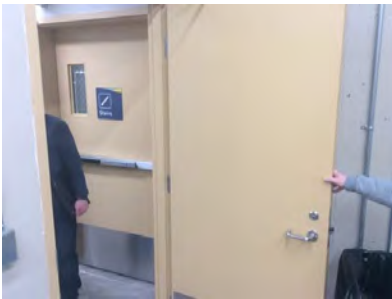
This wall and door should have a 1hr FR as this is a storage room. No rating to the door or frame

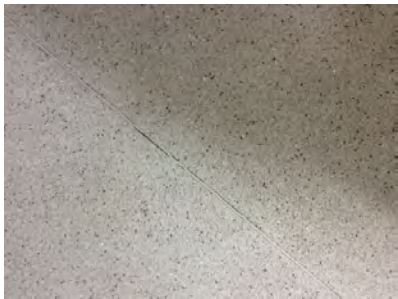
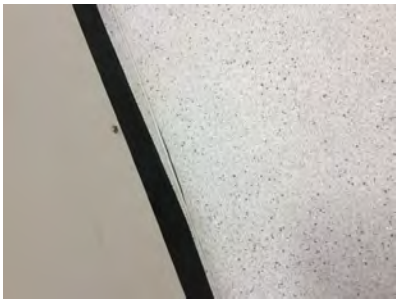
Location
C1-038

Description
Seaming failed

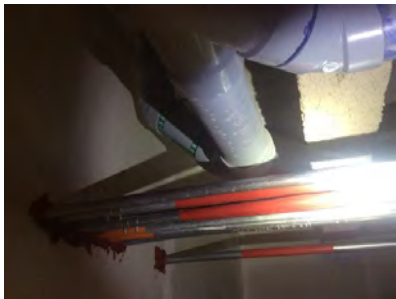
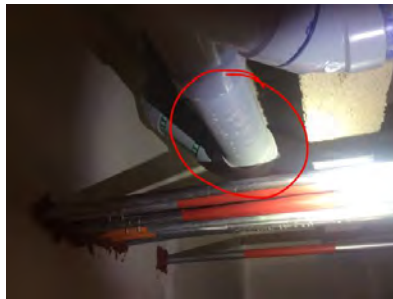
Numerous evidence of leaks to t-bar

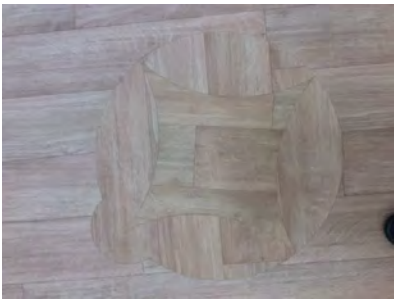
Open seams in icon cut in to floor

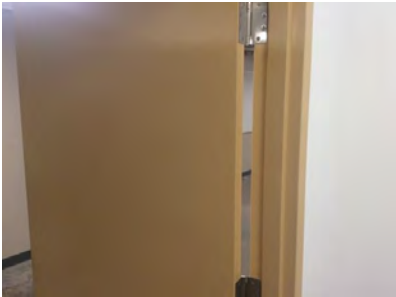
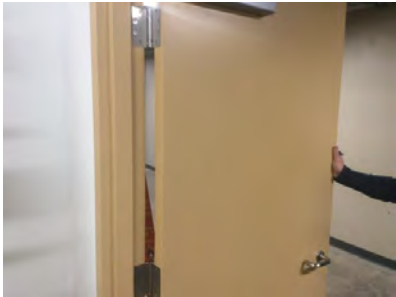
Description
No fire rating label to either door

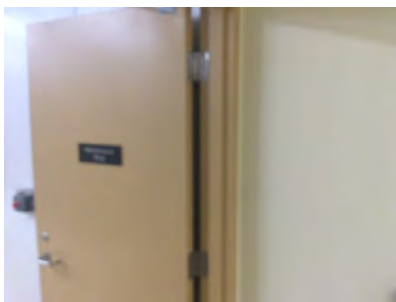
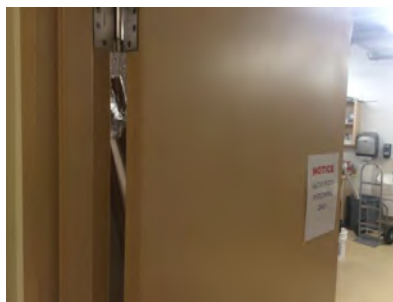
No fire rating label to either door
and no security screws installed

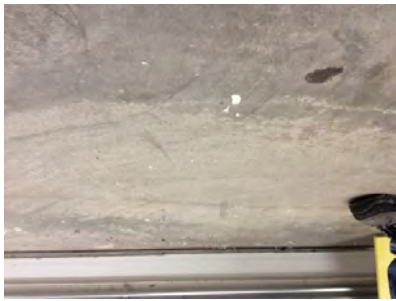
Drywall not sealed to floor in fire separation

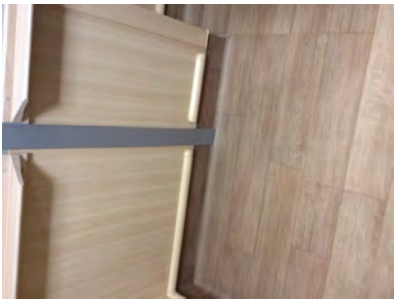
Building movement joint does not have joint in floor

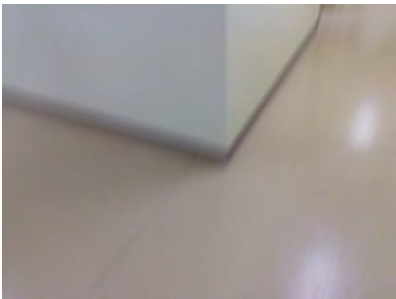
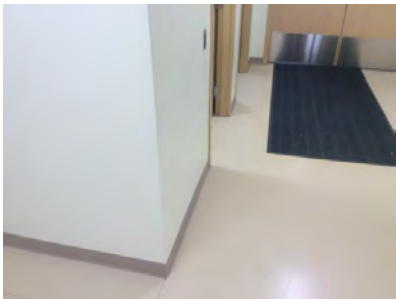
Description
Corner guard required

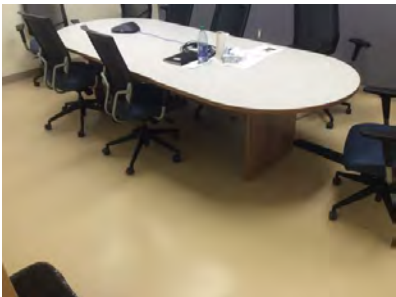
Description
Inappropriate flooring

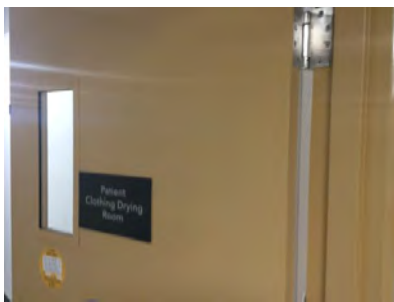
Confirm that linen services & storage does not need to be rated

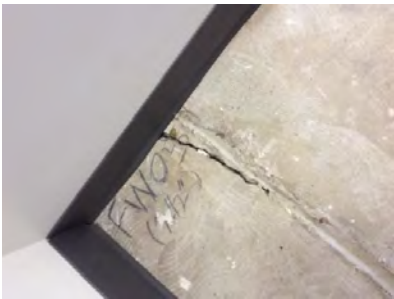
Cracked slab

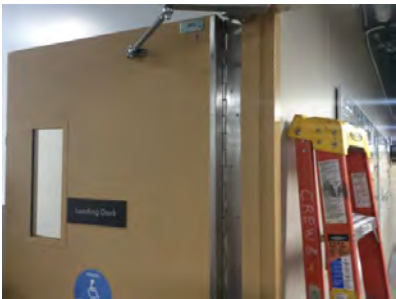
Description
No fire label visible

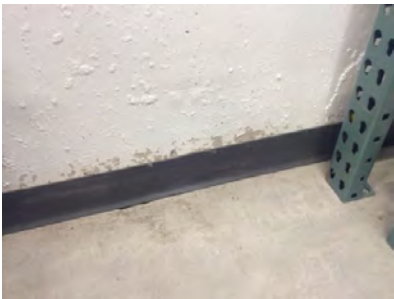
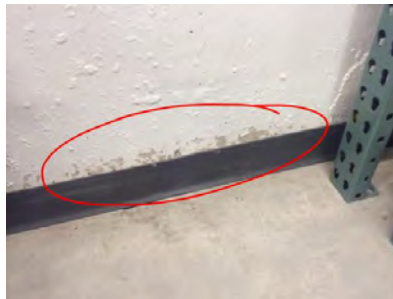
Paint peeling potential moisture problem

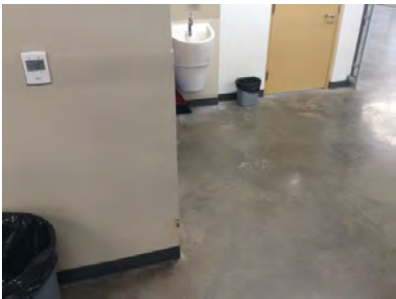
Description
Suggest corner guard

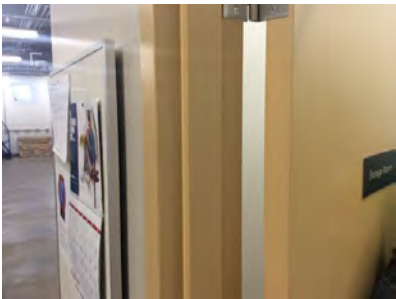
Description
No fire rating label to door or frame

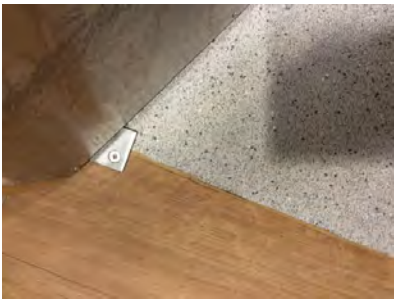
20200219_124812_photo

Flooring weld failing.

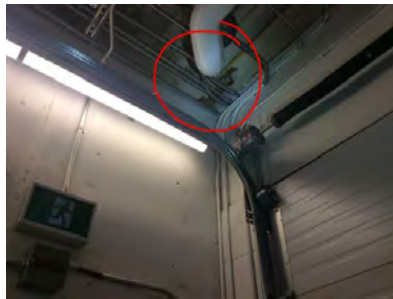
20200219_124958_photo

Fire spray failure

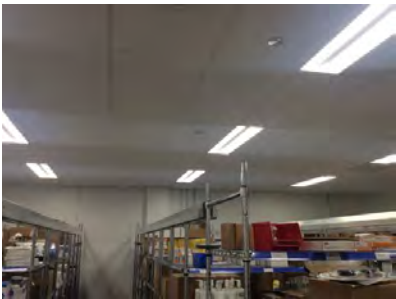
20200219_125710_photo
James Holtom
Feb 19, 2020 12:57 PM

Description
T-bar suitable?

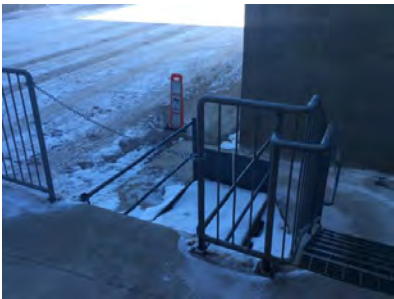
20200219_125844_photo

Lift is not accessible

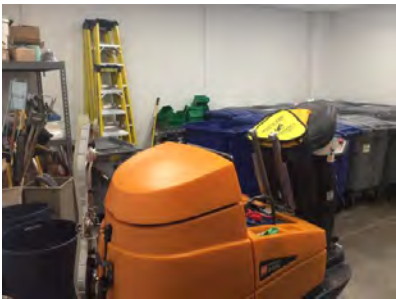
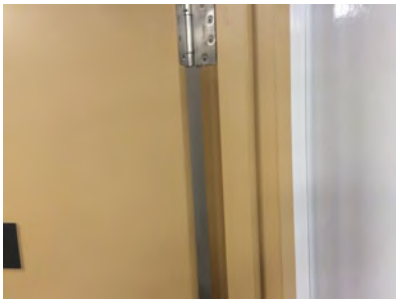
Description
This storage room needs to be rated, not currently rated. No rating label to door

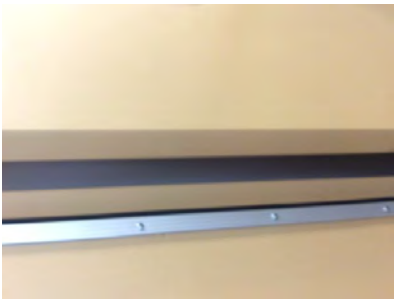
20200219_130329_photo

No stamp on door in rated wall
