APPENDIX C – PlanGrid Task Report

PlanGrid Task Report - Aug 19, 2020

Prepared by James Holtom

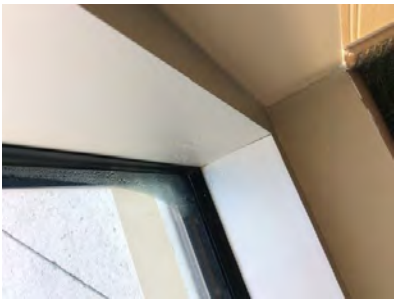
20200219_133139_photo

Condensation on glazing

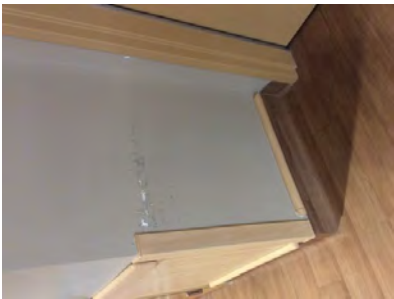
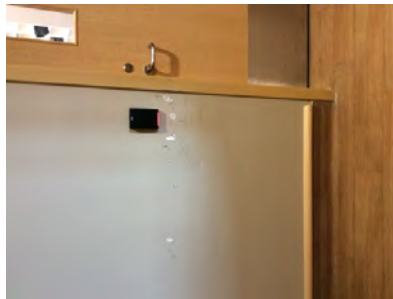
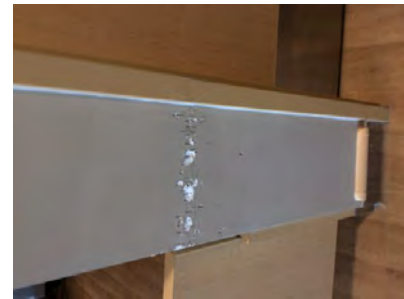
No cart rail and significant damage

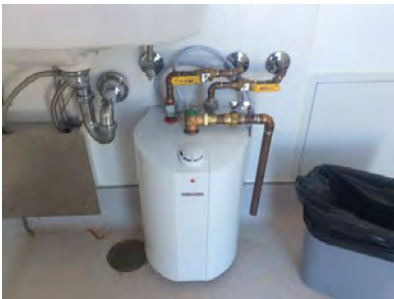
20200219_134632_photo

Should be housed in millwork

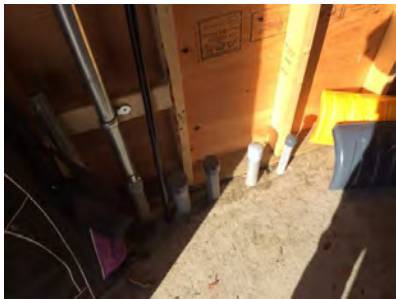
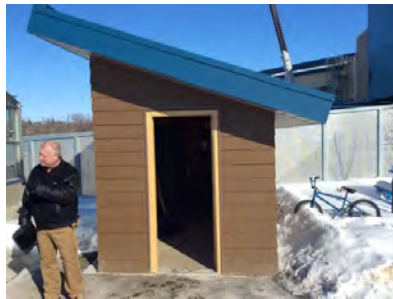
Not constructed, storage shed constructed in place. Confirm if approved change

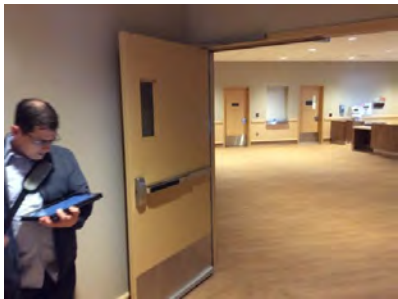
Description
Label to fire doors not visible

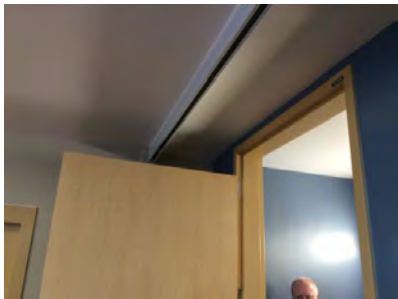
Description
Door too short, gap to frame

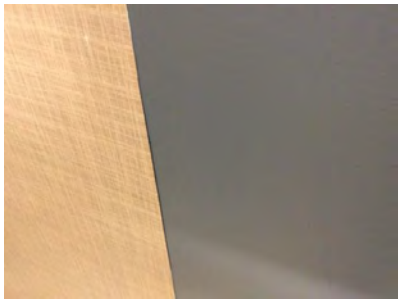
Description
No trim to shower wall covering,
infection control issue - typical

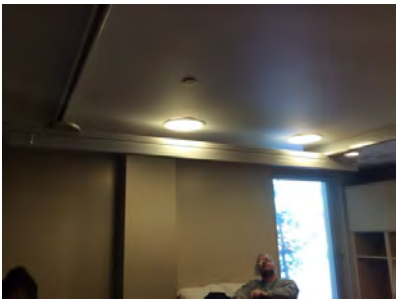
Description
No motors visible for gantry,
clear ligature issue

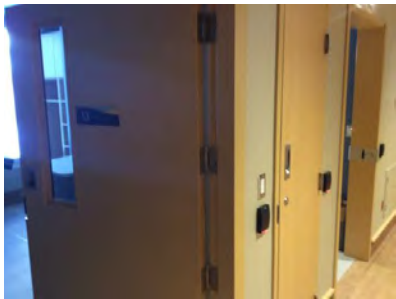
Are there hinges appropriate considering anti ligature issues

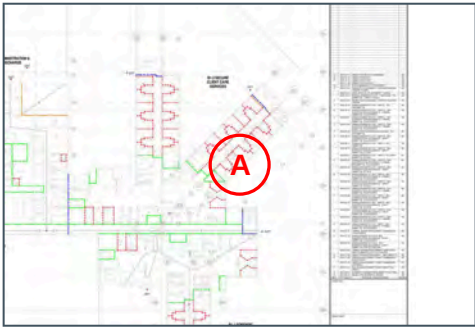
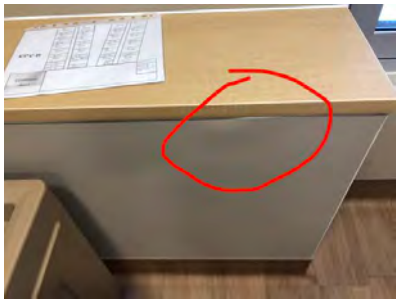
Description
E1-481. Panel delaminating.

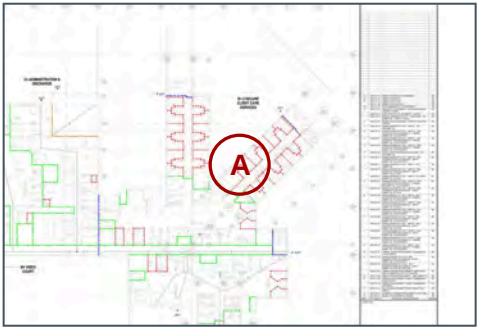
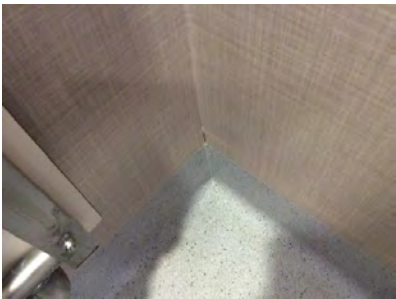
Description
Failure of sealant to shower wall
covering

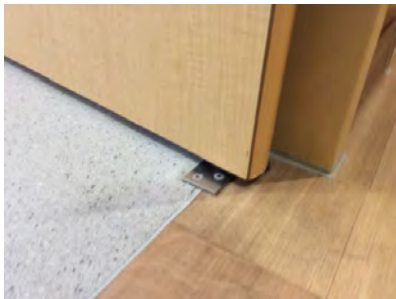
Flooring lifting at floor bracket,
also plate not flush with floor
finish

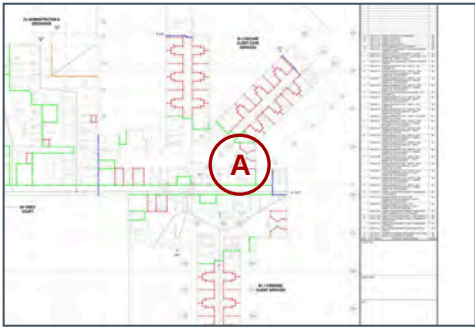
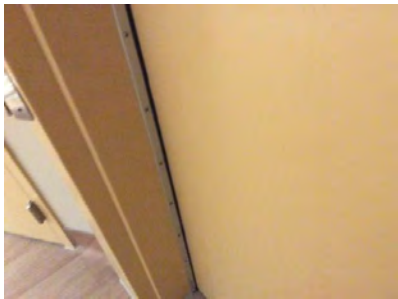
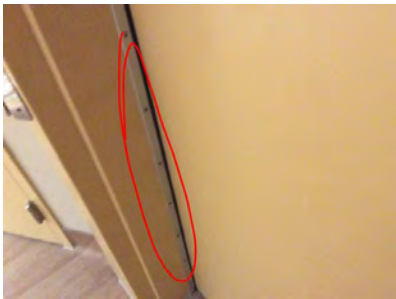
Description
Acoustic seal not effective

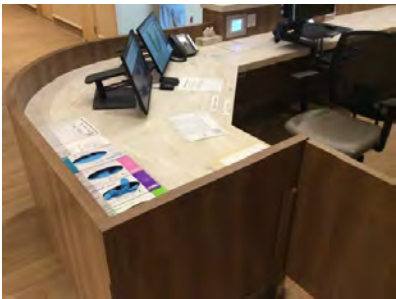
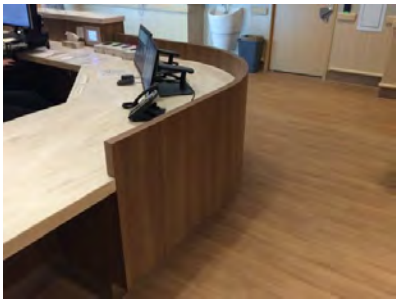
Description
Concern expressed over the protection afforded by the millwork design

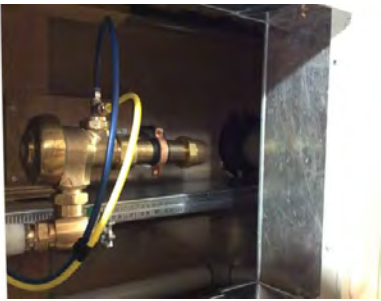
No insulation to provide acoustic sep in manifold cover

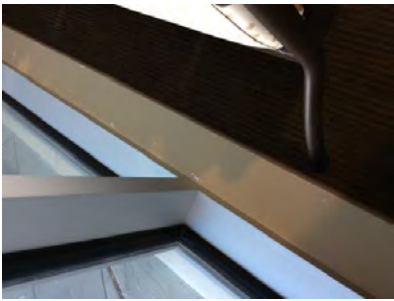
Paint chipping from sill in an unoccupied wing

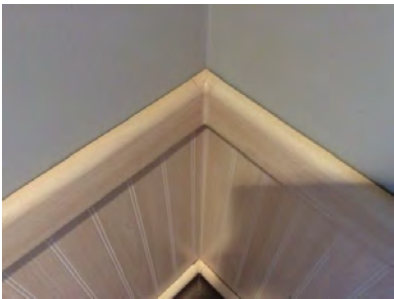
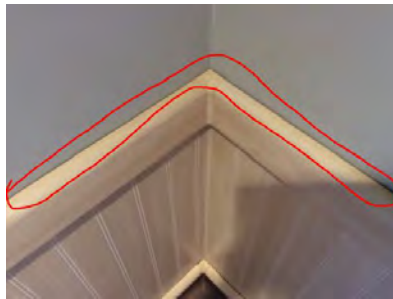
Typical issue - gap presents a potential infection control issue

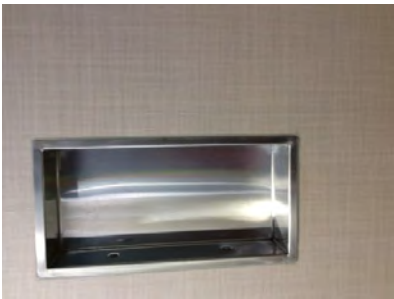
Rust already apparent on niche

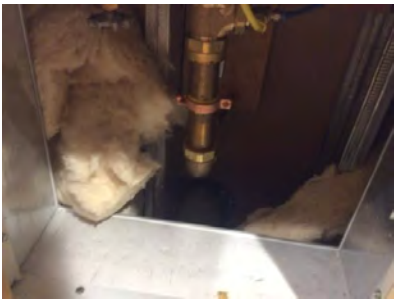
Inconsistent insulation to provide a required stc rating - typical

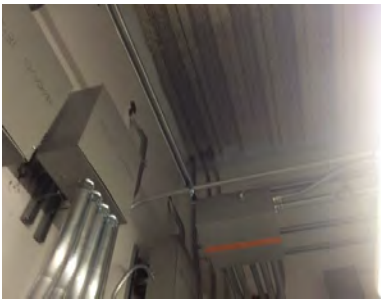
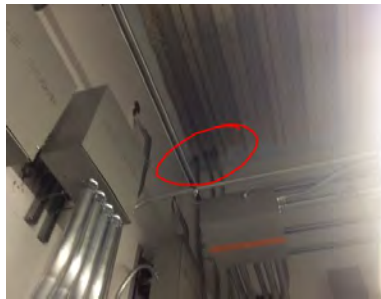
Fire sealant missing to ceiling

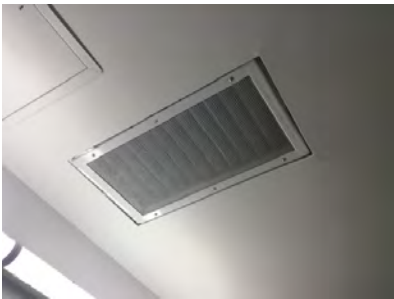
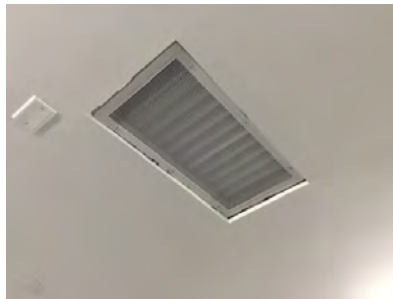
#441 Architectural

Poor quality installation issue

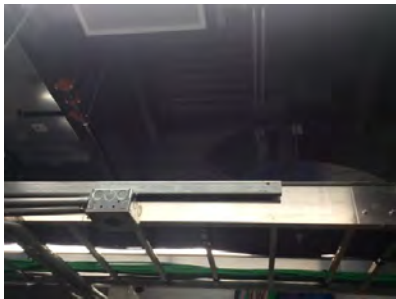
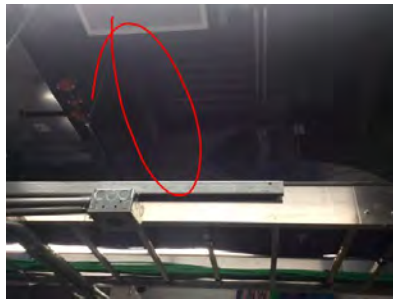
Possible fire rating issue, failure of these structural members may cause failure of beams with fire spray to north supporting the second floor

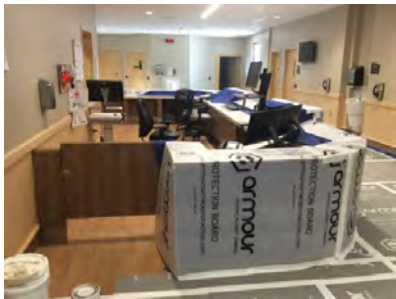
#445 Architectural

Concern expressed by staff on the protection afforded to staff behind the wing reception

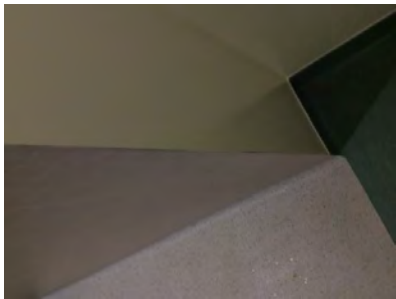
#448 Architectural

No SS corner guards on side of shower

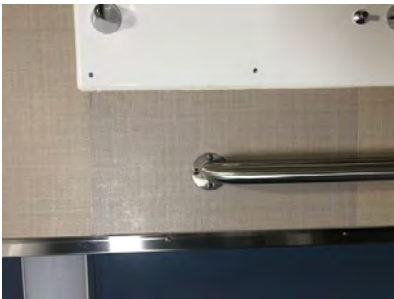
#451 Architectural

Description
Repairs to washrooms are of poor quality. High risk of future maintenance issue.

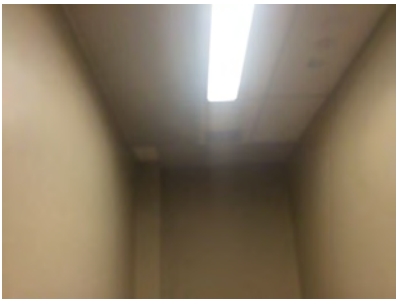
#452 Architectural

Description
Room very cold, possible envelope issue. Radiant panel appears to be off or nonfunctional

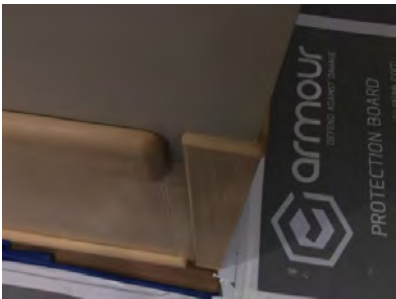
#453 Architectural

Description
No caulking example

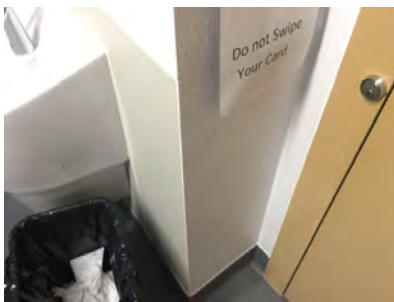
Typical - no trim corner piece

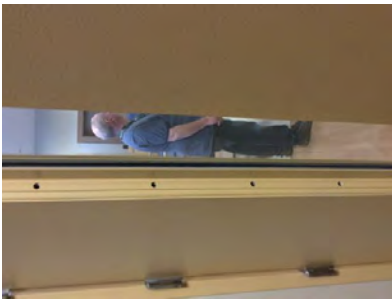
Missing fasteners in glazing stop

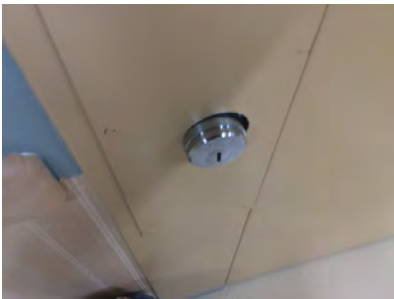
#465 Architectural

Locks appear unfinished, plate required

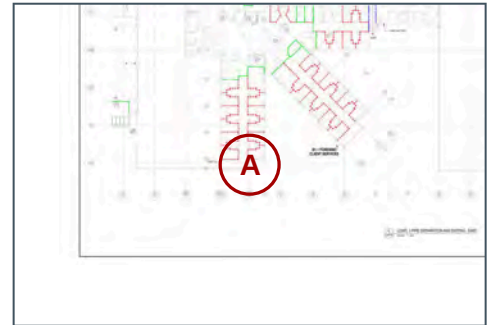
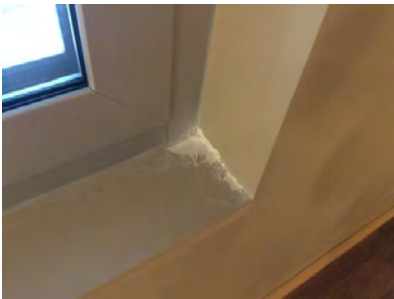
Maybe evidence of damp

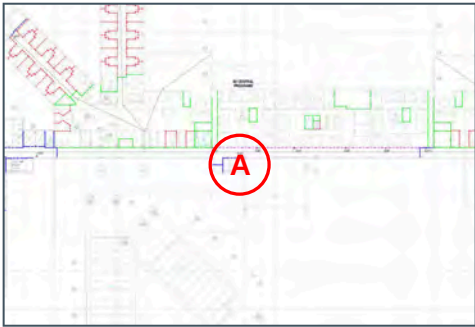
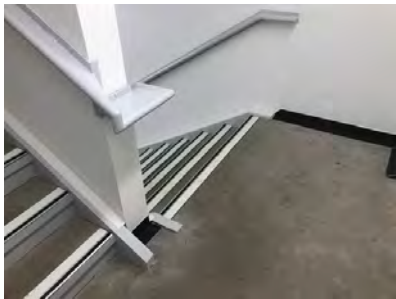
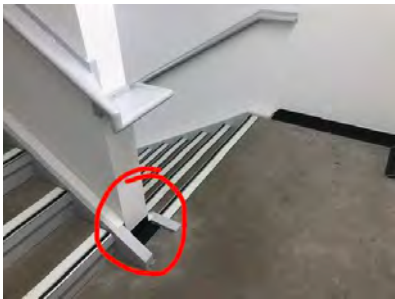
Description
Potential trip hazard

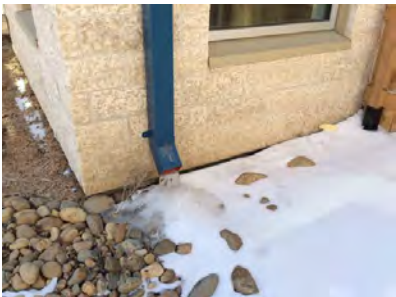
Description
Confirm if heat tracing required
per contract

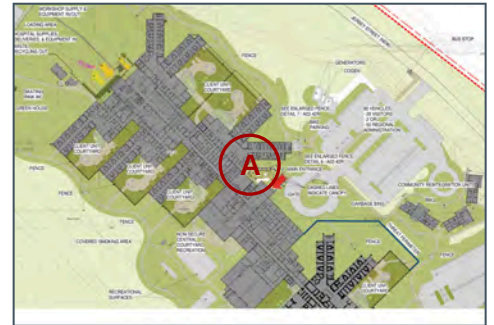
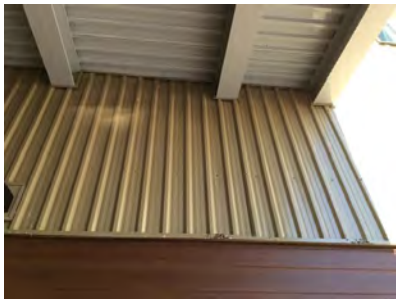
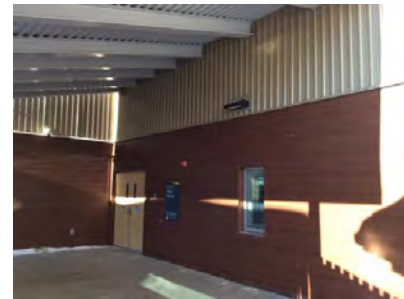
Bird deterrent required to u/s of canopy

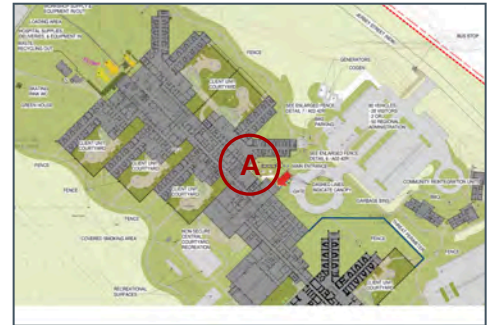
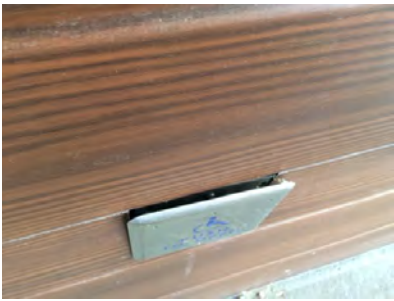
Poor quality install of push button

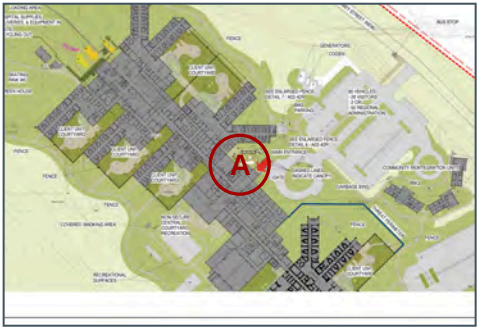
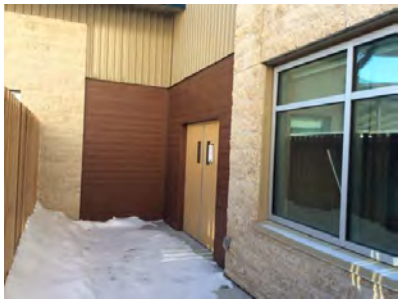
Description
No light over door

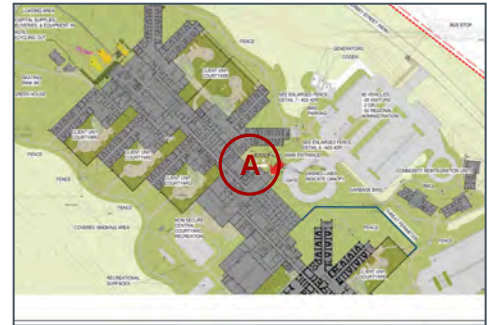
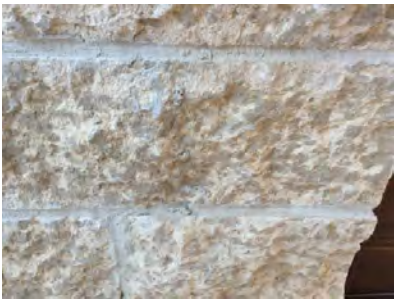
typical - Poor quality of mortar install

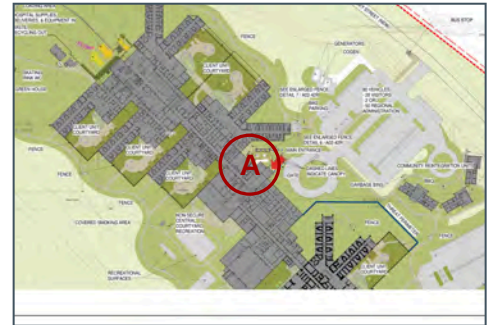
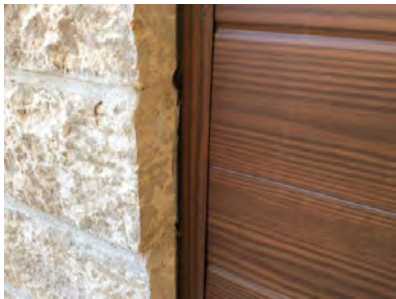
typical - No sealant between masonry and siding

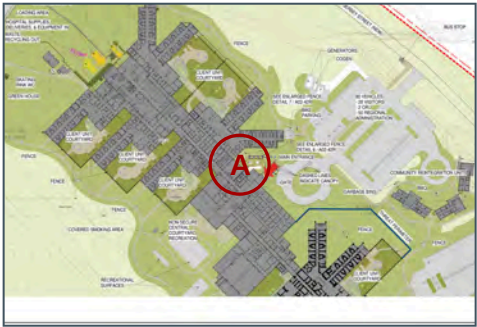
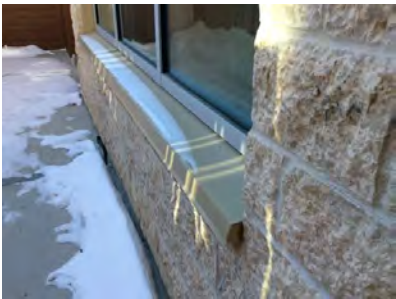
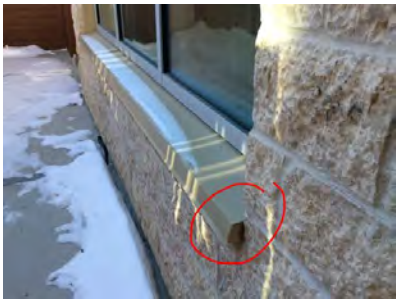
Sheet
A01-02

Description
Poor quality of sill flashing install

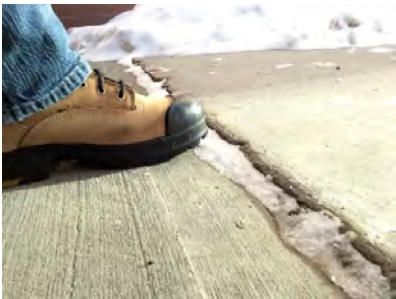
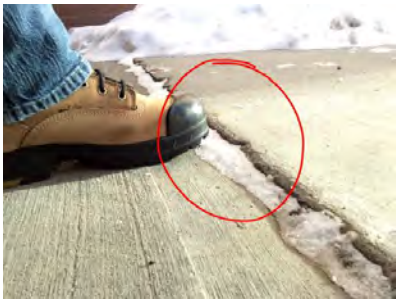
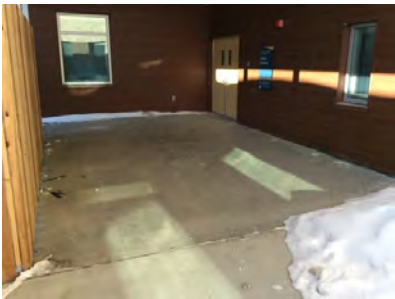
Sheet
A01-02

Description
Large slab with no saw cuts, cracking evident. Also trip hazard noted

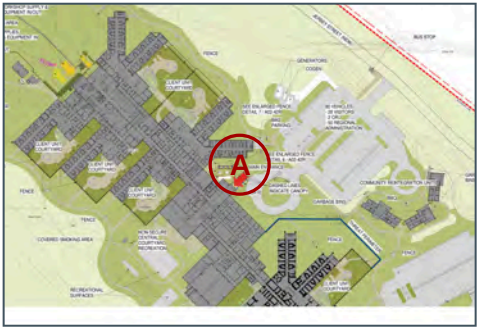
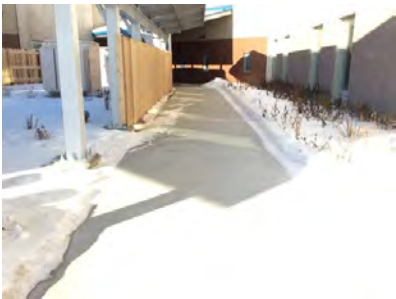
Sheet
A01-02

Description
Minimal saw cutting, landscape
to review

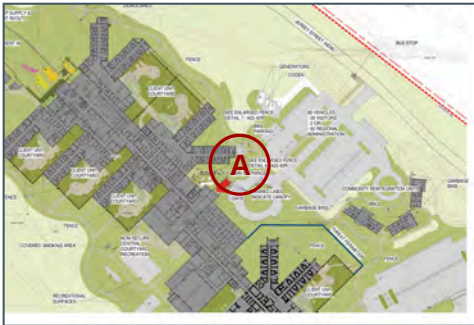
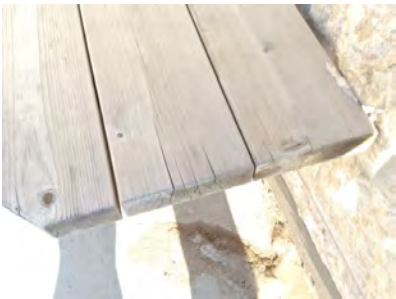
Sheet
A01-02

Description
Confirm material requirements to bench, treated wood appears unsuitable from a maintenance standpoint

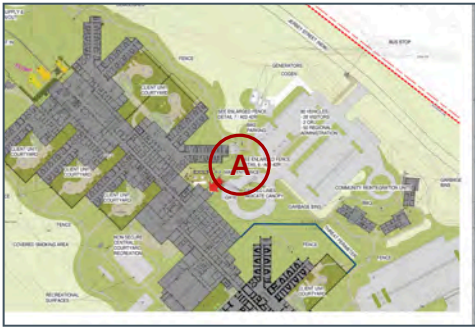
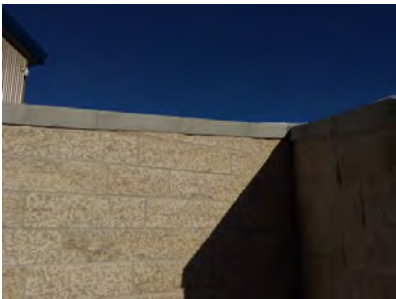
Sheet
A01-02

Description
Poor installation to concrete
capping

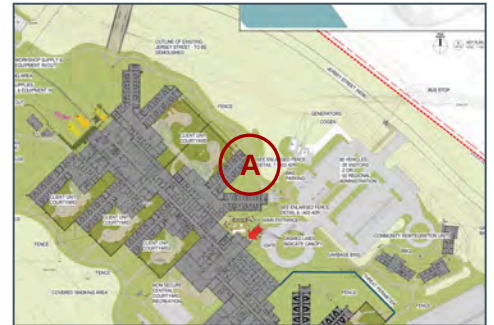
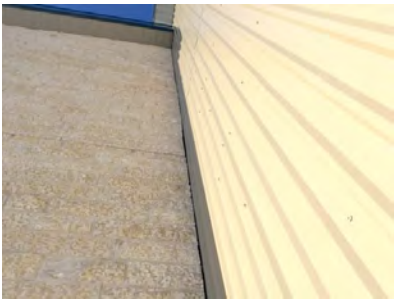
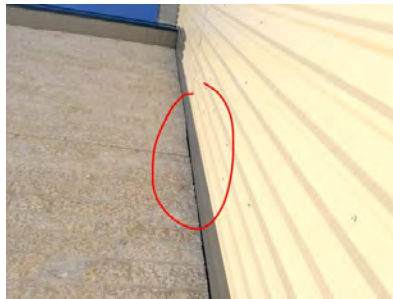
No sealant between masonry & cladding, some large gaps evident

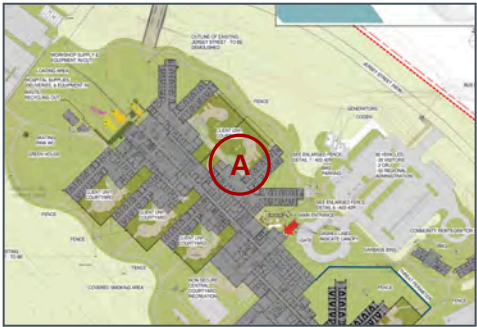
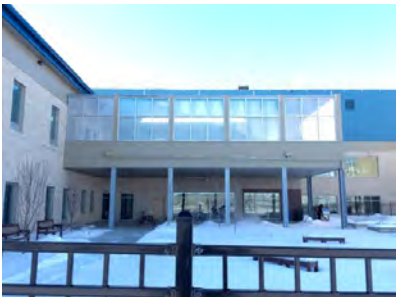
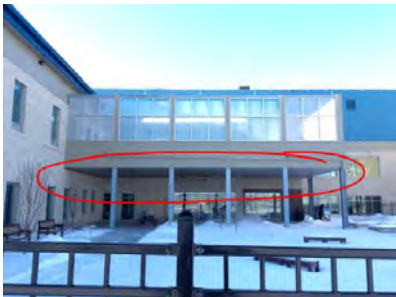
Sheet
A01-02

Description
No sprinkler coverage to overhang, to be reviewed by mechanical

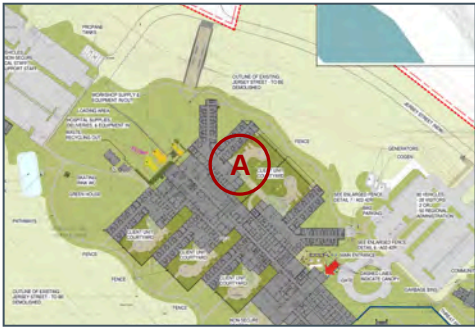
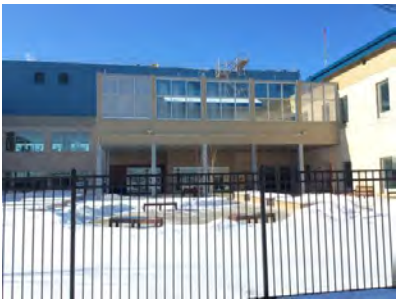
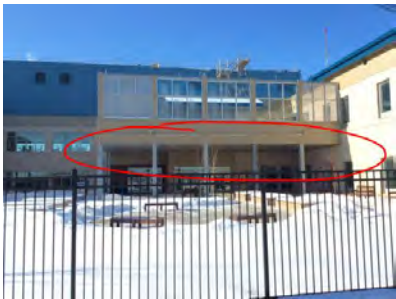
Sheet
A01-02

Description
Confirm required sprinkler coverage

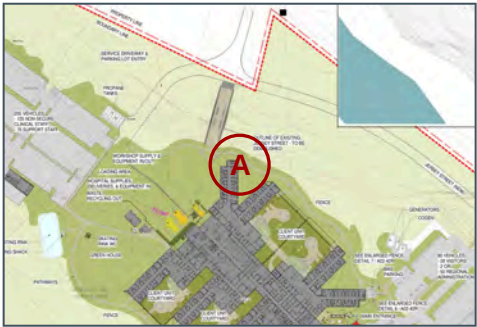
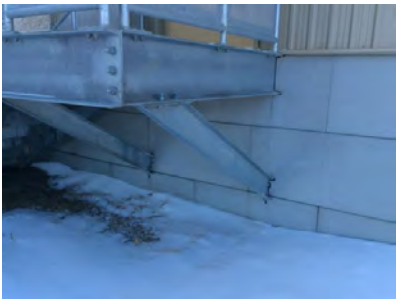
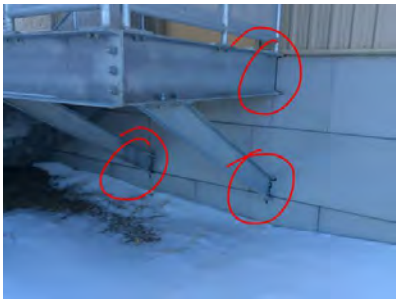
Sheet
A01-02

Description
Steel penetrations to be sealed
rainwater is directed in towards
the building envelope

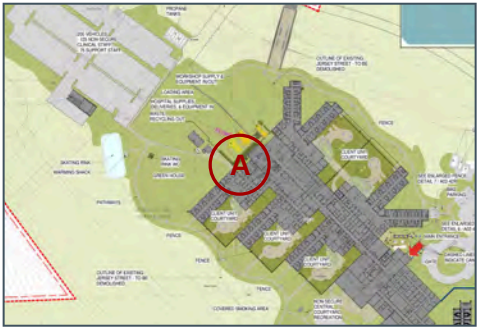
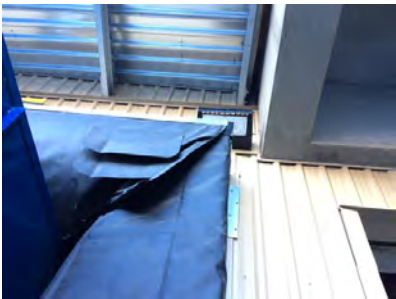
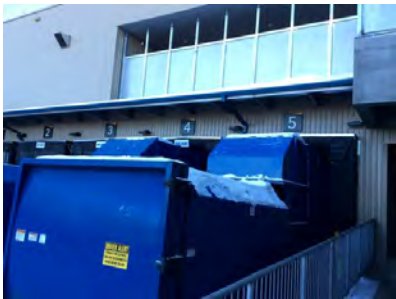
Sheet
A01-02

Description
Poor light location

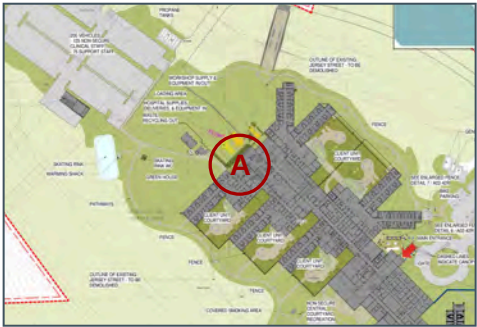
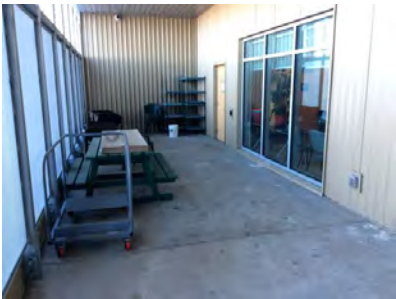
Sheet
A01-02

Description
No saw cuts evident

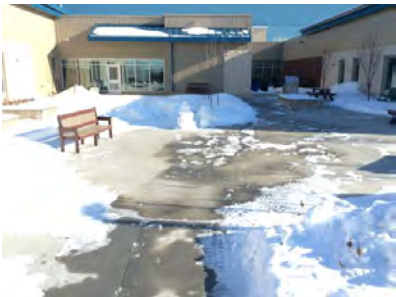
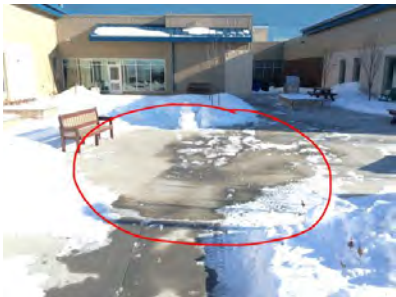
Description
Lack of saw cuts, cracking evident

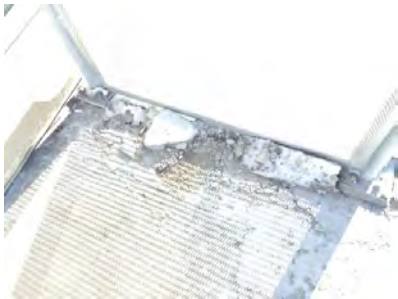
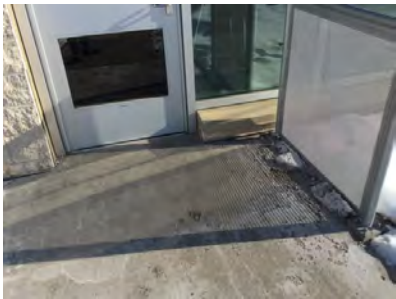
Description
Concrete spalling

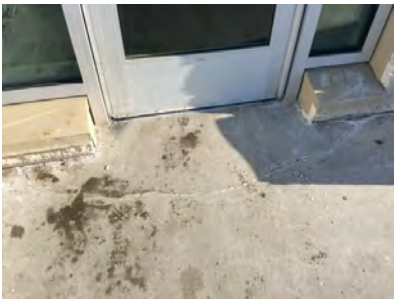
Poor quality ramp/transition
creating trip hazard

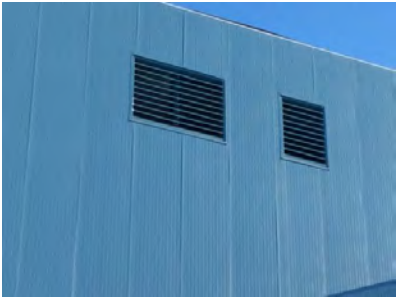
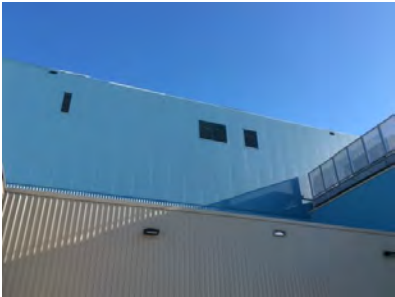
Description
Confirm expansion gap
requirement, some buckling
evident to wall panels

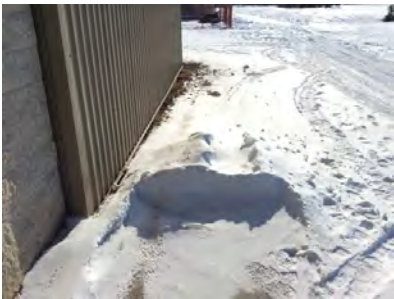
Concrete sidewalk stops here
does not extend to patient wing

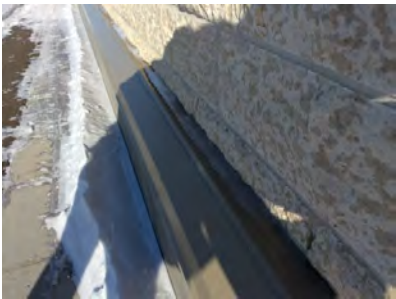
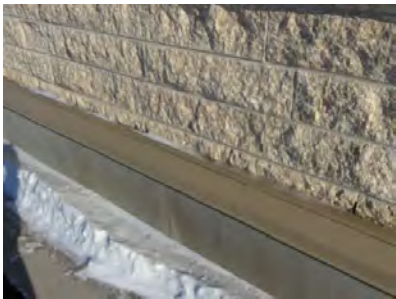
Description
Flashing sloped back towards wall

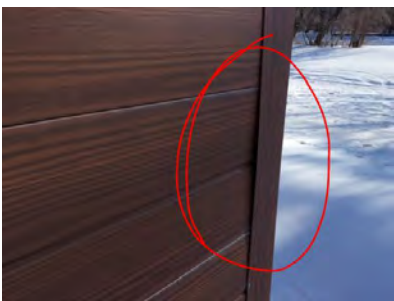
Confirm rivet centres with submittal, typical buckling to corners. Concealed fasteners required?

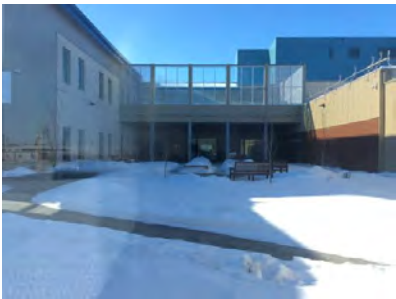
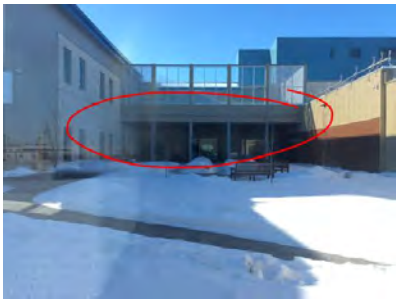
Description
Sprinkler coverage required to overhang?

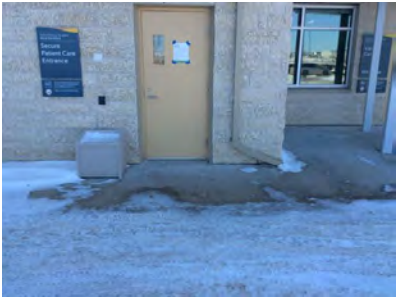
Description
Lack of saw cuts, cracking evident

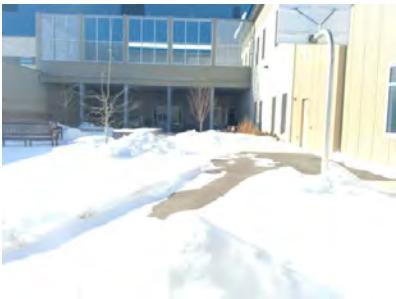
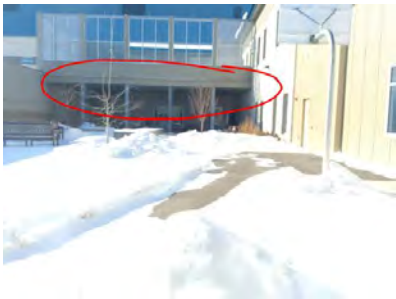
Description
Sprinkler coverage to overhang?

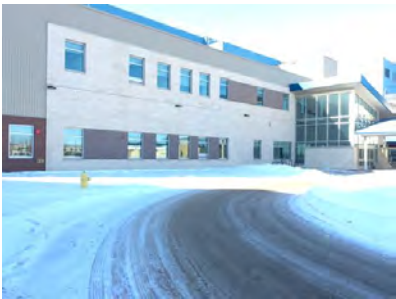
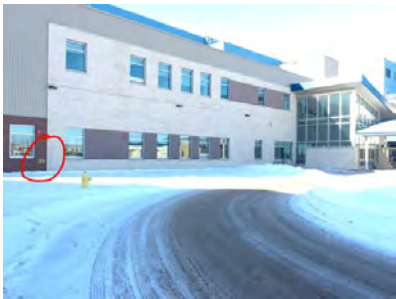
Description
Fire department connection
appears more than 15 m from
the main entrance, appears to
be closer to 30m

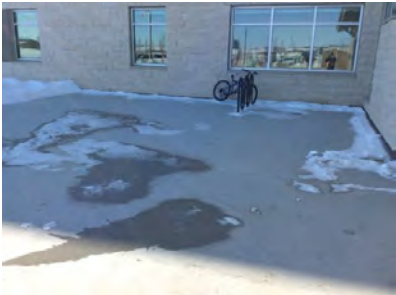
Description
Lack of saw cutting

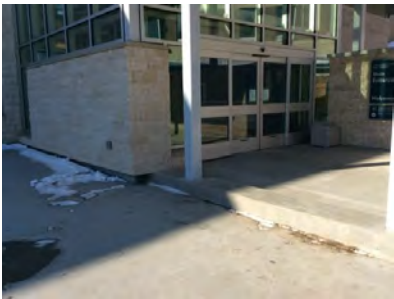
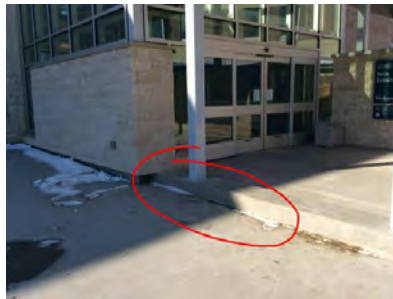
Unconventional approach
condition to the building

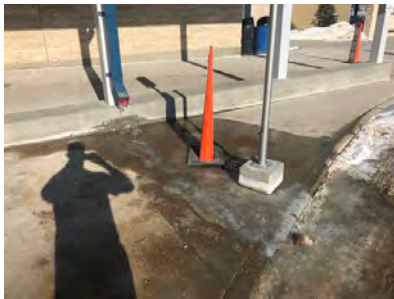
20200221_112847_photo

Possible infection prevention & control weak point

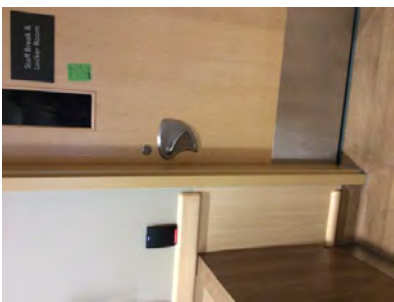
20200220_110134_photo

Rooms appear to have STC rating as drywall goes up to deck but no hardware sweeps

seals et. Applies throughout
suite

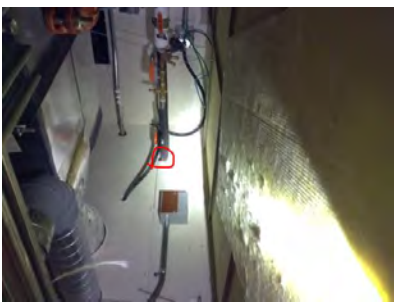
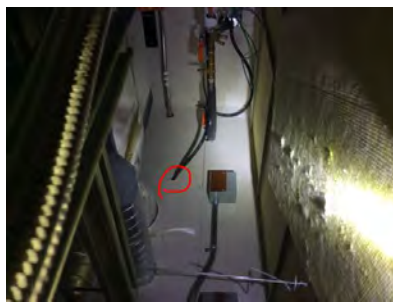
Fire seal appears to be missing on some penetrations through walls with FRR

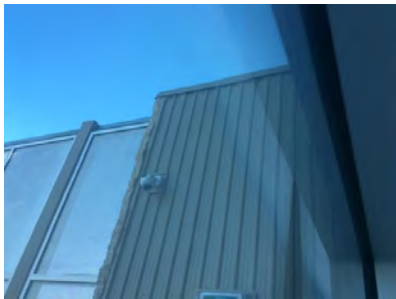
No step above suspended balcony

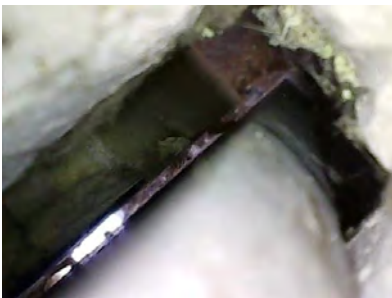
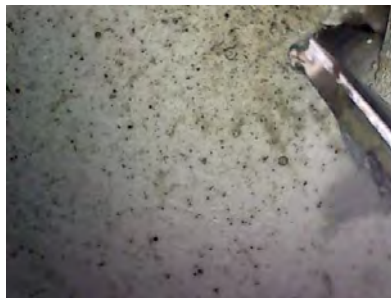
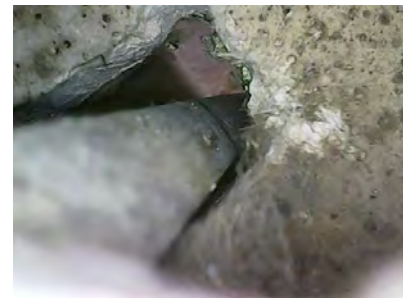
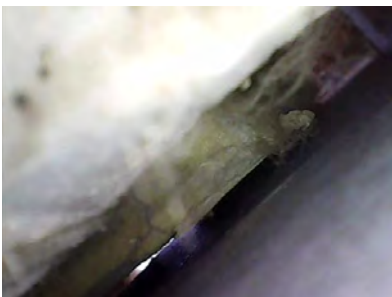
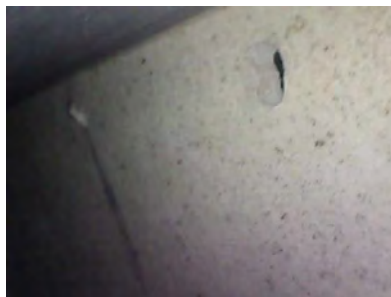
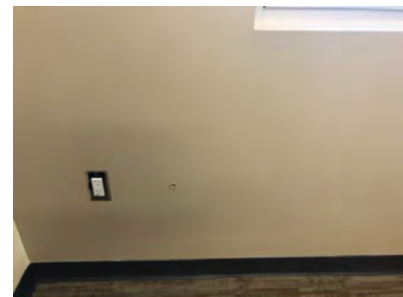
Exposed damaged Blueskin noted along base of wall above balcony deck

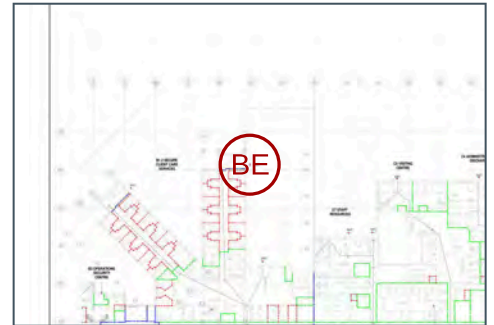
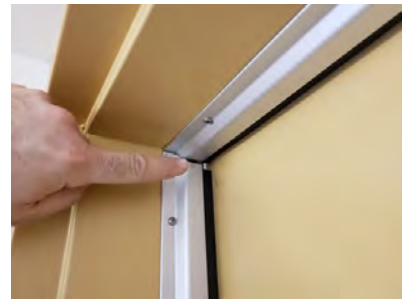
Exterior door weather stripping discontinuous and not adjusted to seal door to frame.

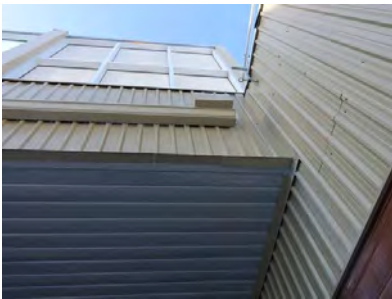
Issue 556

Stains on balcony soffit

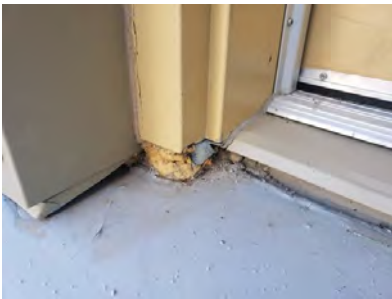
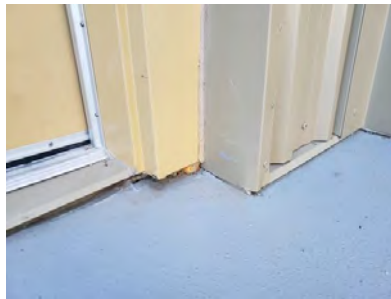
Exposed spray foam at bottom of door frame

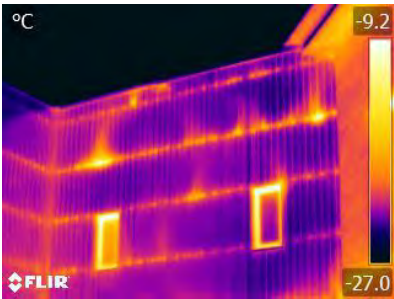
Sheet
A00-05

Description
Increased heat loss at various locations in east exterior wall

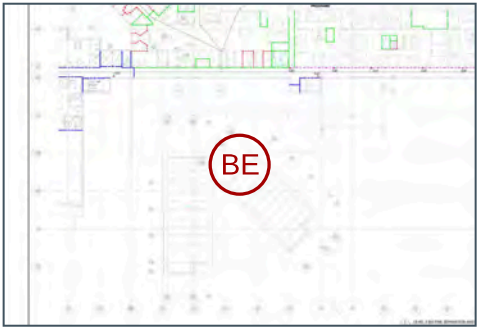
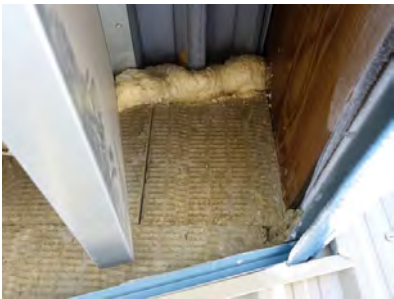
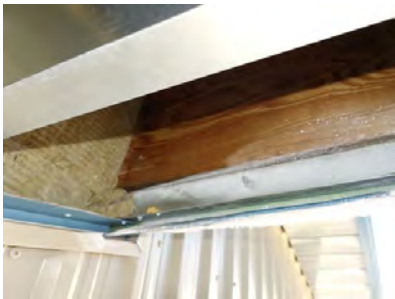
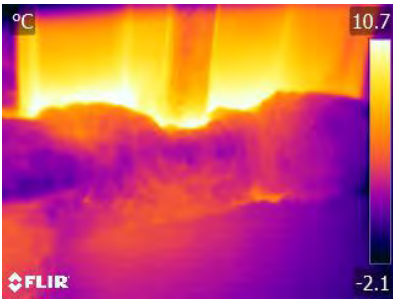
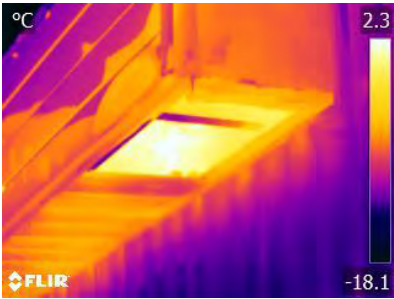
Sheet
A00-05

Description
Air leakage between top of exterior wall and sloped roof, resulting in wet surfaces inside soffit. Frost also visible on exterior metal surfaces

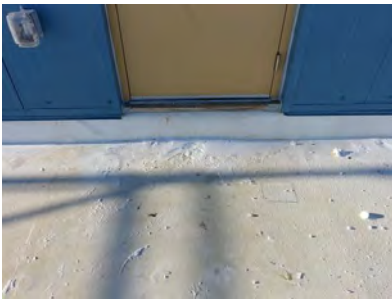
Issue 564

Missing sill flashing below
exterior door above roof

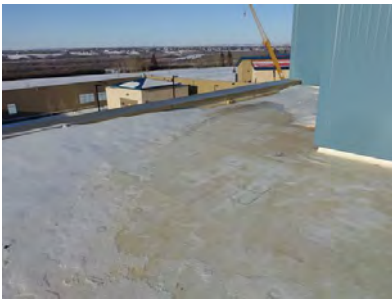
Numerous roofing patches which is indicative of poor workmanship

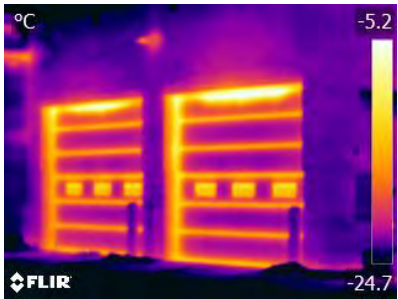
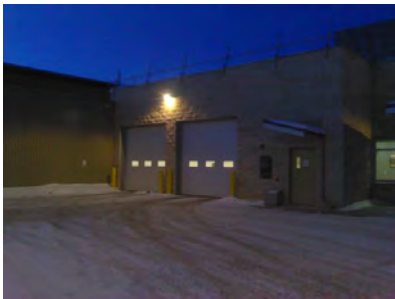
Sheet
A00-03

Description
Air Leakage above overhead doors

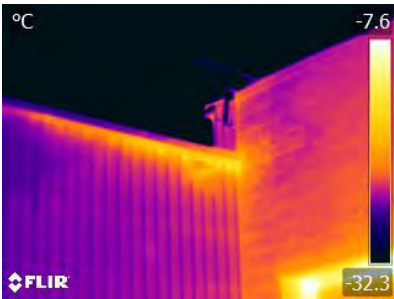
Sheet
A00-03

Description
Increased heat loss at top of wall at northeast corner of building.

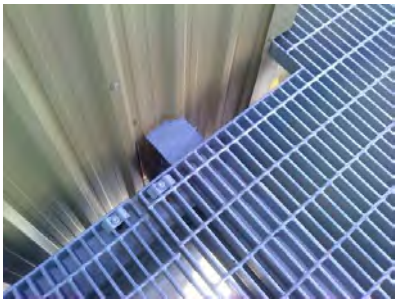
Sheet
A00-07

Description
Increased heat loss at exterior wall penetration

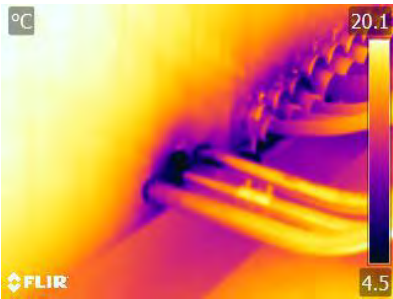
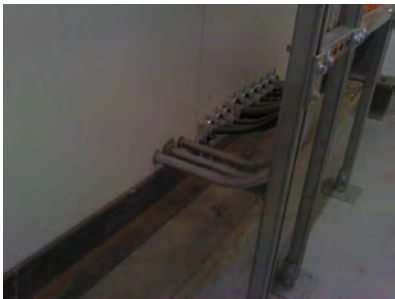
Sheet
A00-07

Description
Poorly sealed electrical
penetrations through insulated
metal panels

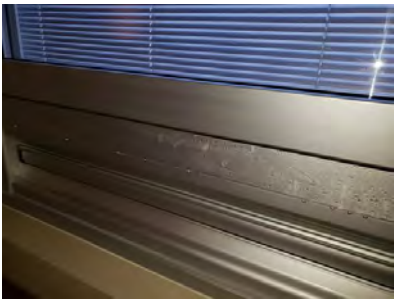
Sheet
A00-04

Description
Condensation on interior face of aluminum window frames in unit with higher humidity

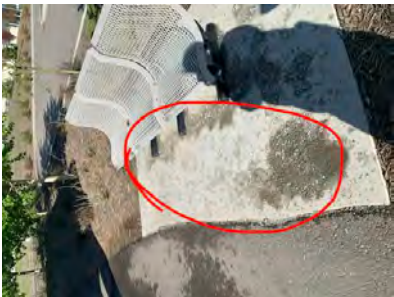
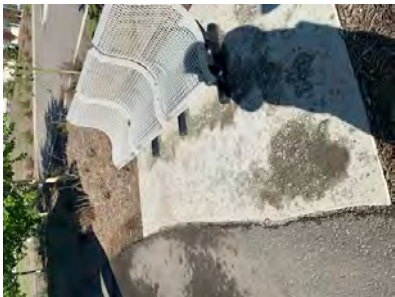
Sheet
A01-02

Description
Concrete deterioration

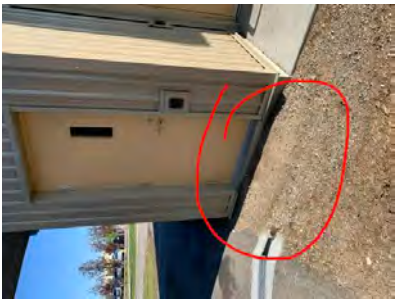
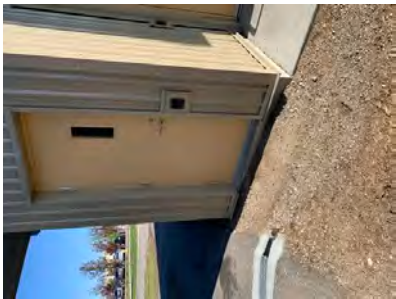
Sheet
A01-02

Description
Missing concrete pad? Outside
reintegration unit C

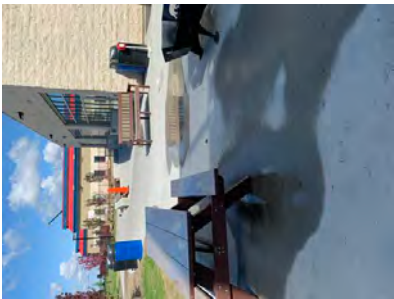
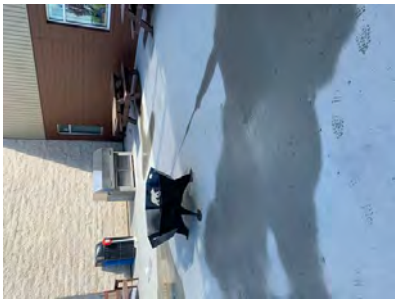
Sheet
A01-02

Description
No intervening joints on concrete. No control joints on pad

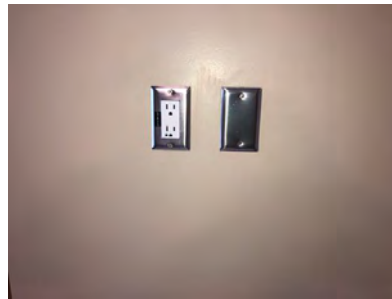
Non tamper proof receptacles.
Should be a safety requirement.
What is intent of outlet. Too
high? No grommet to
receptacles below desk.

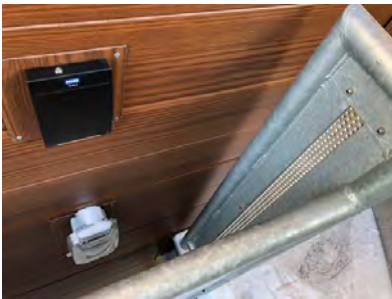
E1-464. Smoke detector may be too close to diffuser.

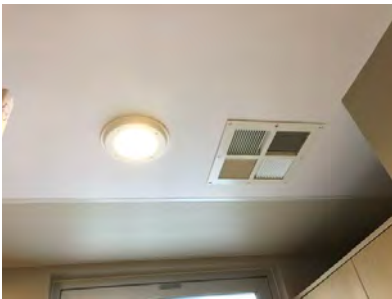
Why are there horn strobes only in the washrooms in patient wings? It would be very loud in the washrooms, quiet in the patient rooms.

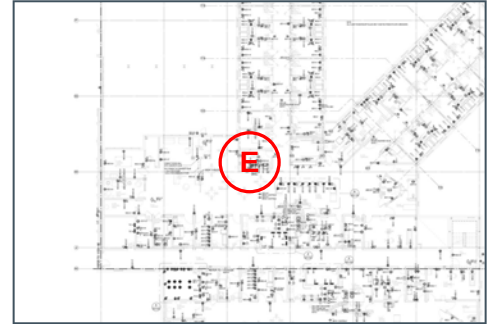
receptacle not present - blank
coverplate

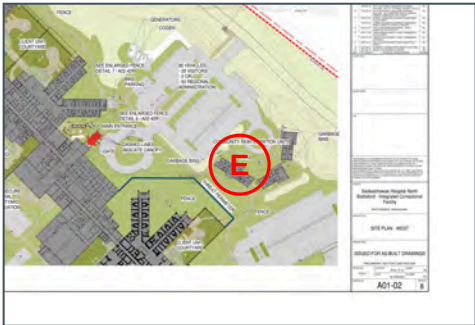
Sheet
A01-02

Description
Security camera not installed on exterior soffit

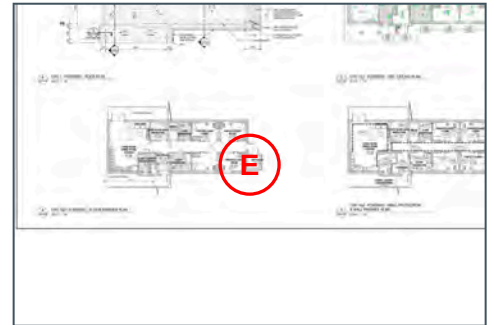
A02-33R

CRU-2: electrical enclosure box
improperly cut to fit into space
behind data rack

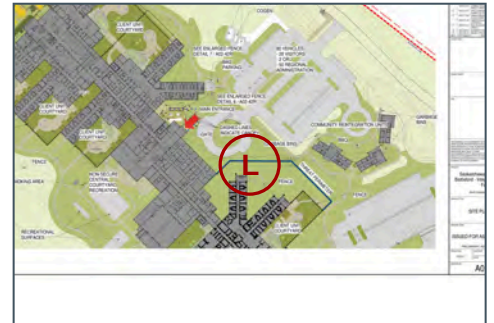
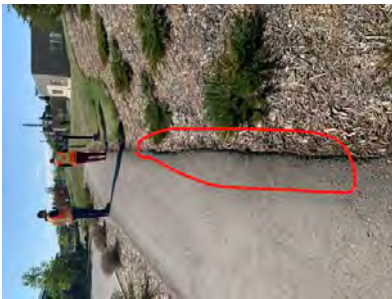
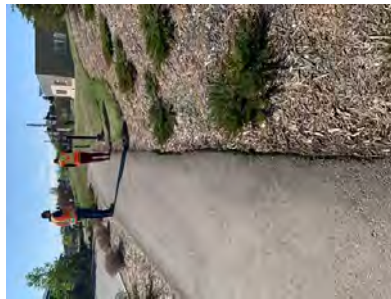
Edging on the path appears to be non-compliant for wheel chair accessibility

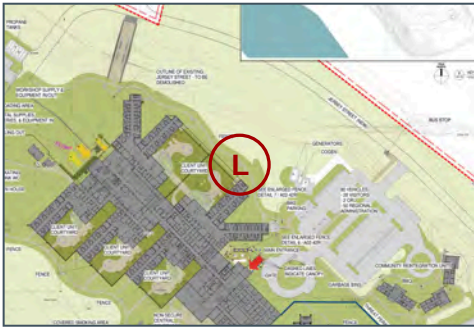
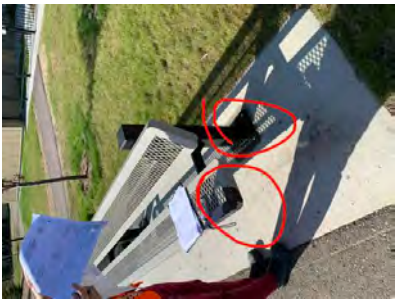
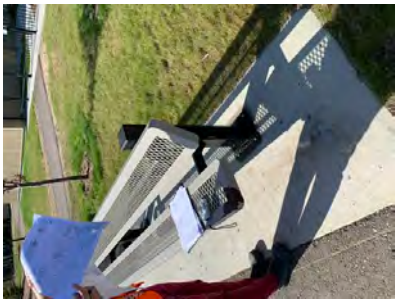
Sheet
A01-02

Description
Furniture is deteriorating and rusting. Bench centred and not accessible.

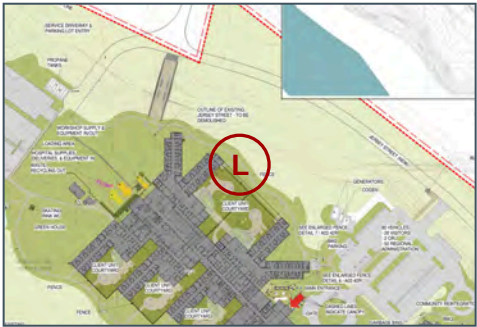
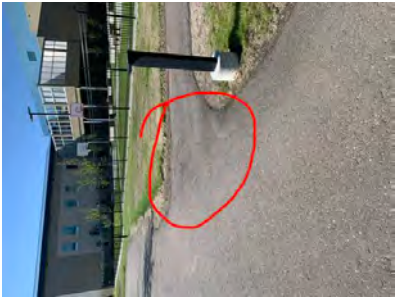
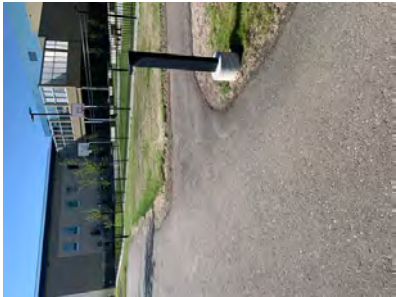
Sheet
A01-02

Description
Tactile strips missing?

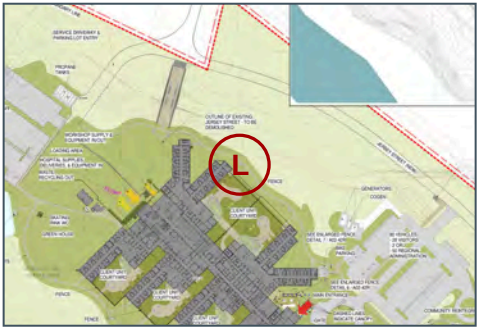
Sheet
A01-02

Description
Different bench styles.

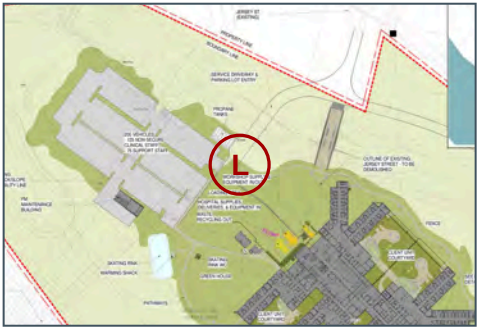
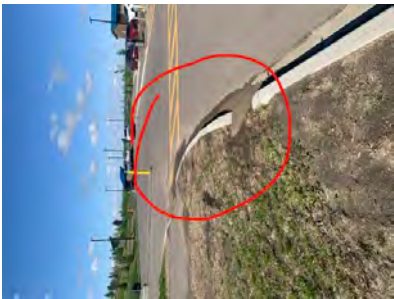
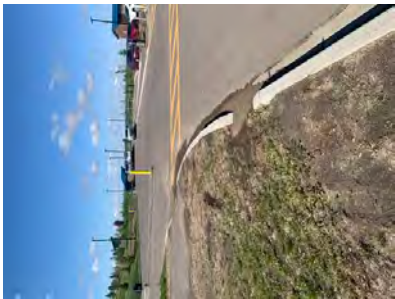
Sheet
A01-02

Description
Pounding at pedestrian crossing. Near staff parking lot

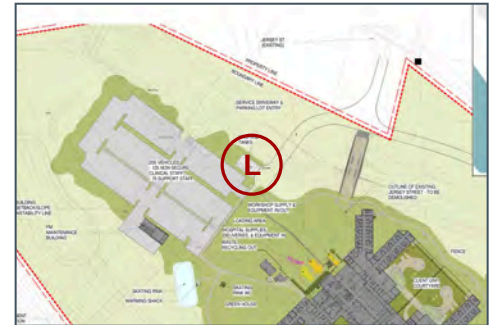
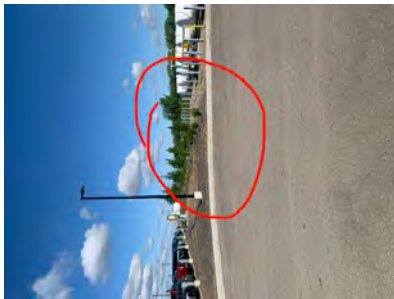
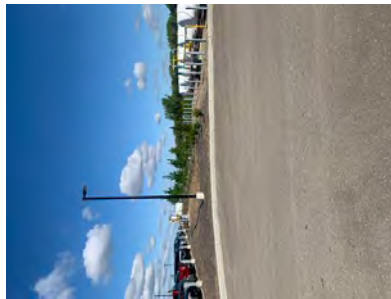
Location of propane tanks differs from plans. Not aligned with layby. Fence around propane tanks?
