APPENDIX C – PlanGrid Task Report

PlanGrid Task Report - Aug 19, 2020

Prepared by James Holtom

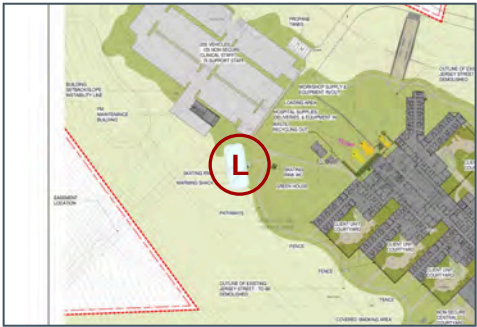
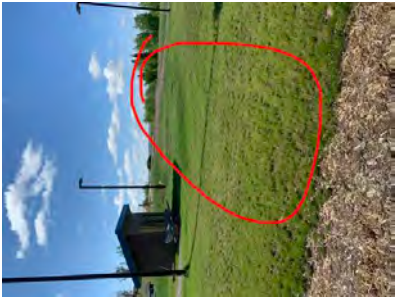
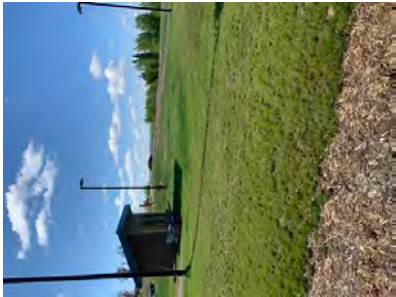
Sheet
A01-02

Description
Missing rink?

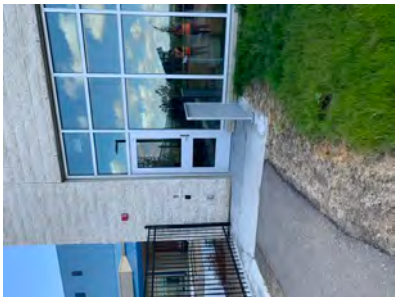
#656 Landscape

Description
Lines missing?

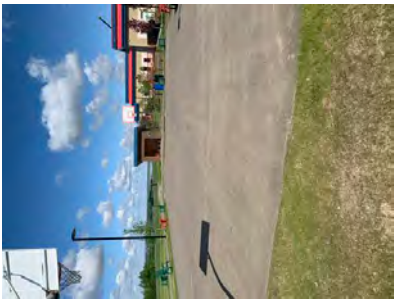
#657 Landscape

No control joints on concrete entrance.

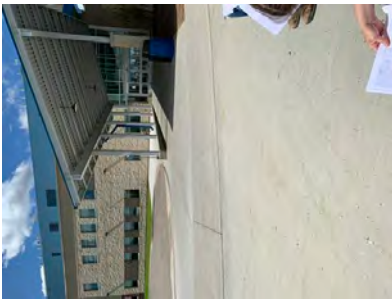
Description
Tripping hazard.

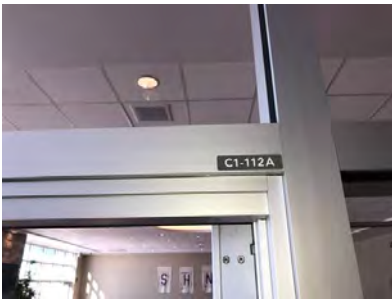
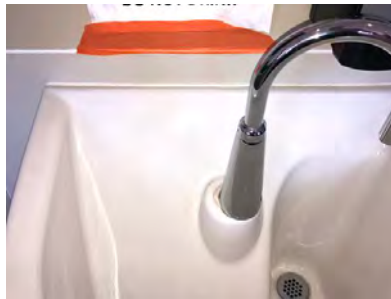
#22 Mechanical

Sink faucet is loose. Risk of damage. C1-112A

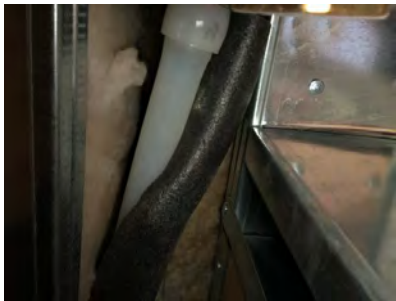
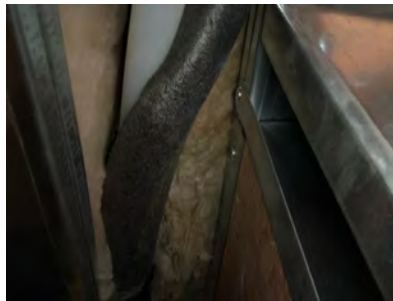
Access panel outside E2-450.
Pex insulation not on properly.

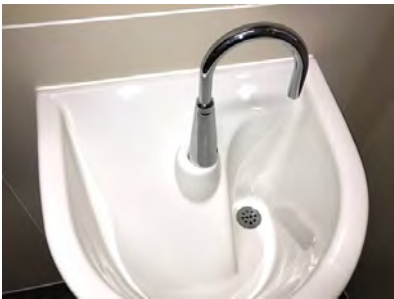
Description
C2-049. Sink faucet loose.

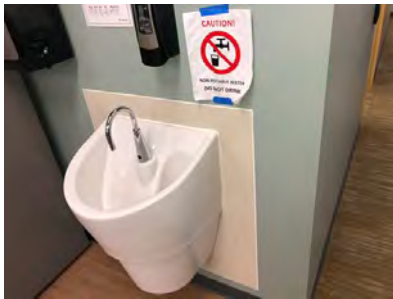
#132 Mechanical

Sink has too much pressure.

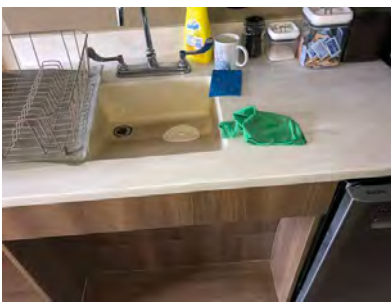
CRUs - Hand washing sink only.
Dish washer is not large enough
for pots.

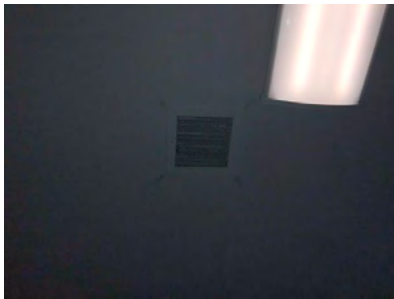
CRUs - HVAC diffusers have leaks. Pushing dust into space.

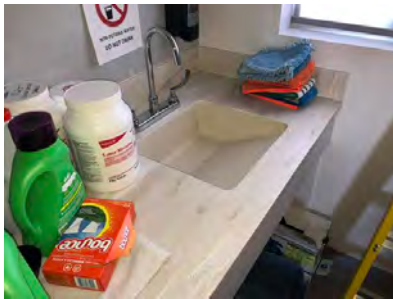
Laundry sink is very small. Hand washing only.

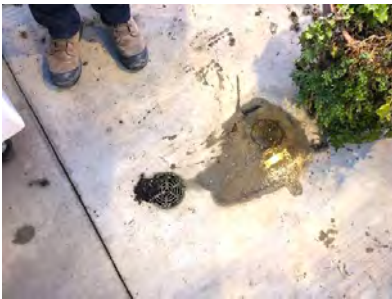
Greenhouse - Drain not at lowest spot on floor.

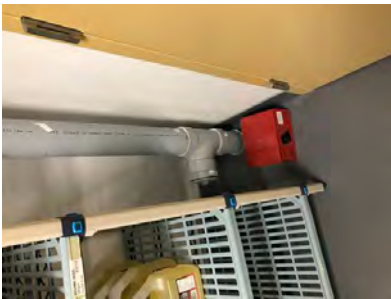
Exposed pipe in C0-126B.

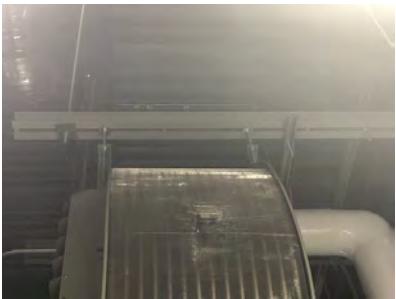
Description
Penthouse - Unit heater has no isolation

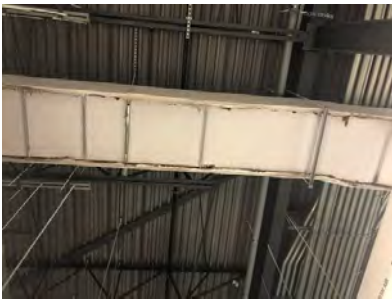
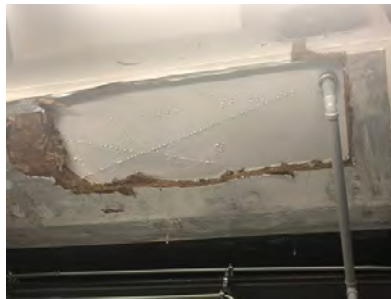
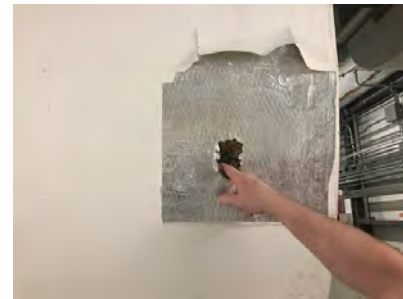
#208 Mechanical

Penthouse - Outside air duct has holes and ice buildup. Many ducts have holes in insulation.

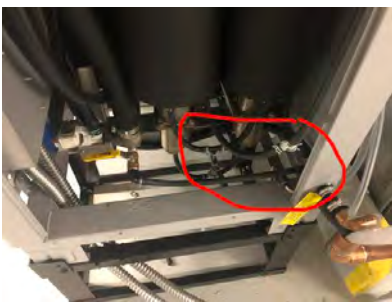
20200219_080318_photo

Penthouse - Humidifier piping is leaking. Manufacturer parts.

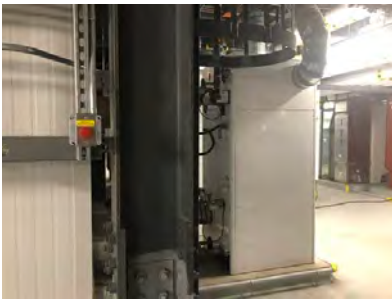
20200219_081430_photo

Penthouse - Emergency off push button is small and not well marked or protected. Not visible from boilers.

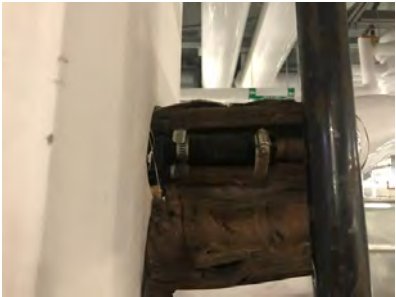
20200219_082844_photo
James Holtom
Feb 19, 2020 8:28 AM

Description
Penthouse - Corrosion of line.
Unsure if its purpose.

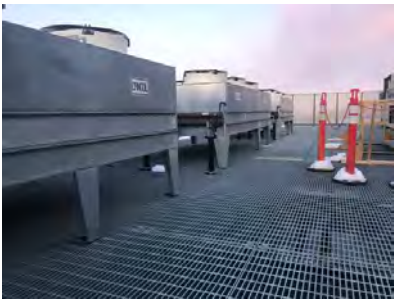
Description
Penthouse Outside - No
isolation on dry coolers.

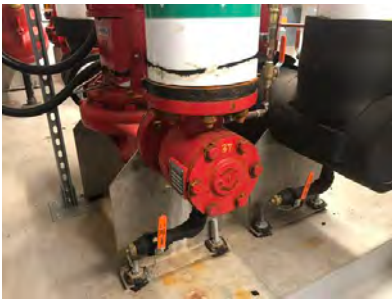
20200219_083158_photo

Penthouse - Corrosion issue on pump.

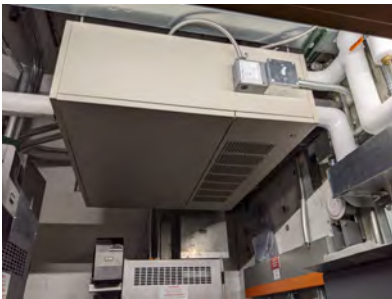
IMG_20200219_083352.jpg

Elevator equipment room
cooling fan coil placement
prevents access to electrical
panels on wall.

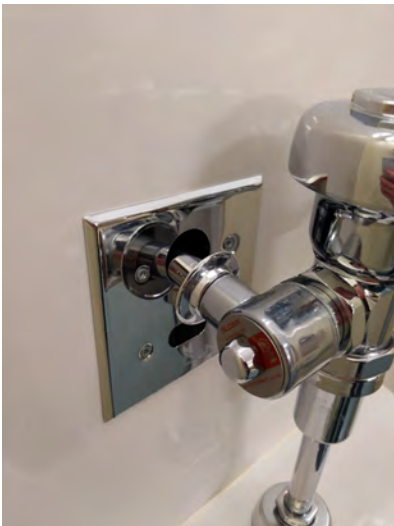
20200219_124342_photo

Wire connection to urinal flush valve not good quality construction

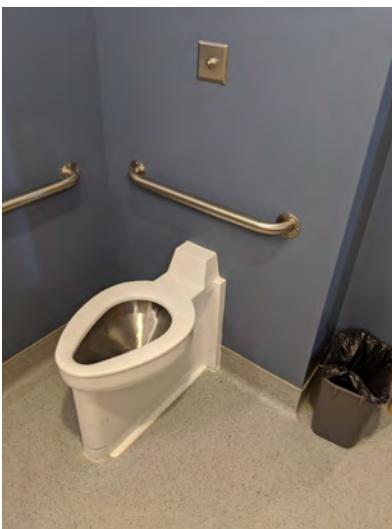
IMG_20200219_141544.jpg

Pipes rattle when vacuum toilet flushed. Piping not secured enough. Not as bad as other unit.

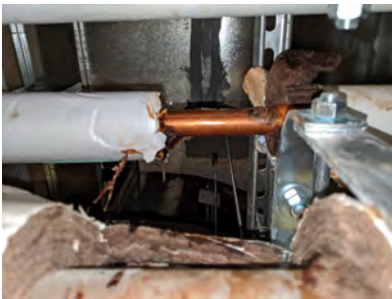
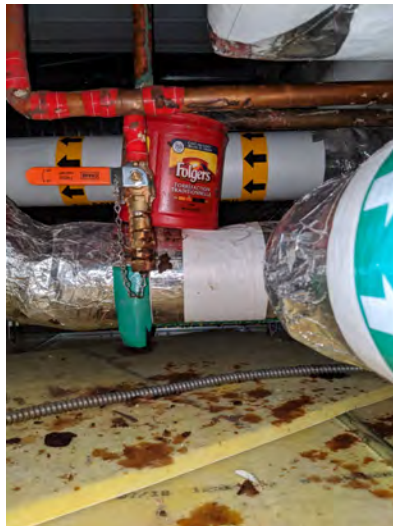
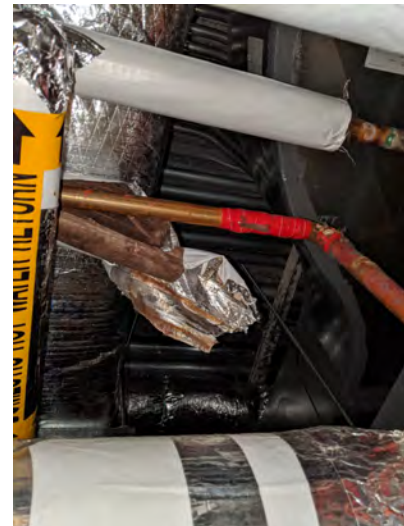
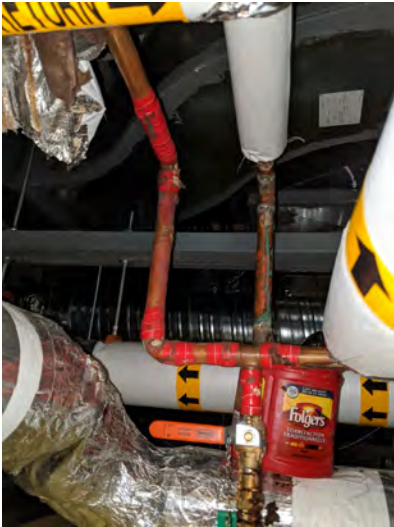
Leak in domestic hot water and DHW recirculation lines & elbows. Pipes partially sealed with tape. Coffee can collecting drips. Ceiling tile damaged.

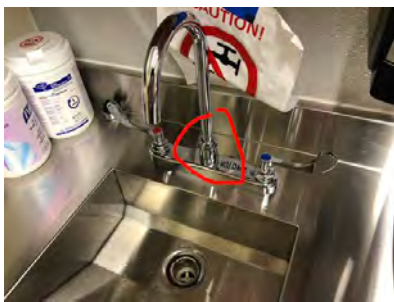
E1-426B - faucet isn't very easy to remove. Only requires finger strength.

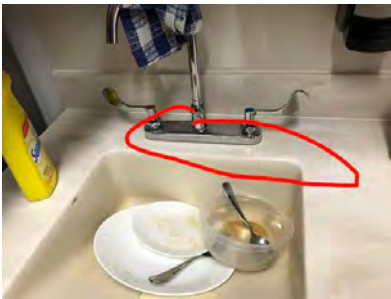
E1-427B - faucet isn't very loose. Faucet ran for over 30 second.

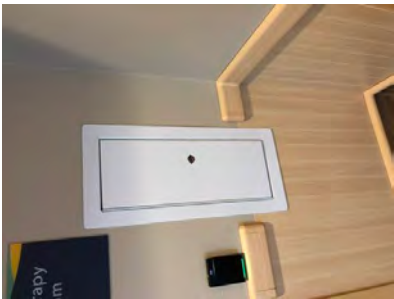
Description
Fire extinguisher cabinets are not easily identifiable.

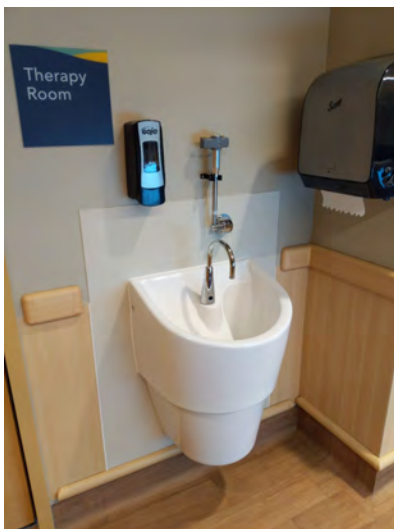
Hand wash faucet was warm.
Thermostatic mixing valve
setpoint.

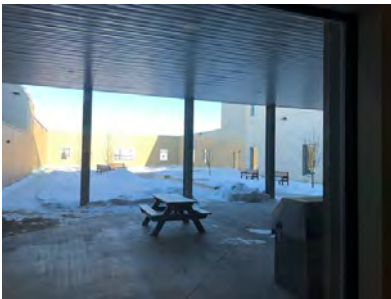
Is this a gathering space that would require a sprinkler system?

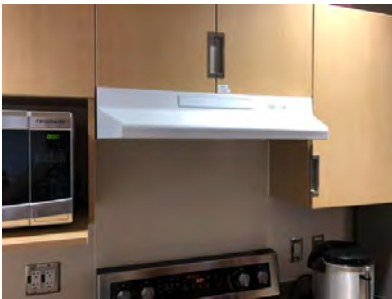
Where does kitchette exhaust connect to?

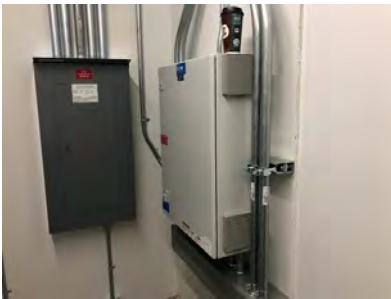
E1-008. Heat generating in service room with no exhaust or cooling. What is temperature trend?

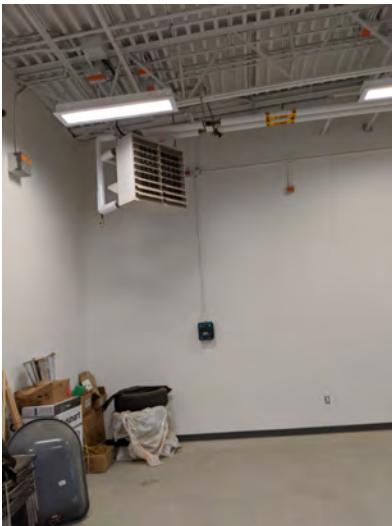
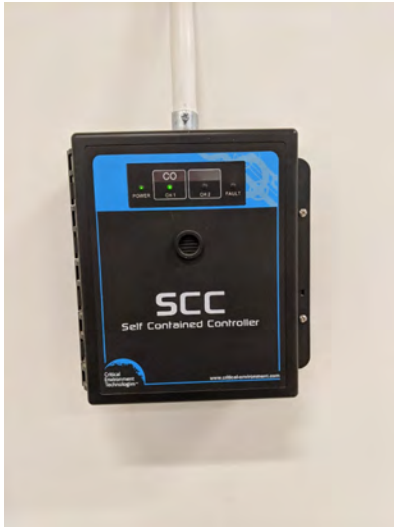
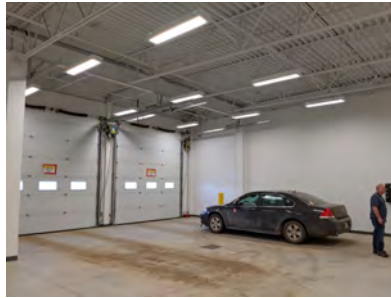
No ventilation for vehicle sally port. Unit heaters and CO detector only. Code violation.

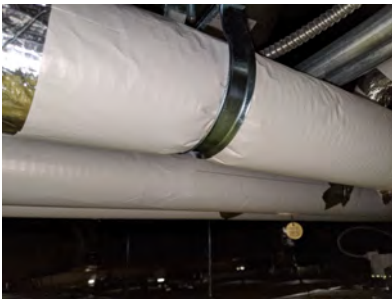
Pipe support lacking appropriate blocking / saddle. Insulation is crushed.

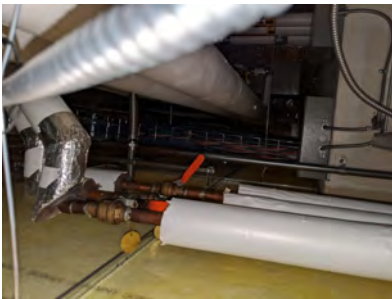
Hot water recirculation closed

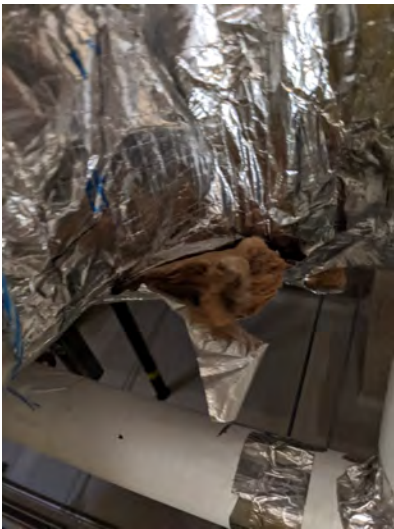
Leakage on duct main.
Insulation ripped away.

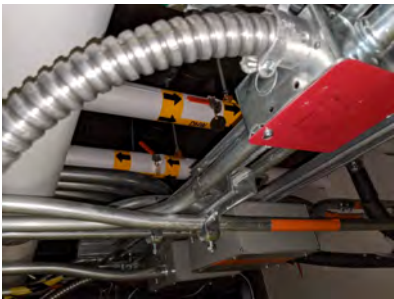
Description
Domestic hot water recirculation
partially closed.

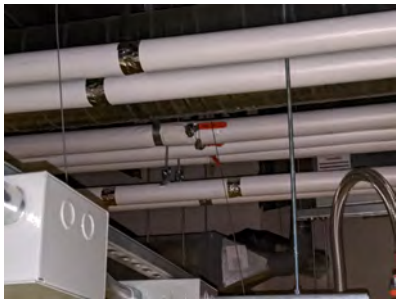
Description
Domestic hot water recirculation
turned off

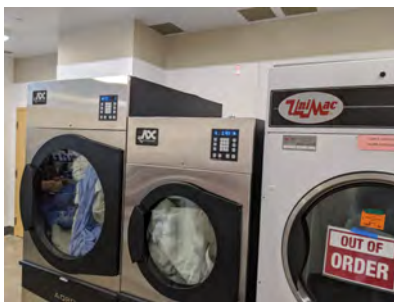
No provision for makeup air of dryer exhaust. Dryers draw air from general ventilation system.

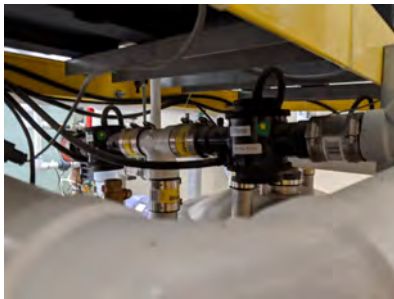
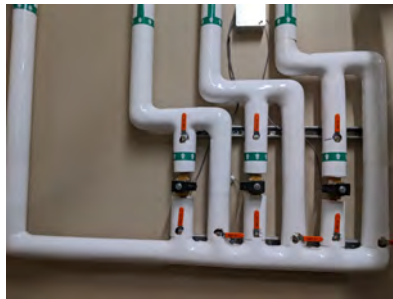
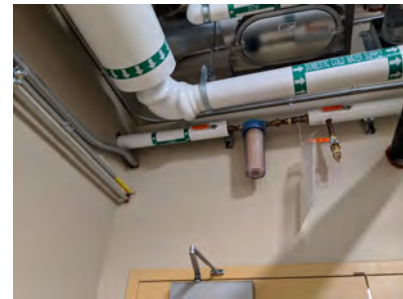
No backflow preventer for domestic cold water lines serving sanitary vacuum system.

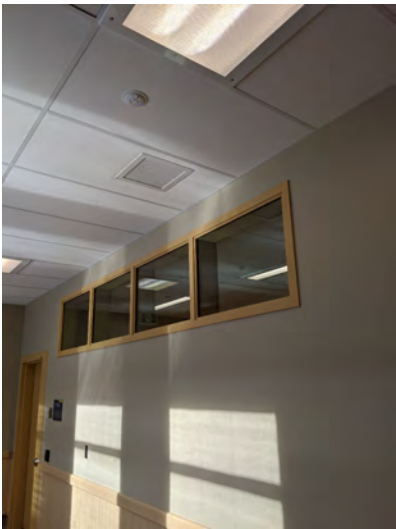
Description
Return air grille exceptionally loud

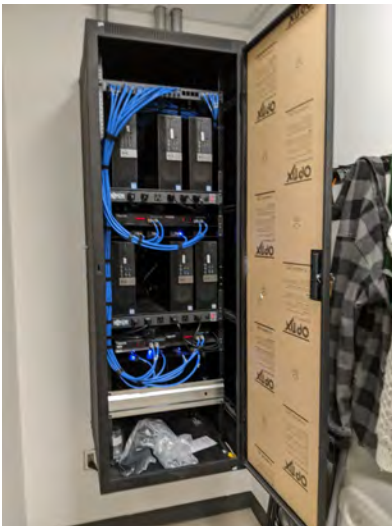
Equipment room warm.
Insufficient cooling?

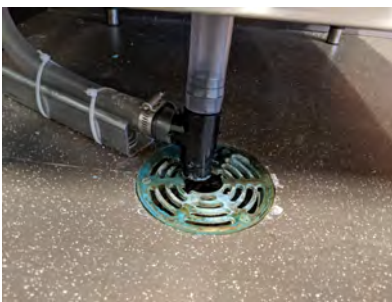
High copper content in domestic water causing discolouration and wear on floor drain.

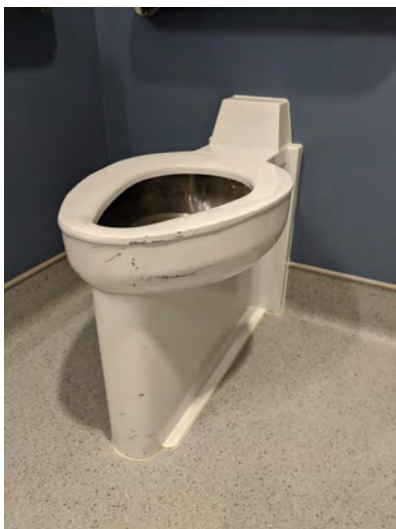
Vacuum water closet valve takes extended time to close. WC visibly scuffed / damaged.

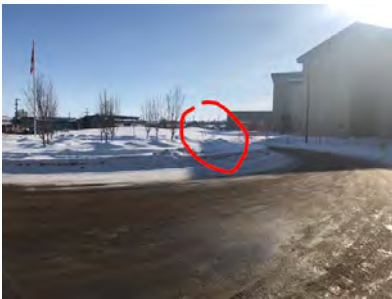
Main entrance. Grease interceptor vents near main entrance cause sewer gas smell.

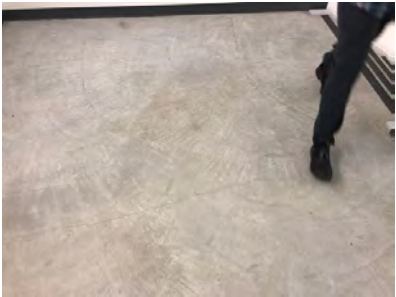
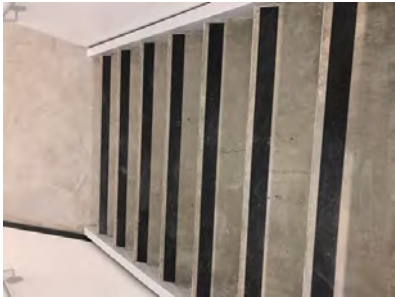
Description
Stairwell. Many cracks. Poor workmanship. Concern on rough finish and ability clean. Raw concrete.

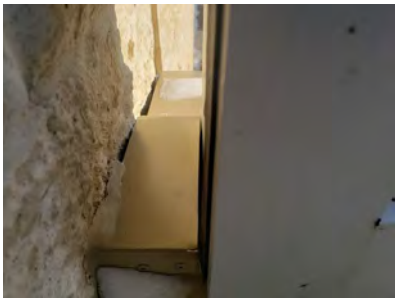
Missing, and/or poorly installed exterior sealant at balcony/ exterior wall junctions

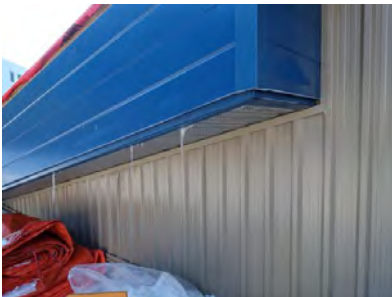
Frost on metal soffits and fascia

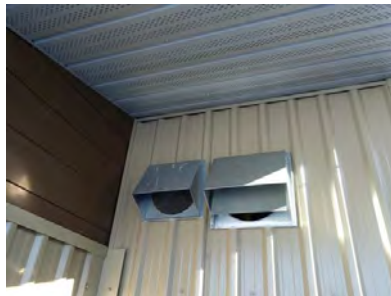
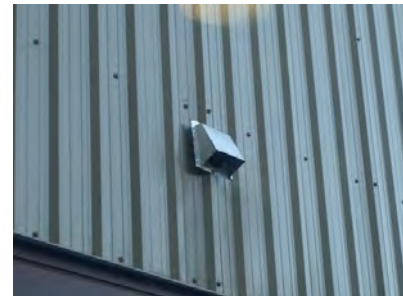
#567 Building Envelope

Exterior wall duct penetrations are not properly flashed or sealed

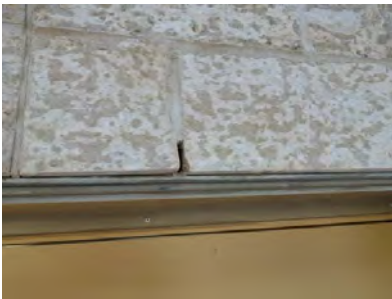
Missing and loose weep vents in brick cladding

missing weep vent

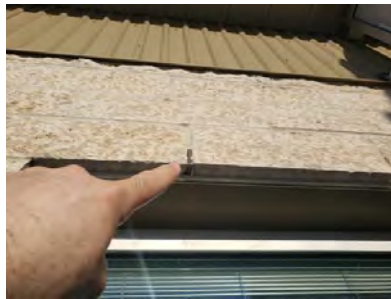
loose weep vent

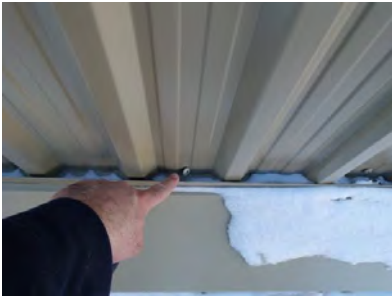
DSC02920

Loose fasteners at base of metal cladding, which could be used as a weapon
